## Lower Harbor Ore Dock Inspection Report

Marquette, Michigan

December 11, 2014

GEI Project No. 1330920

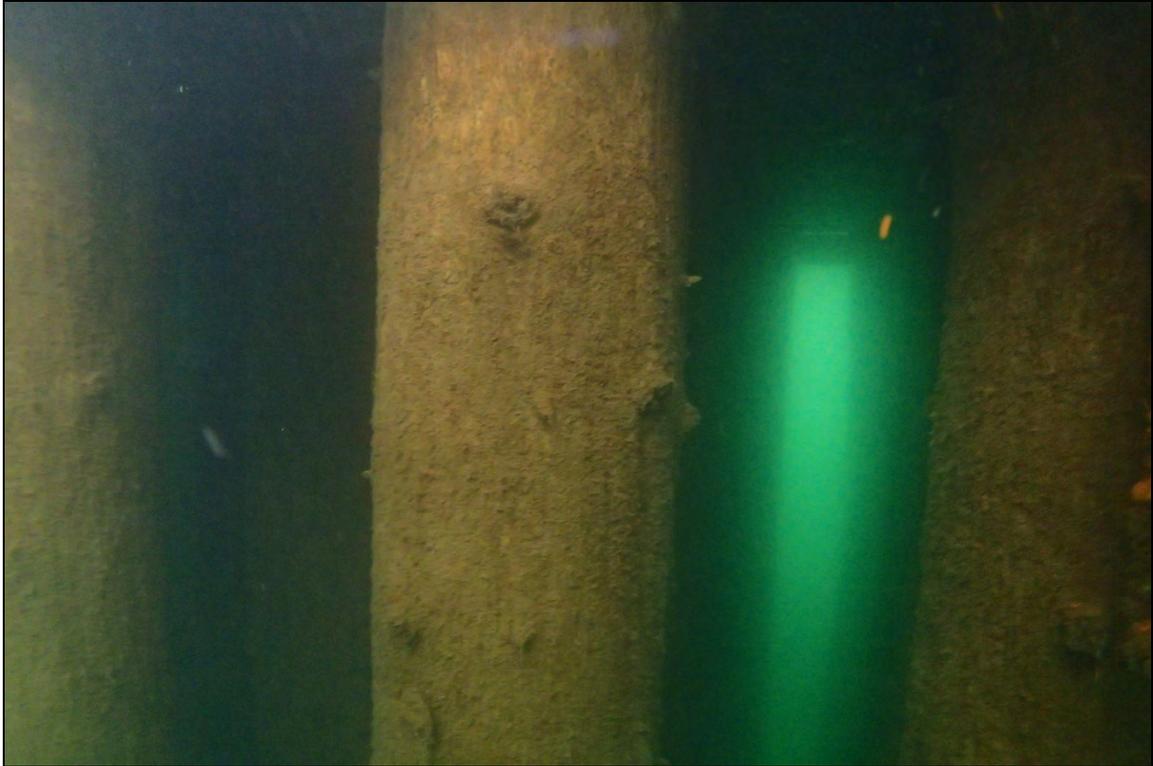
Photograph 4: Overall interior view of Ore Dock, Looking West.

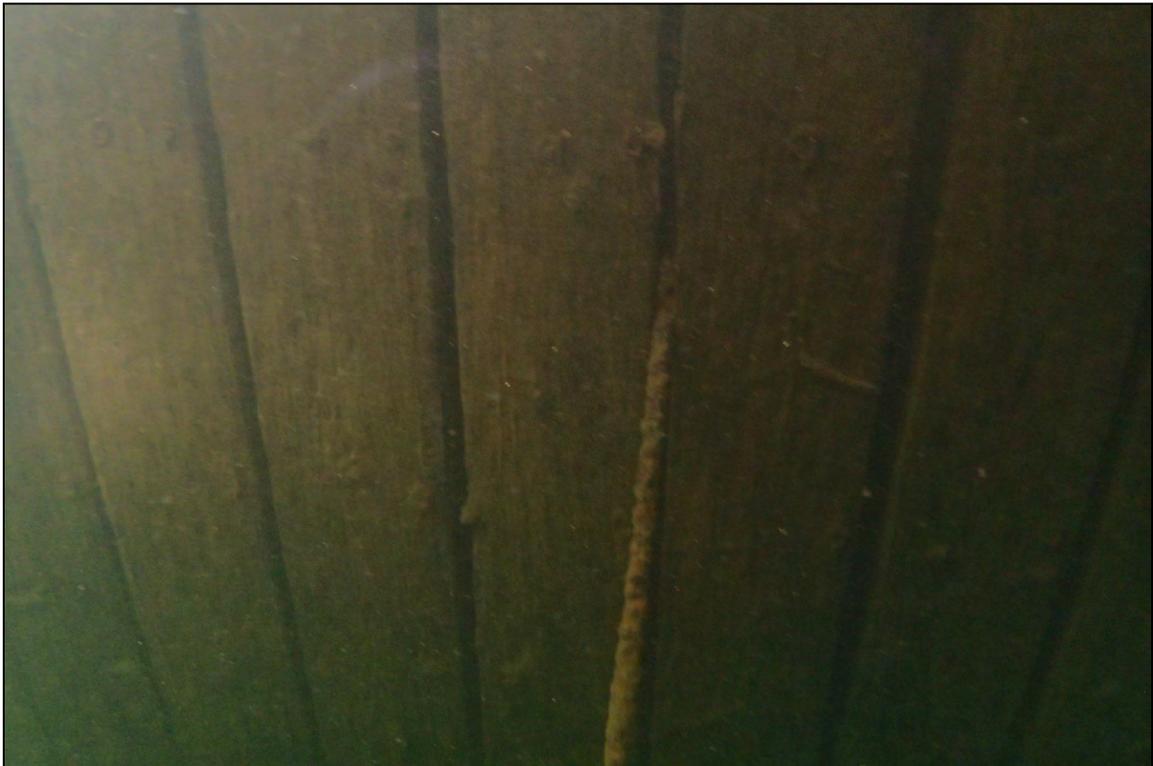
Photograph 5: Typical pile condition below water at interior of Ore Dock, Looking North.

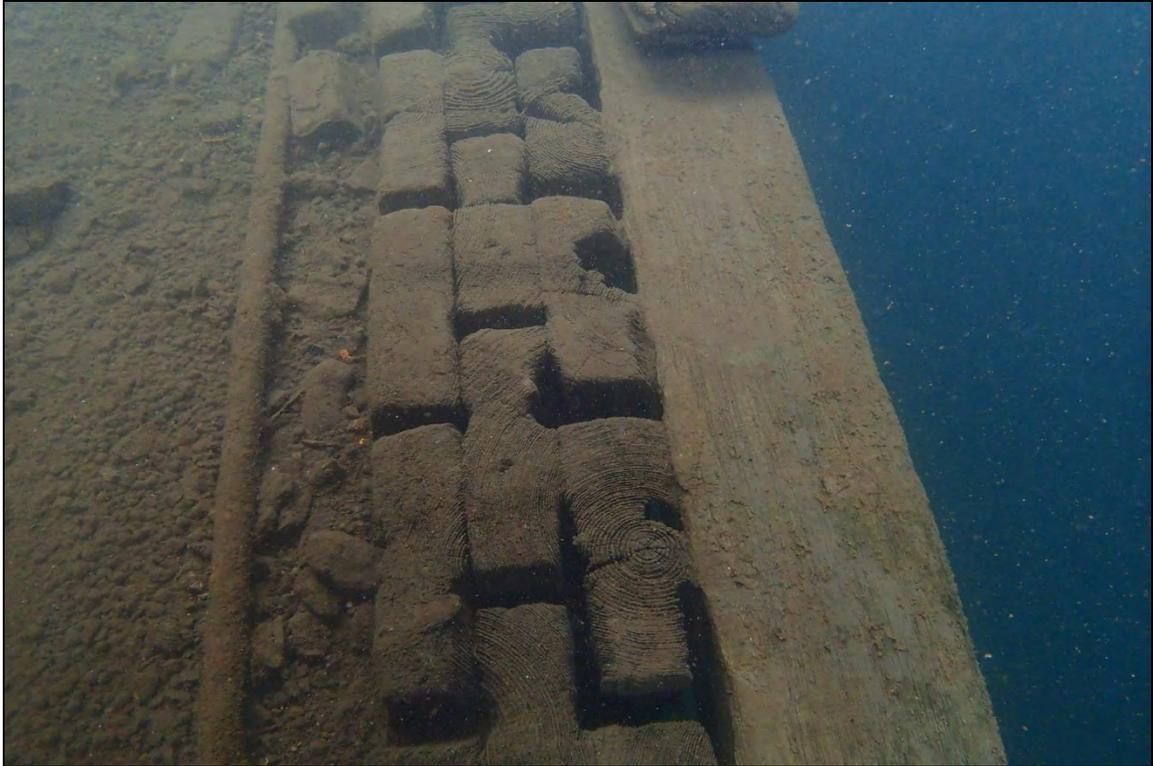
Photograph 6: Typical timber crib condition at interior of Ore Dock, Looking West.

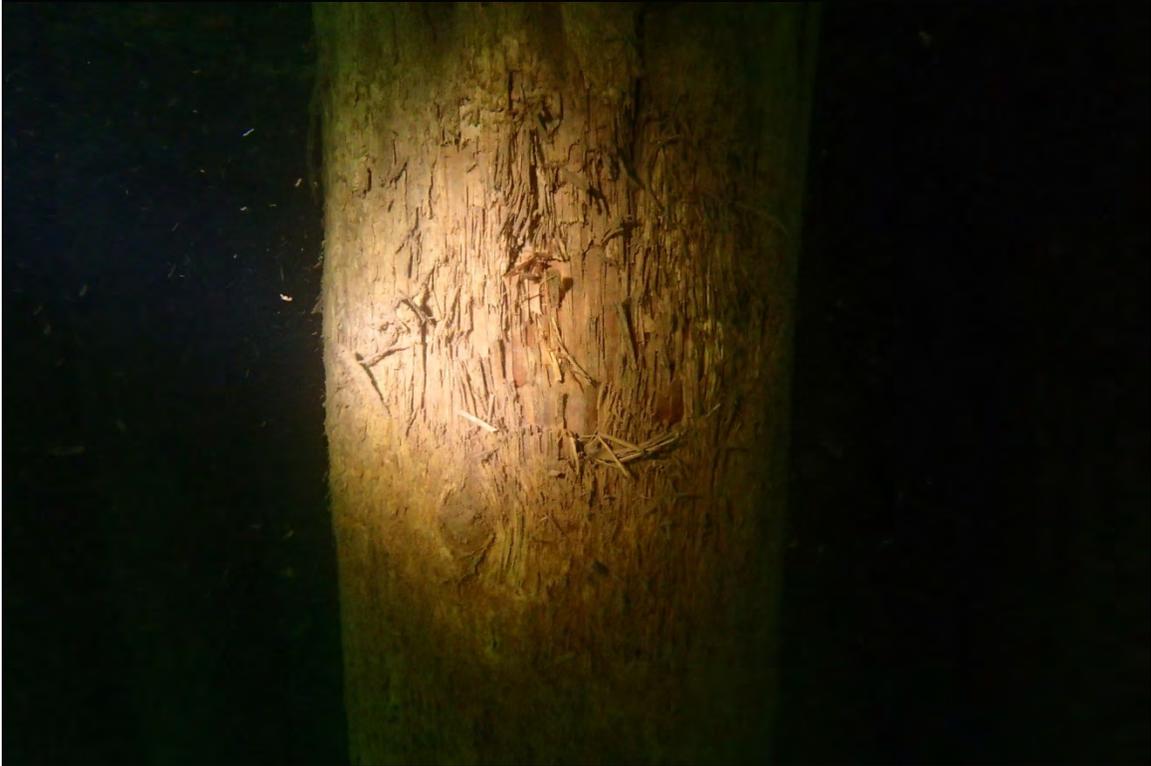
Photograph 8: View of delamination of outer shell at Pile 35J in Section 7.

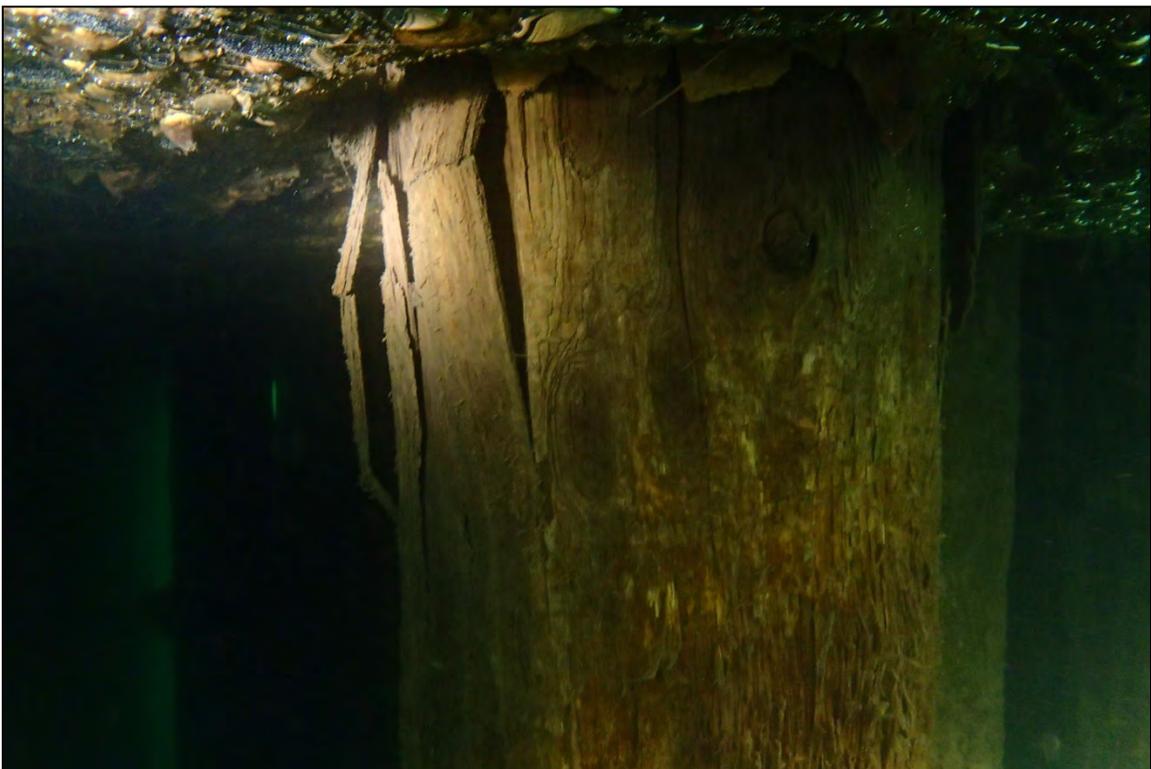
Photograph 9: View of abrasion damage at Pile 33J in Section 7.

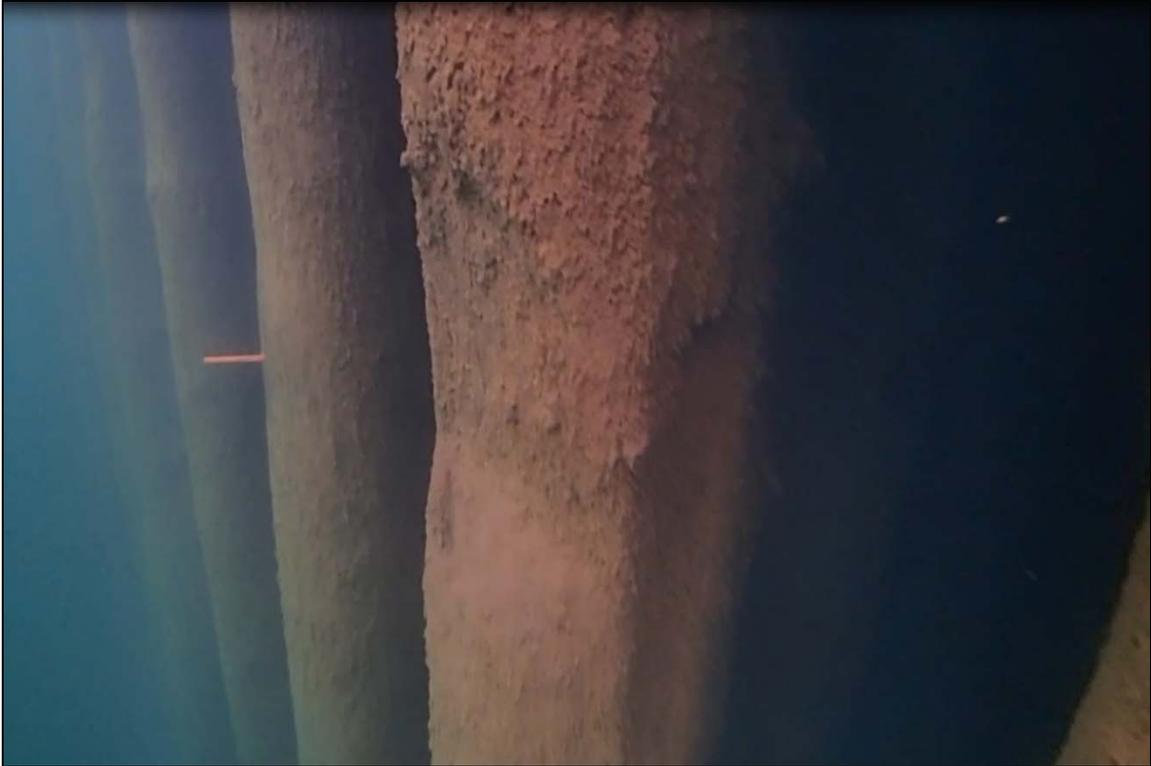
Photograph 18: View of loss of outer shell at Pile 40R in Section 6.

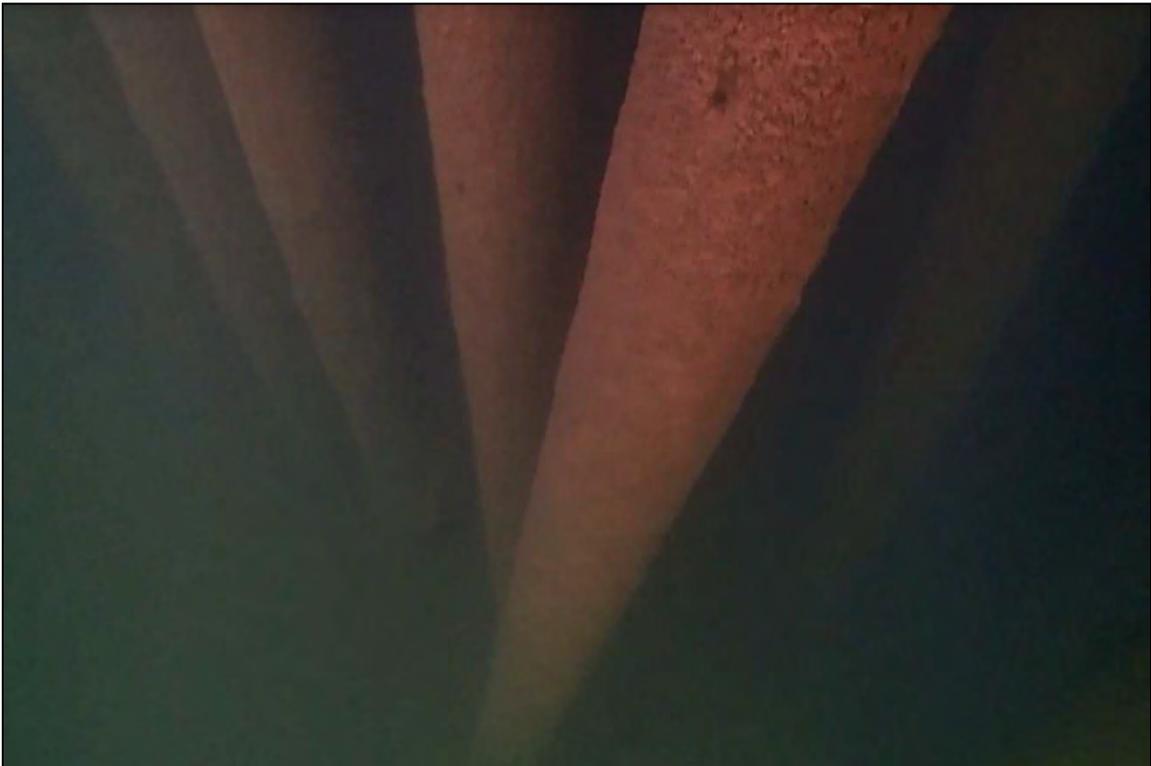
Photograph 19: View of abrasion damage at Pile 40R in Section 3.

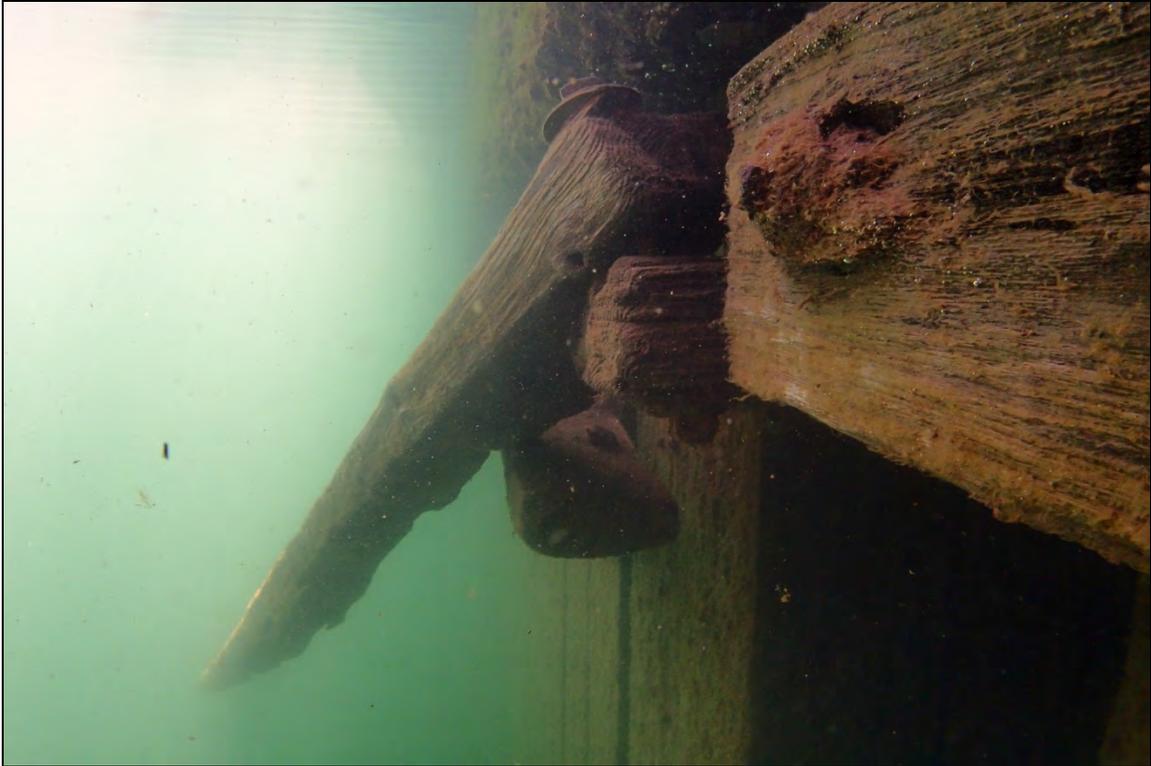
Photograph 22: View of split in Pile 35A in Section 7.

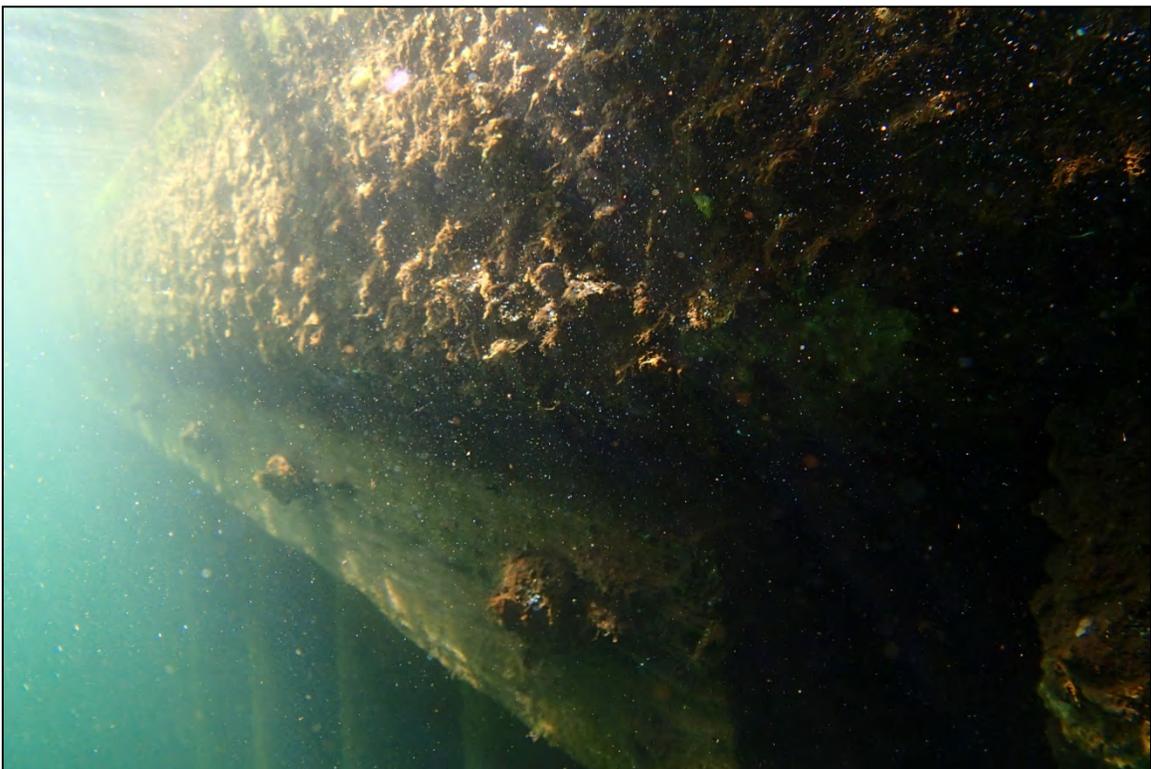
Photograph 23: View of broken timber wale on northeast side of Section 7, looking east.

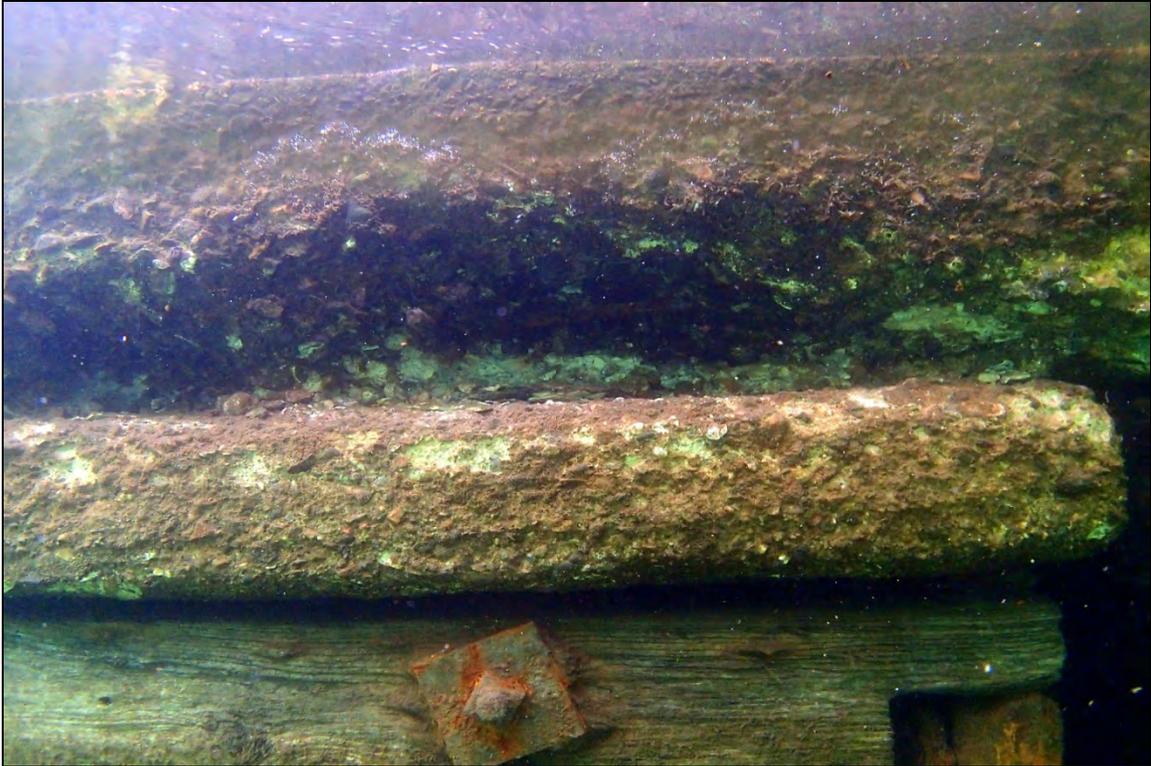
Photograph 24: View of typical concrete scaling on north side of Section 2, looking southeast.

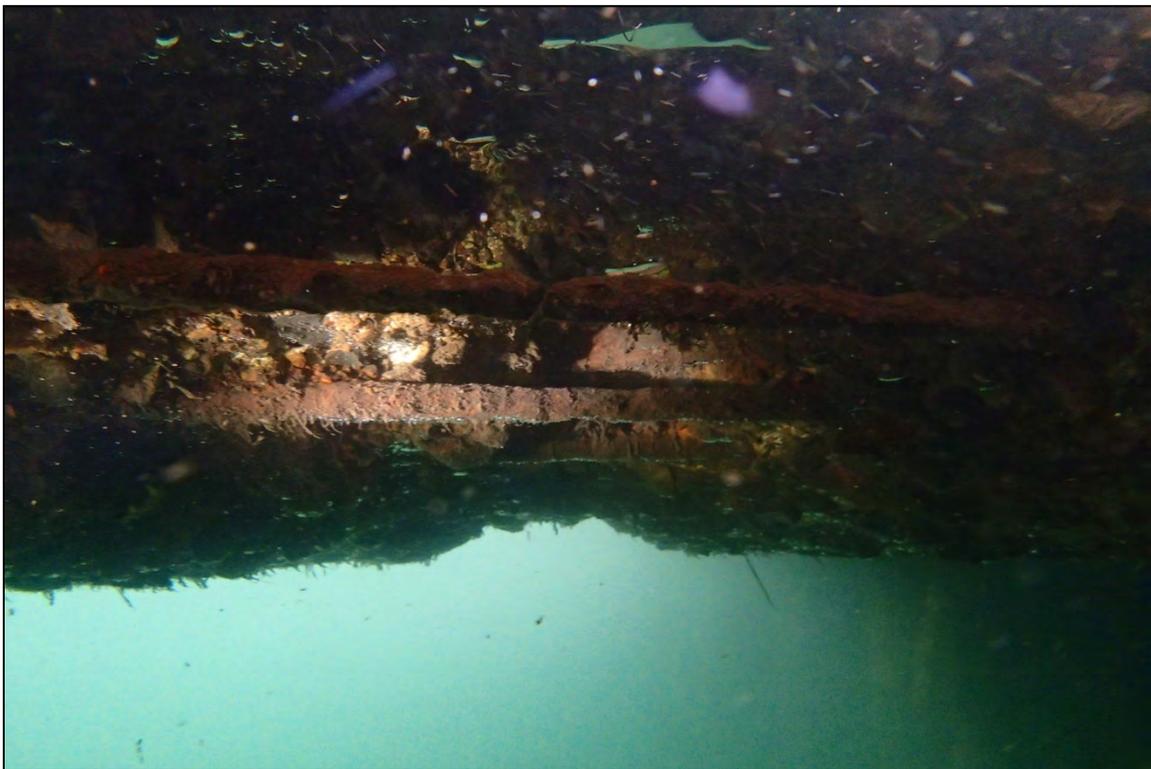
Photograph 25: View of typical concrete spalling above the timber cribs on the north side between Sections 5 and 6.

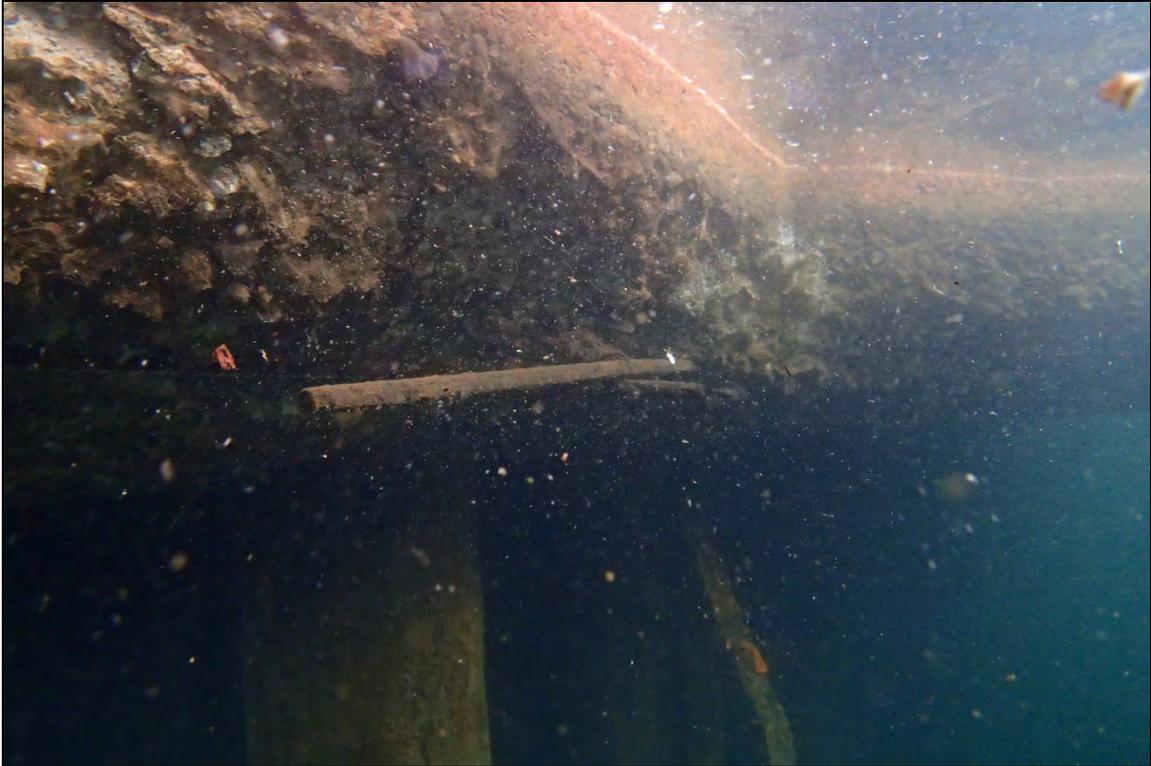
Photograph 26: View of concrete spalling at second transverse concrete section in Section 5.

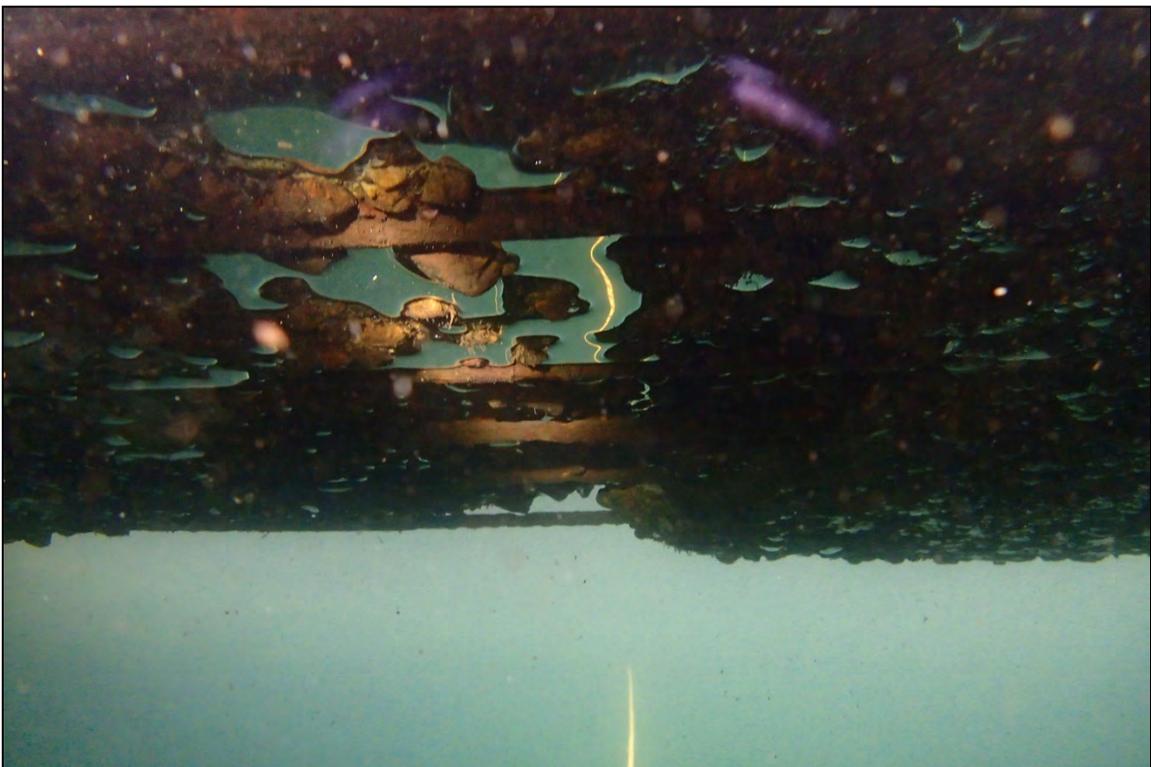
Photograph 27: View of concrete spalling on the north side of Bay 2 in Section 3.

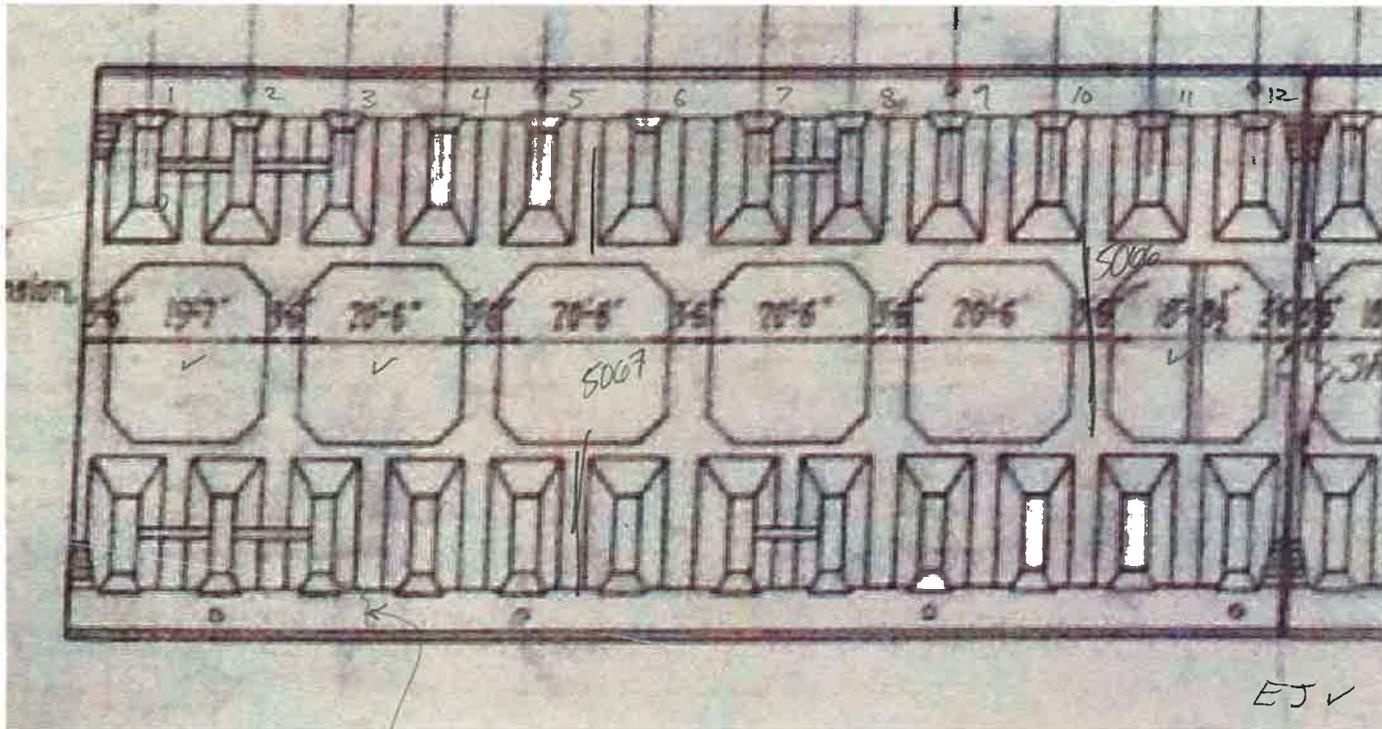
SECTION #: 1

cracks typical @ this locations

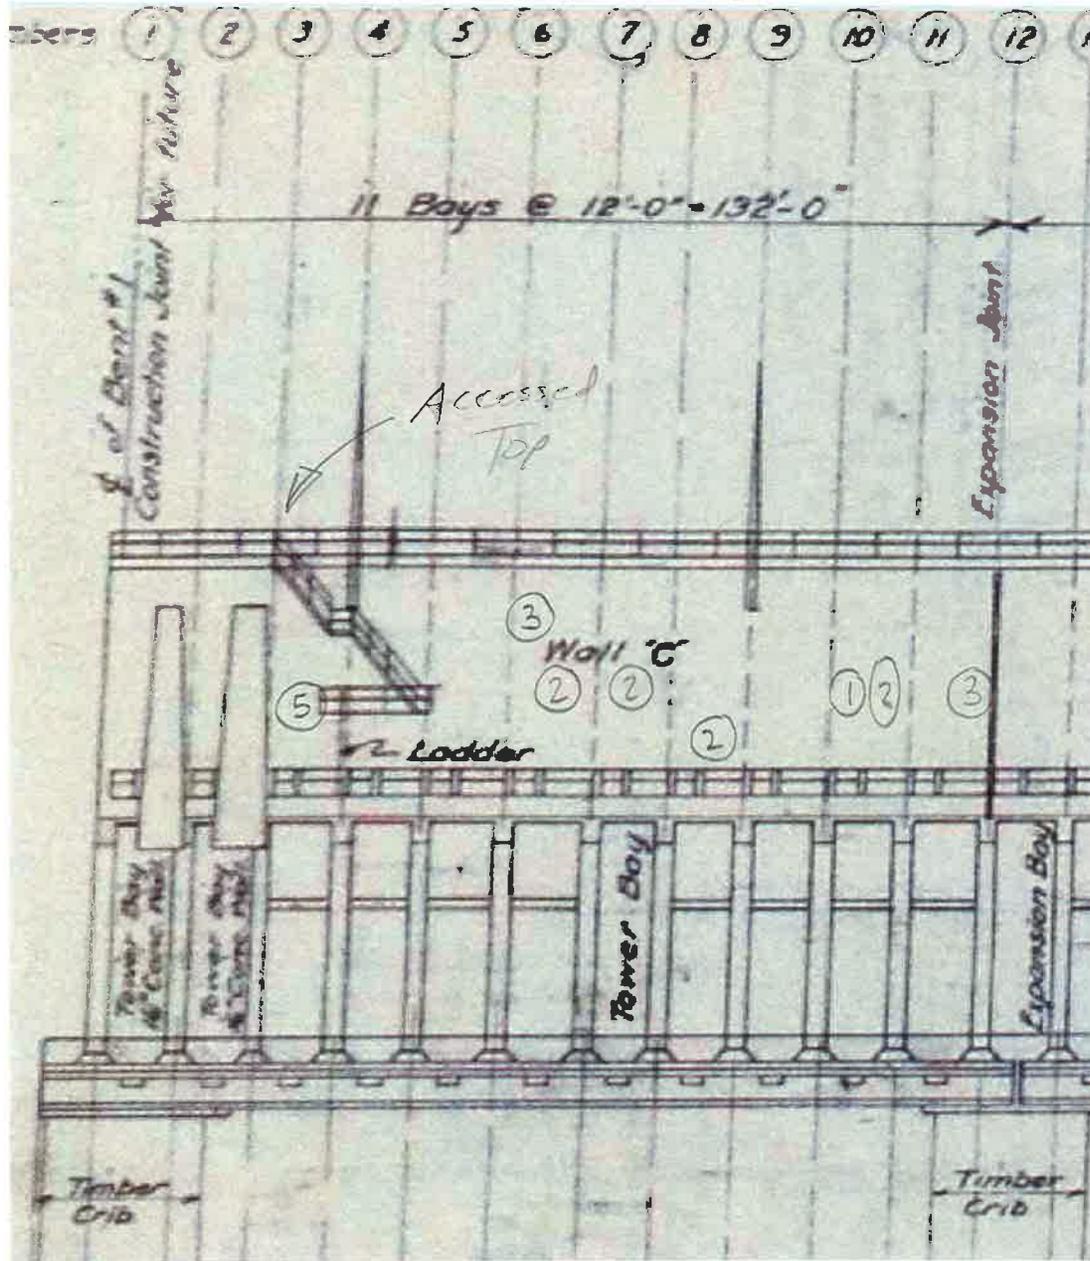
SECTION #1 (SOUTH SIDE)

Spalled concrete locations identified

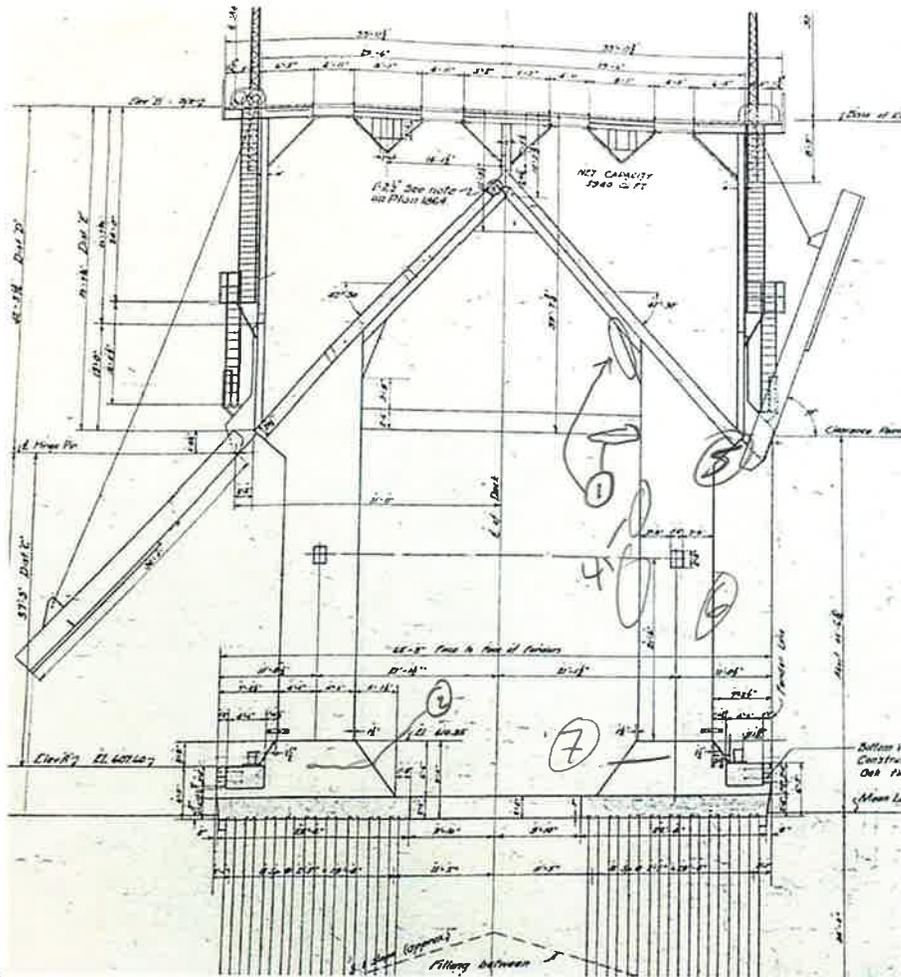
BENT #: 2

- ② crack along cold joint
- ③ vert. crack b/w 1 & 2 (4207)  
on north side
- ① spalled up exposed rebar (4208)  
Also cracks along b/w of beam  
Between 1 & 2 overlapping construction joint  
4281
- ④ Between 1 & 2 vertical crack on North side, on South face  
South: 4285/4286 Spalling > Cracking on  
North West edge.  
Between 2 & 3 vertical & Diagonal Cracking on  
North Face. 4287 4288  
Horizontal & Vertical Cracking on South Face of 203
- ⑤ Cracking & Spalling occurred along overlap

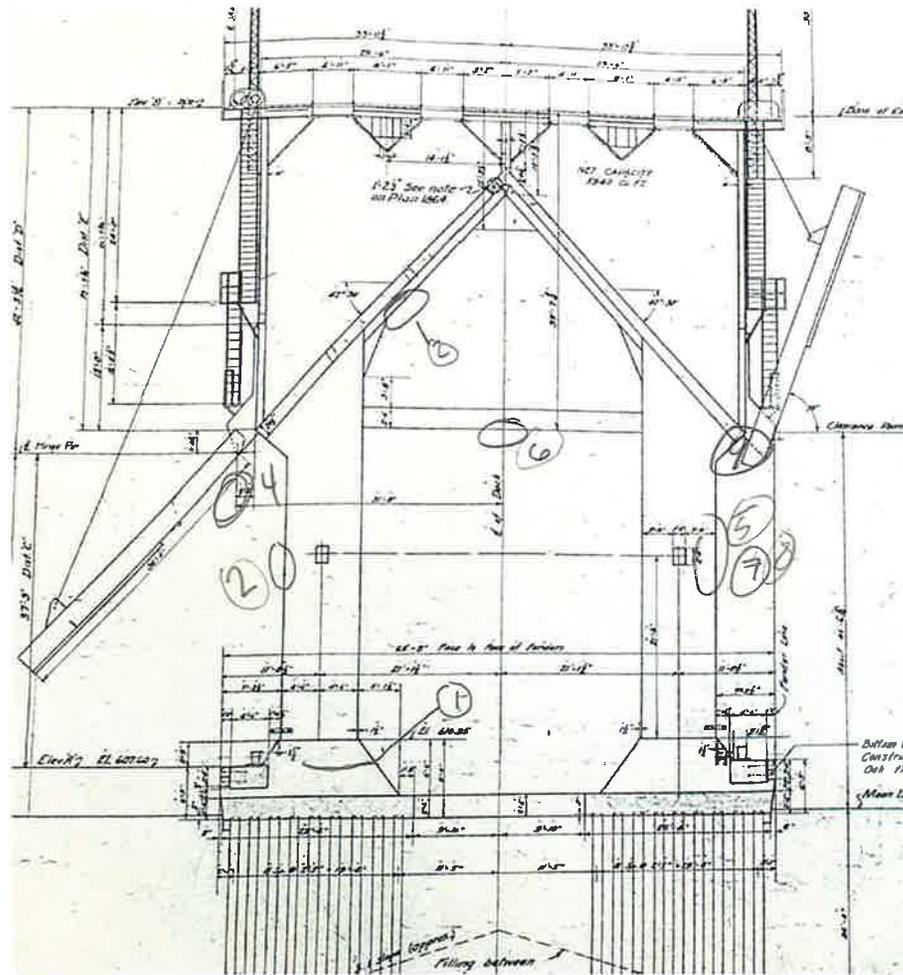
BENT #: 3

South - Cracking & Spalling w/ Rebar visible up entire North East edge  
 (5) also on Northwest edge about 3/4 up.  
 (6) Cracks along Cross Beam, Rebar visible in Section.  
 (7) Beam between 3+4 Spalling & Rebar 4292  
 Between 3+4 Crack on South Walkway. 4300 4301  
 (8) Visible Rebar & spalling on cross beam of 3+4  
 (9) Rebar Visible on SE of Vertical.  
 Spalling on <sup>top</sup> face of Vertical  
 (9) Vertical Crack 4362

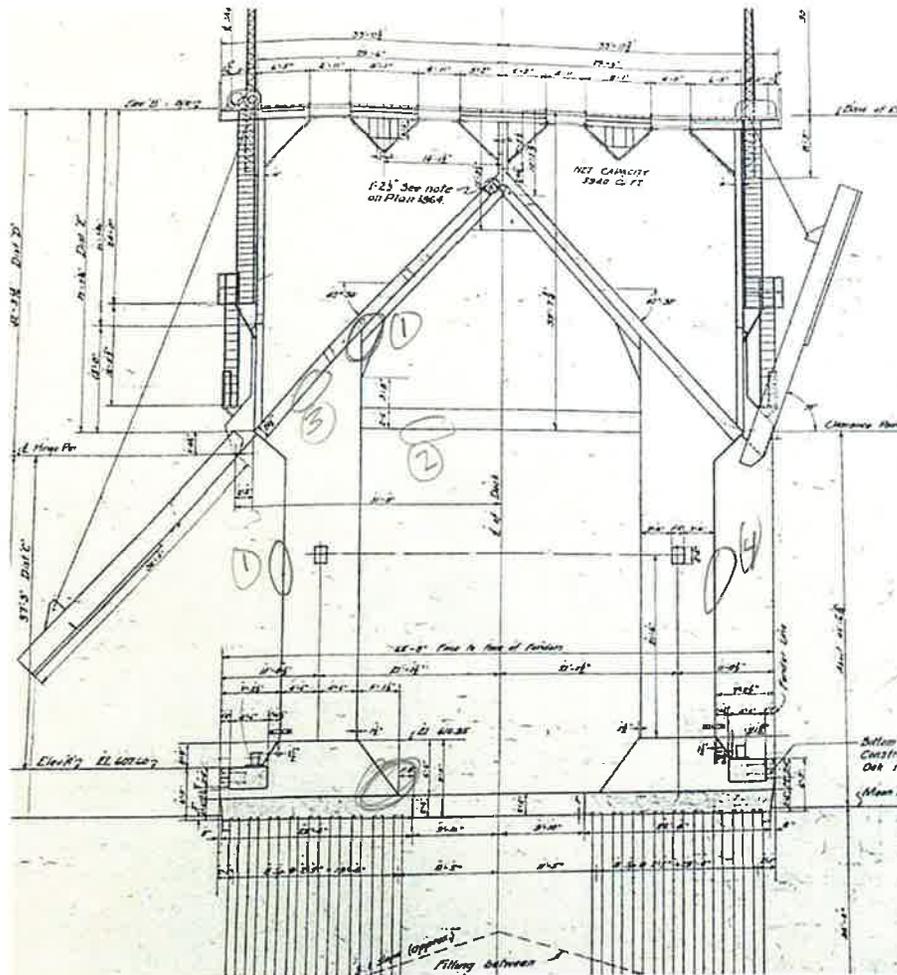
① Spalled Concrete on Corners w/ Rebar Showing  
Photo - 4213

② Cracks in Bottom on Cross Beam.  
Same as on Previous  
Photo 4214 - 4215

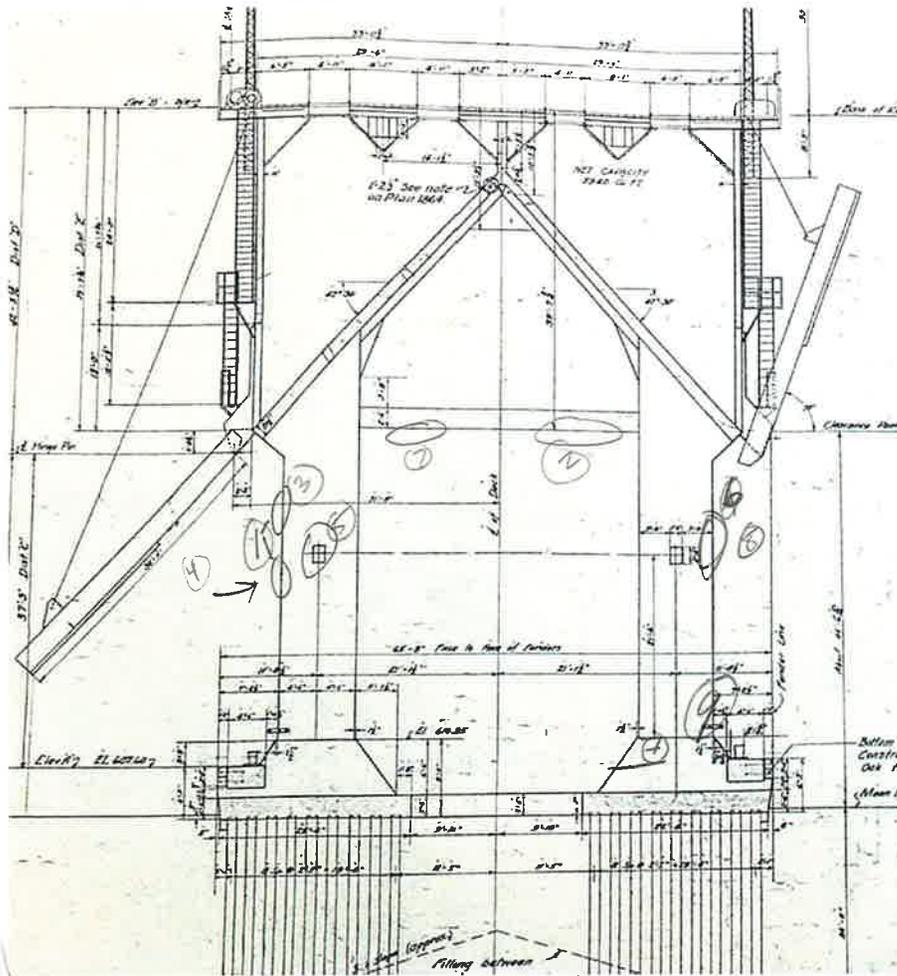
BENT #: 5

- ① Spalled Concrete on Corners  
Photo 4217
- ② Spalled Concrete w/ Rebar showing Cracks as well  
Photo 4219/4220
- ③ Spalled on Corner Previously Patched  
Photo 4218
- ④ Major Spill with Rebar  
# 4221
- ⑤ Spill on Cross Brace with Rebar visible  
# 4222
- Cracking on 5-6 Northside Walkway.
- Between 5-6 spalling & Rebar on  
Cross Beam. 4263/64? 65
- Spill on North side 66/67

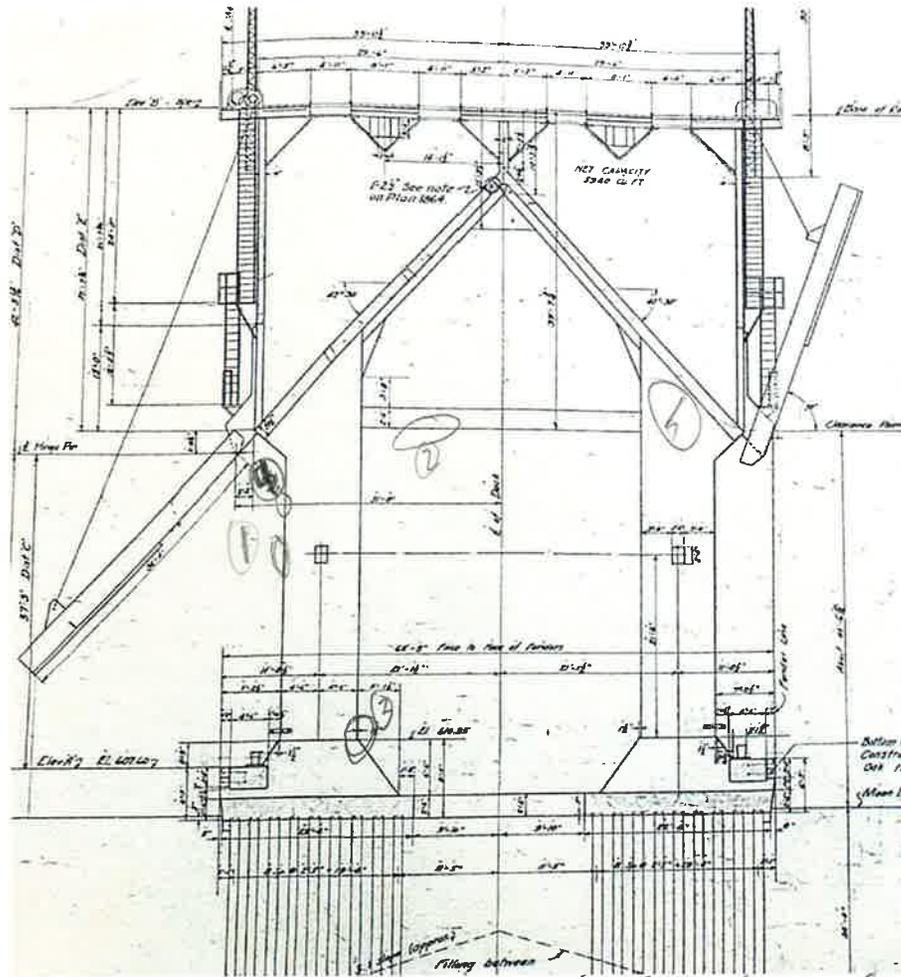
BENT #: 6

South Overlay = *Basilar Cracking* on upper face of Vertical Western + Eastern Sides  
 SE: Spalling on Edge and South Face 4345  
 Cracking on Cross Member at 5+6. Spalling w/ Rebar visible  
 Between 5+6 Crack on South Walkway. 4346  
 4347

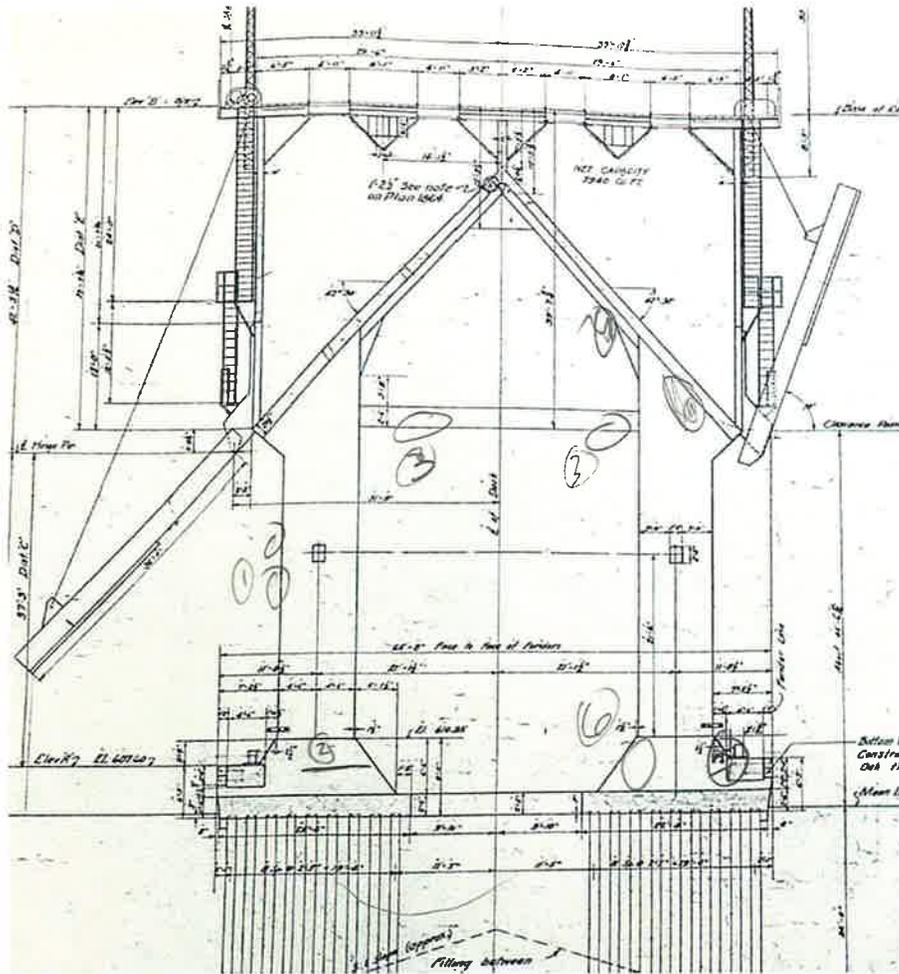
BENT #: 7

- ⑧ Crossbeam of 6+7 West + East 4334
- ⑨ Between 6+7 Crack on South Walkway. Construction Line 4344

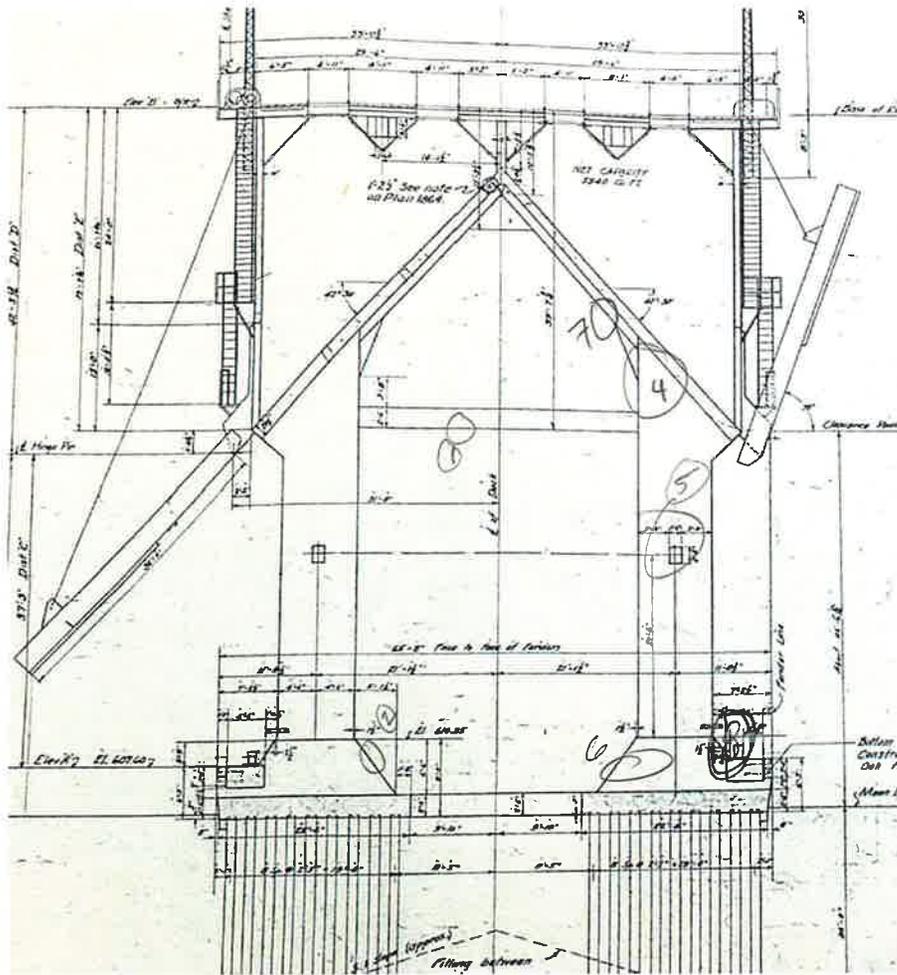
BENT #: 8

(1) Cracking in Bottom of Cross beam

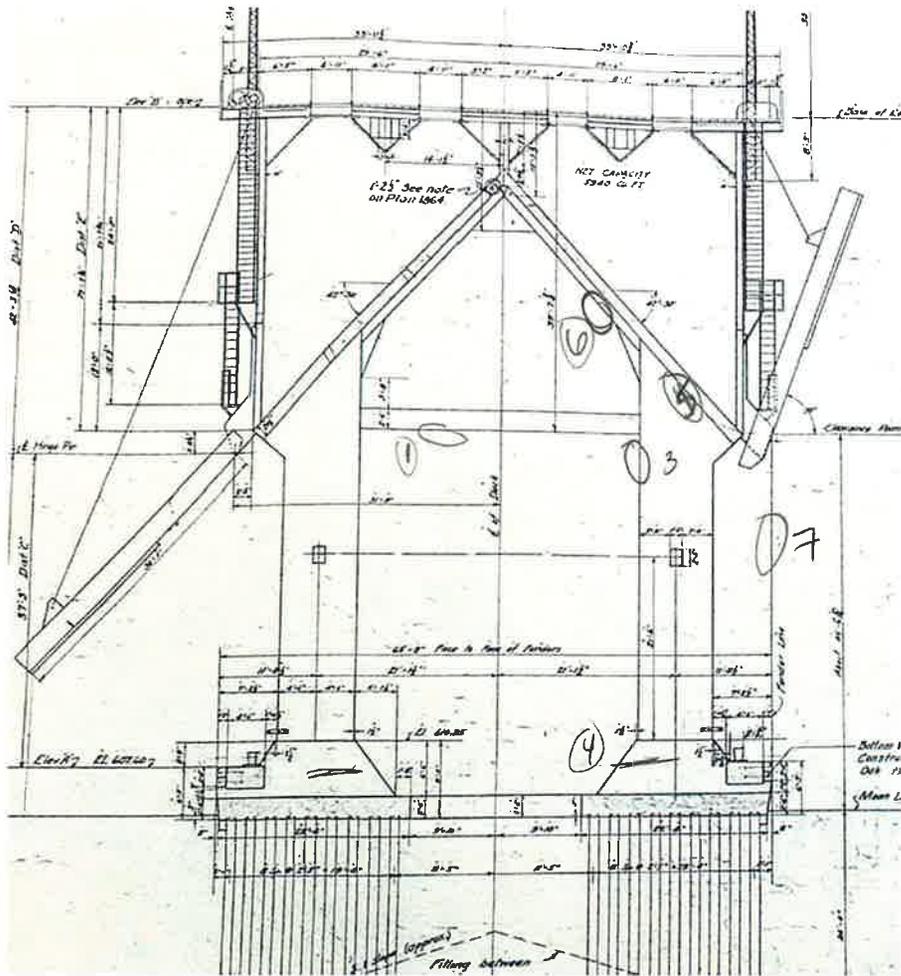
BENT #: 9

(1) Cross member experiencing spalling as well as visible Rebar  
4233

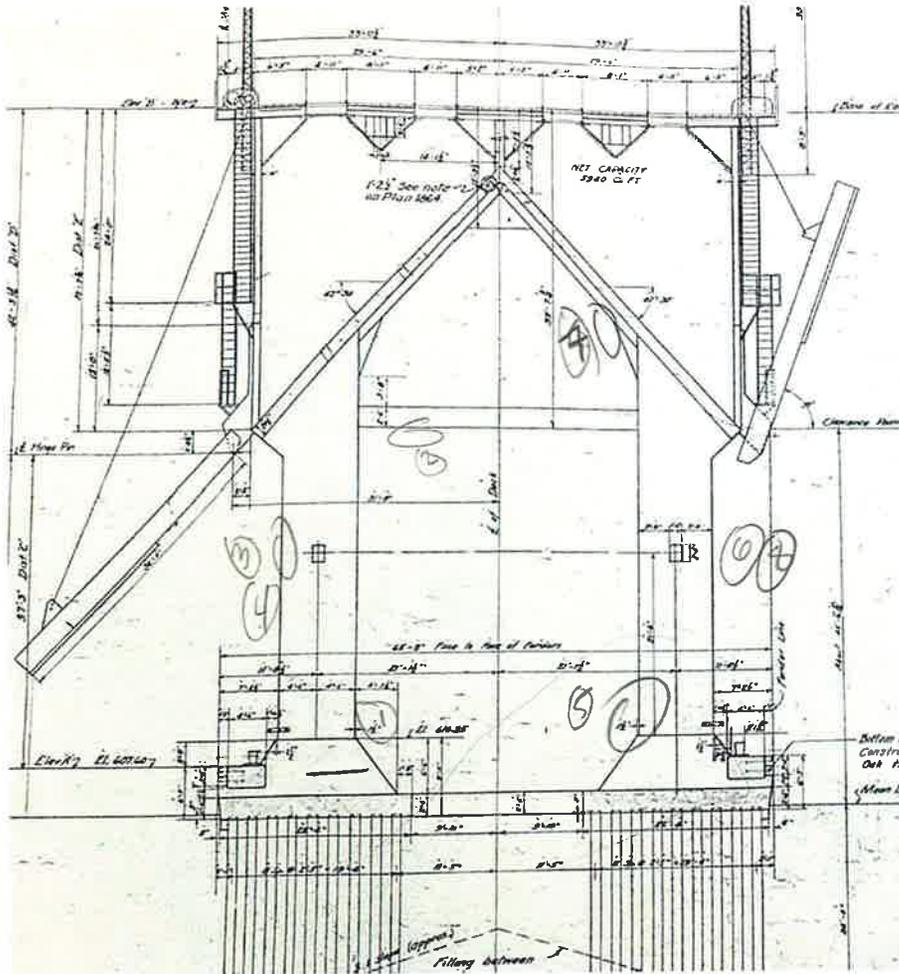
BENT #: 10

① Cracks on footing
4235
② Not Consolidated Concrete, exposed aggregate
Honey Comb feature
③ Eastside Edge experience spalling on corner
4236
4251
④ Cracking on North walkway and
North side Crack of Vertical
South ⑤ Exposed Rebar 308
⑥ Between 10 & 11 Crossbeam Spalling > Rebar Visible
4309 4310
⑦ Cracking > Rebar 4311
⑧ Spalling * Rebar visible 4322 South East > SW
Cracks on South Walkway 4324
