## Lower Harbor Ore Dock Inspection Report

Marquette, Michigan

December 11, 2014

GEI Project No. 1330920

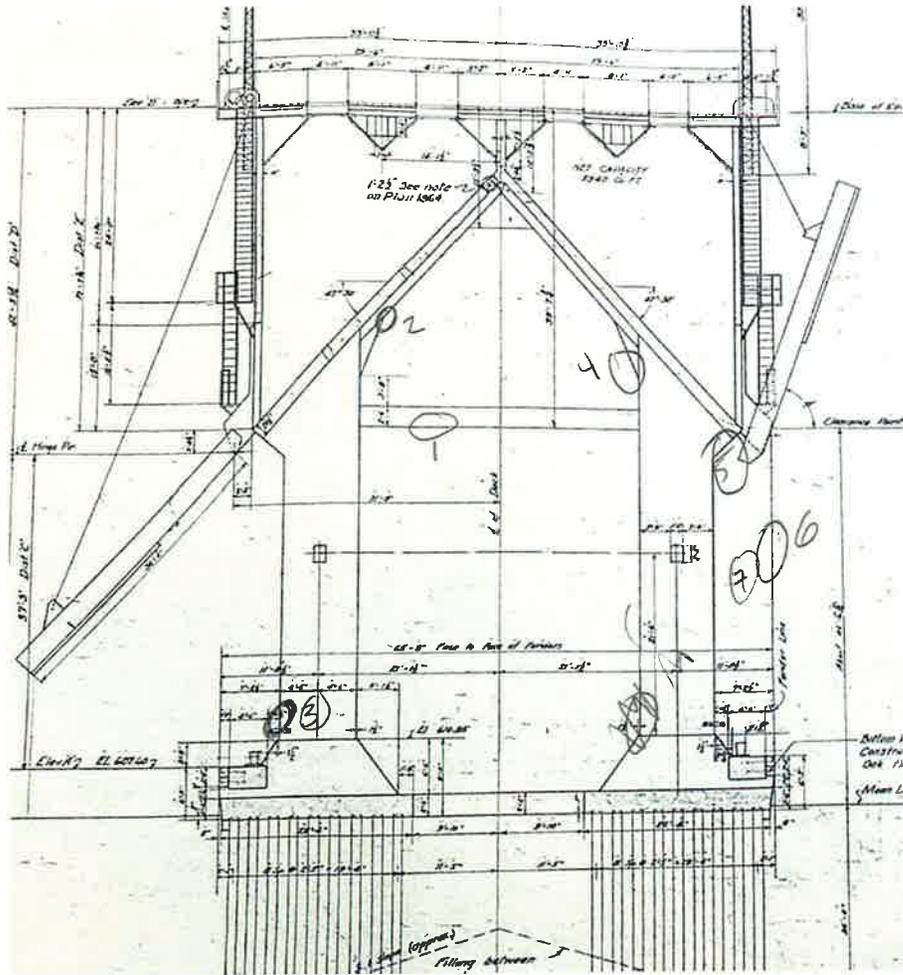
BENT #: 11

- ① Body Consolidated Concrete w/ aggregate visible. Spalling w/ Rebar as well
- ② Rebar exposed on Ceiling  
4238/ 4239
- ③ Northeast side. Spall/Cracking  
4250  
- Between 10/11 Cracking on North Walkway  
South. Cross Member between 11+12  
4312+4313 Spalling.
- ④ Cracking at Truss Joint
- ⑤ Between 11+12 Cracking and Possible falling  
Debris 4319
- ⑥ Southwest face - Spalling & Rebar visible 4320
- ⑦ Cross beam of 10+11 - Crack 4321

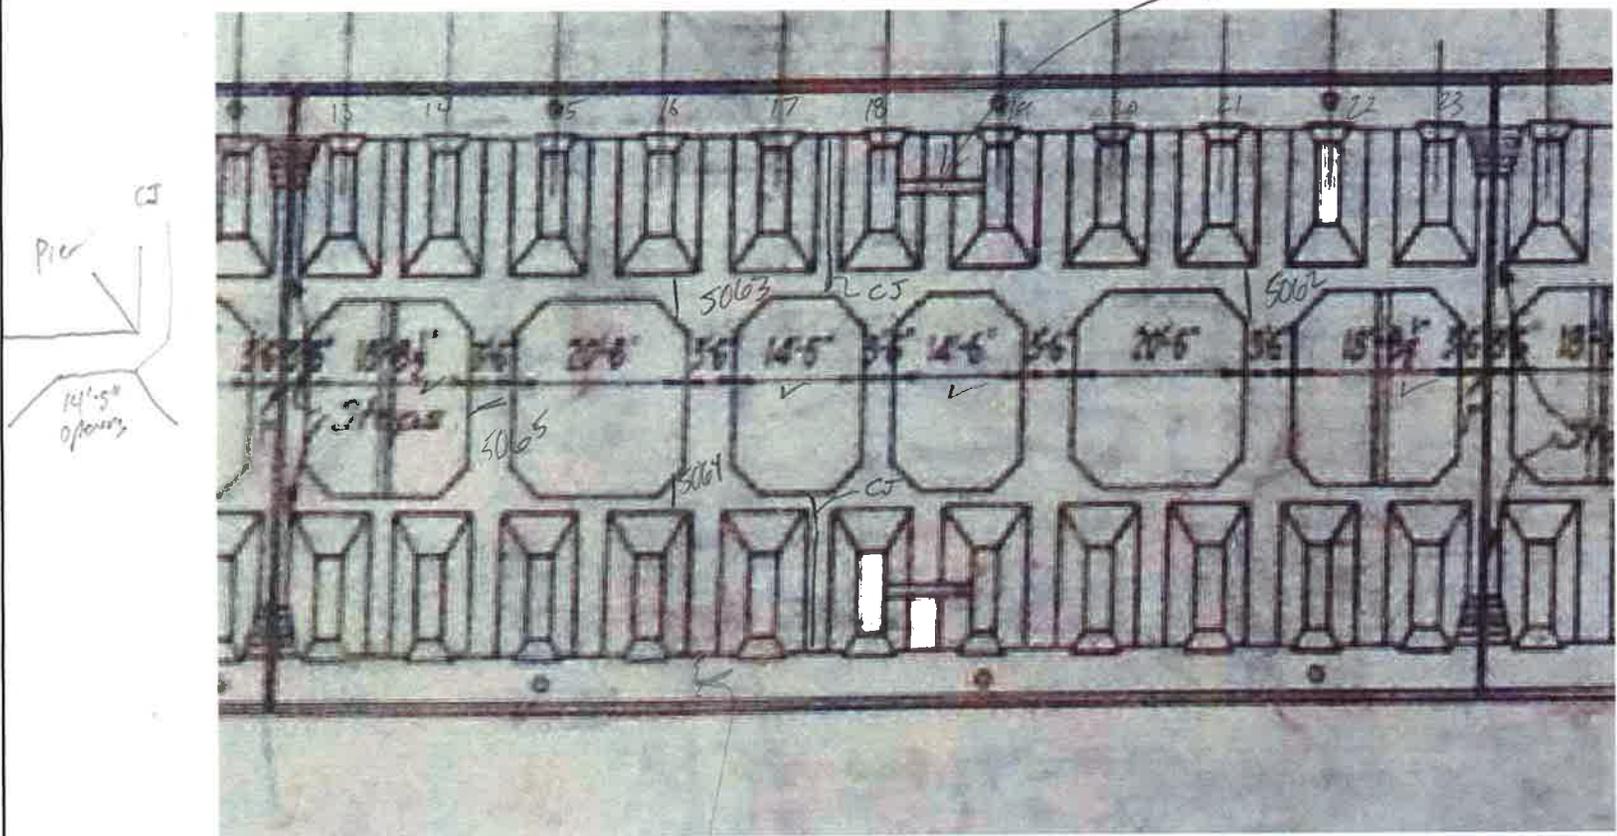
no cracking in clear wall

Cracks typical

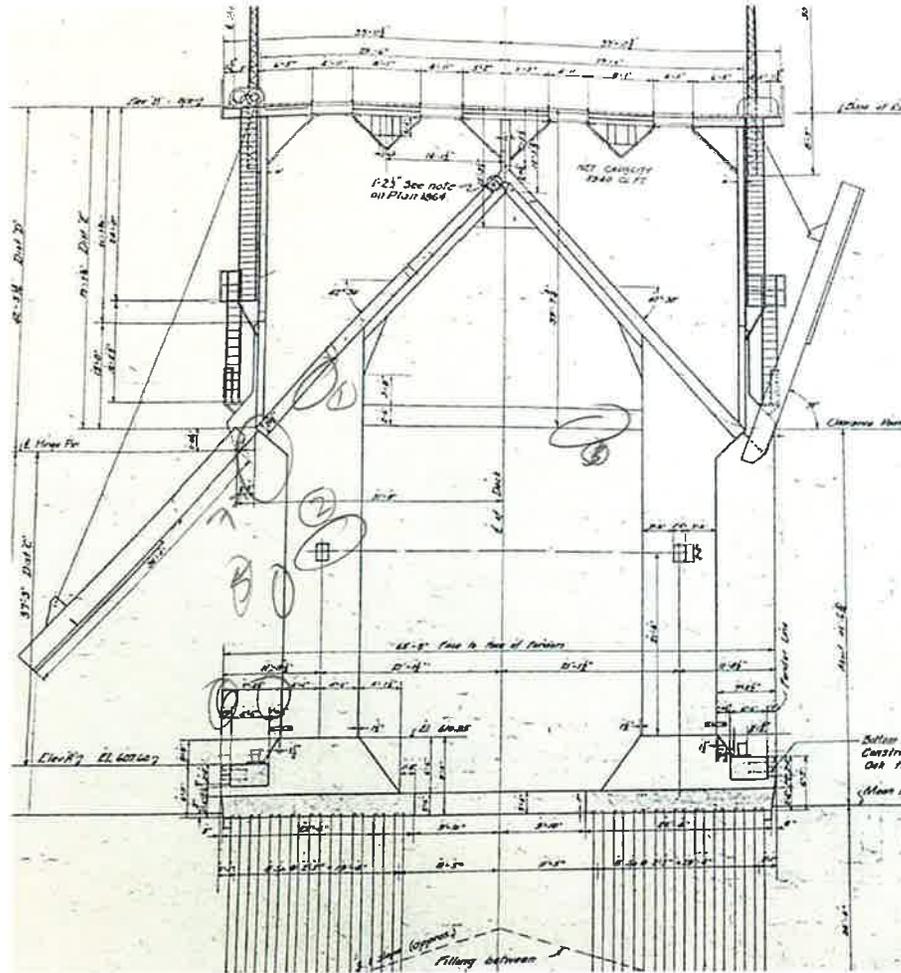
BENT #: 14

- ① Spalling/Aggregate visible  
Between 13 & 14 4383
- ② Cross Member of 13 & 14 Spalling.
- ③ Spalling and Rebar visible 4385
- ④ 4386 Horizontal Crack in first beam side  
Between 14 & 15
- ⑤ 4438 Spalling and Cracking Minor
- ⑥ Minor Vertical Cracking on North Face  
Spalling on North Walkway Pretty Severe compared  
to previous. Exposed Rebar 4439
- ⑦ 4441 Piece of Rebar Visible

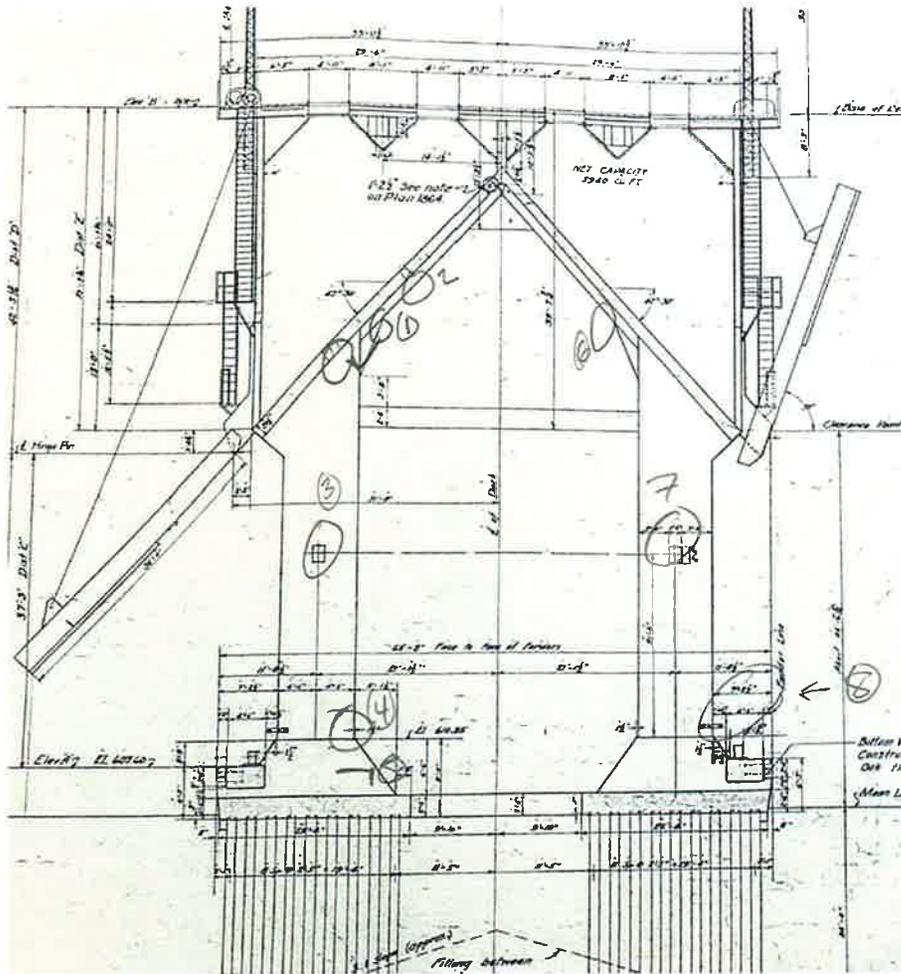
BENT #: 15

North	(1) Spalling and Rebar visible 4387
	(2) Cracking along Diagonal 4388
	(3) Between 15+16 spalling on Cross Member
	(4) Rebar visible on upper footing 4391
	(5) Vertical & Horizontal Cracking on footing
South	(6) Poorly Consolidated concrete becomes Increasingly more common
	(7) 4851 Cross member has cracks between 15+16
	(8) Vertical cracks 4514-4515 on Vertical 4516 Crack on <sup>SOLE</sup> walkway 14-15

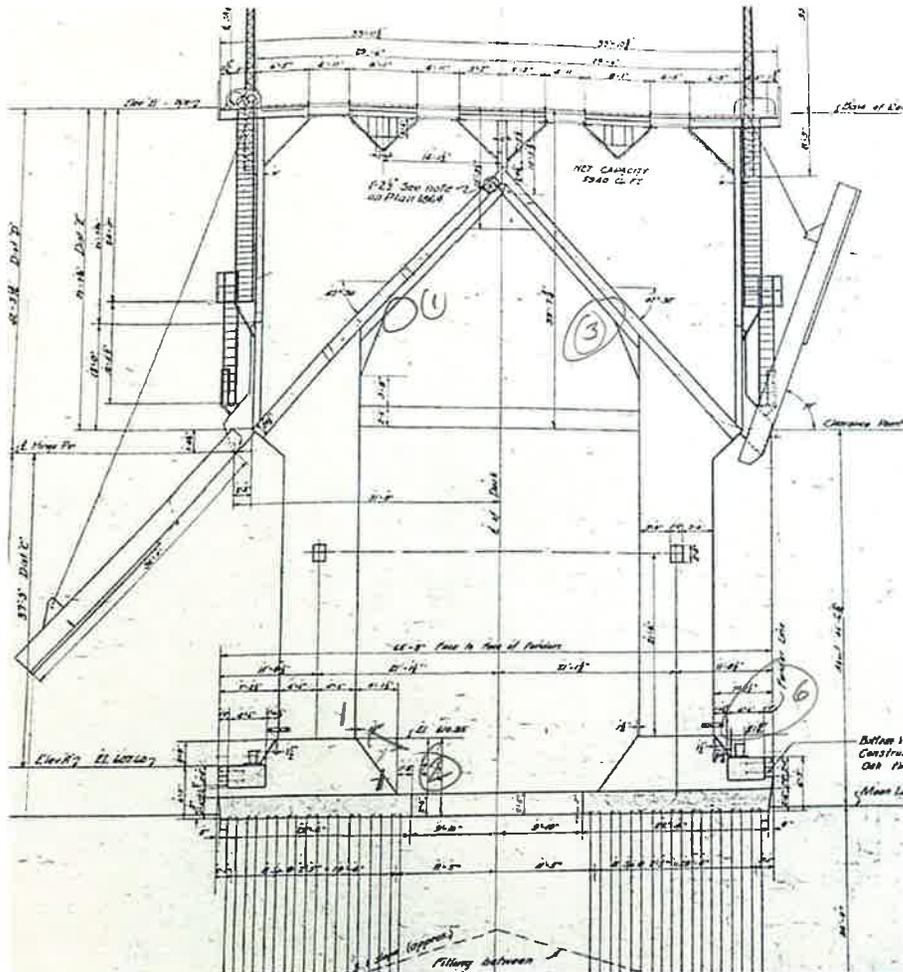
BENT #: 16

- ① 4393 Cracking on upper ceiling Joist.
- ② 4394/4395 Vertical Cracking running up face and Vertical
- 4437 Cracking on Walkway of 15-16
- South West side of Vertical, Vertical Crack roughly 4 feet long.
- ③ Patching taken place on ceiling Possible Cracking.. 4454
- ④ 44510-11 Vertical Cracks on 16. Poorly consolidated Concrete on Vertical
- 15-16 Cracking and Spalling on Cass Room Ceiling South Walkway

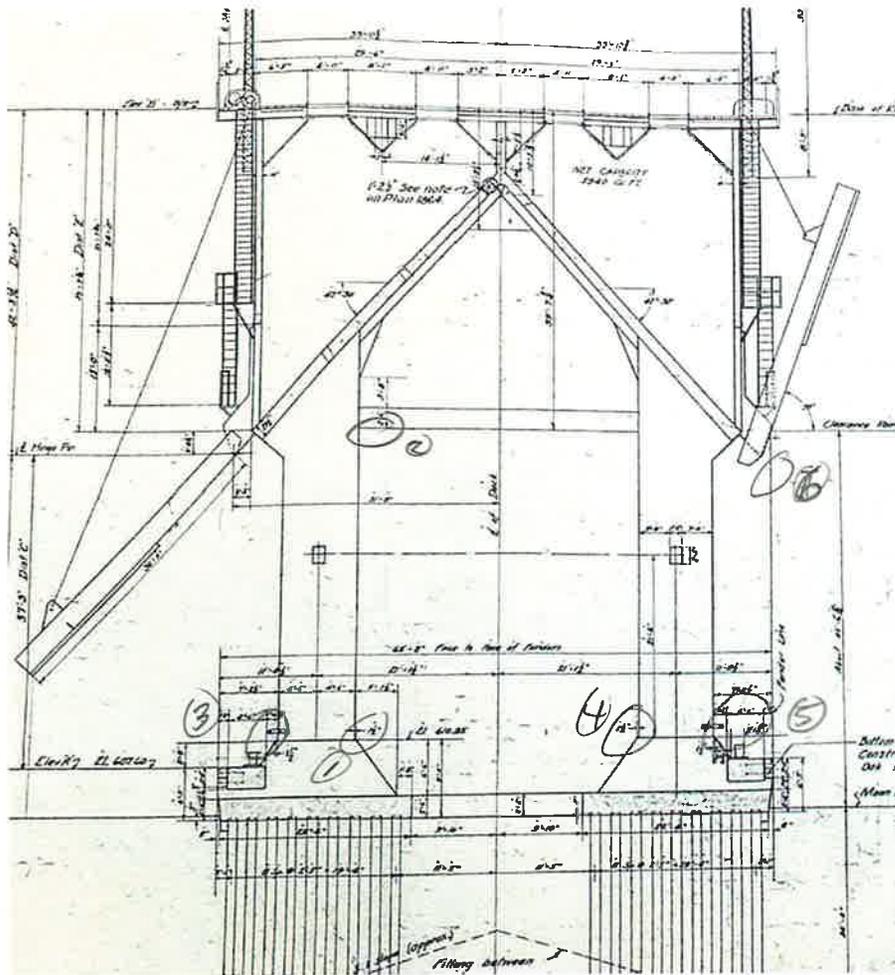
BENT #: 20

① Spall with exposed Rebar 4404
② Spalling with Rebar flight
③ Spalling with Rebar visible 31
Cracking on North Walkway 32 Between 19-20
④ 4466 Spalling on top of footing.
South 20-21 Spalling on Cross Member 4467?
20-21 2 Cracks on South Walkway 89-90
⑤ Cracks and spalling on foot 91-93
⑥ Exposed Rebar.
⑦ 4495 Crack on South Walkway 19-20
4496 Cross Member Rebar showing Spalling 4496

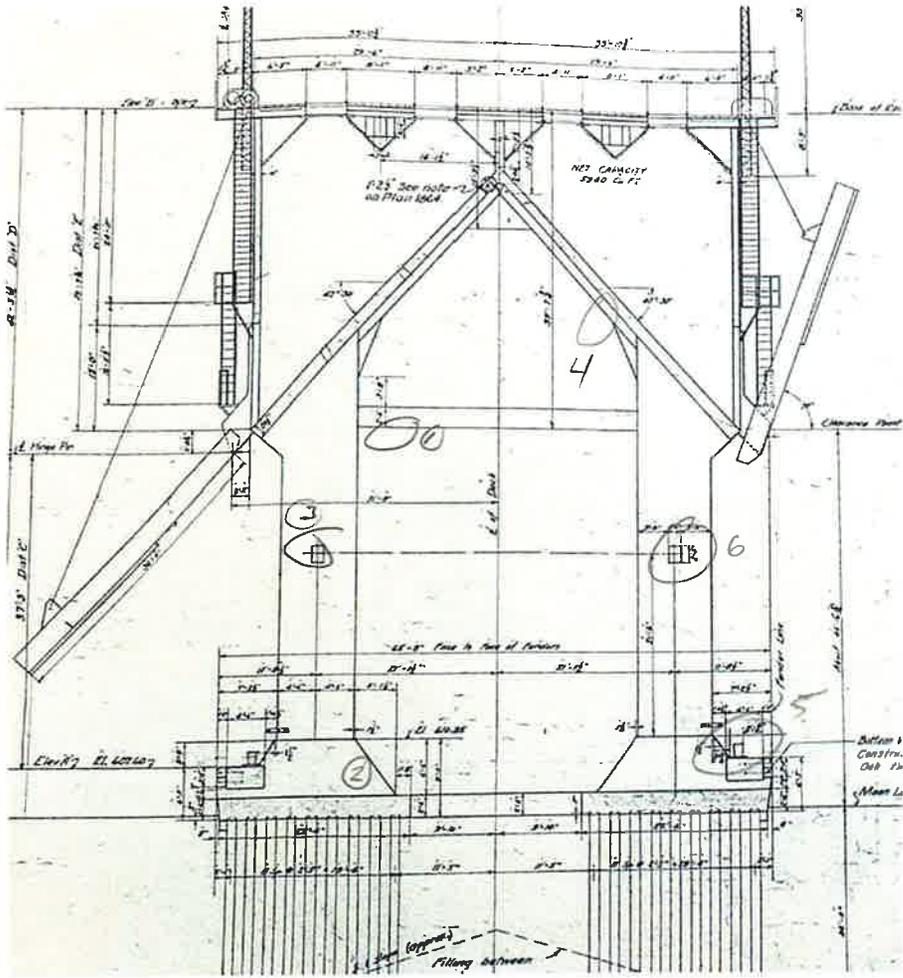
① Rebar showing 4406
② Vertical Cracking on Fasting 4407
③ Between 21+22 Spalling on Cross Member as well as aggregate showing.
④ Cracking on <sup>North</sup> Walkway between 20+21
⑤ Poorly Consolidated Concrete.
⑥ Some Vertical Cracking on Post 4487.
⑦ 4488 <sup>South</sup> Top East Corner of Cross Member

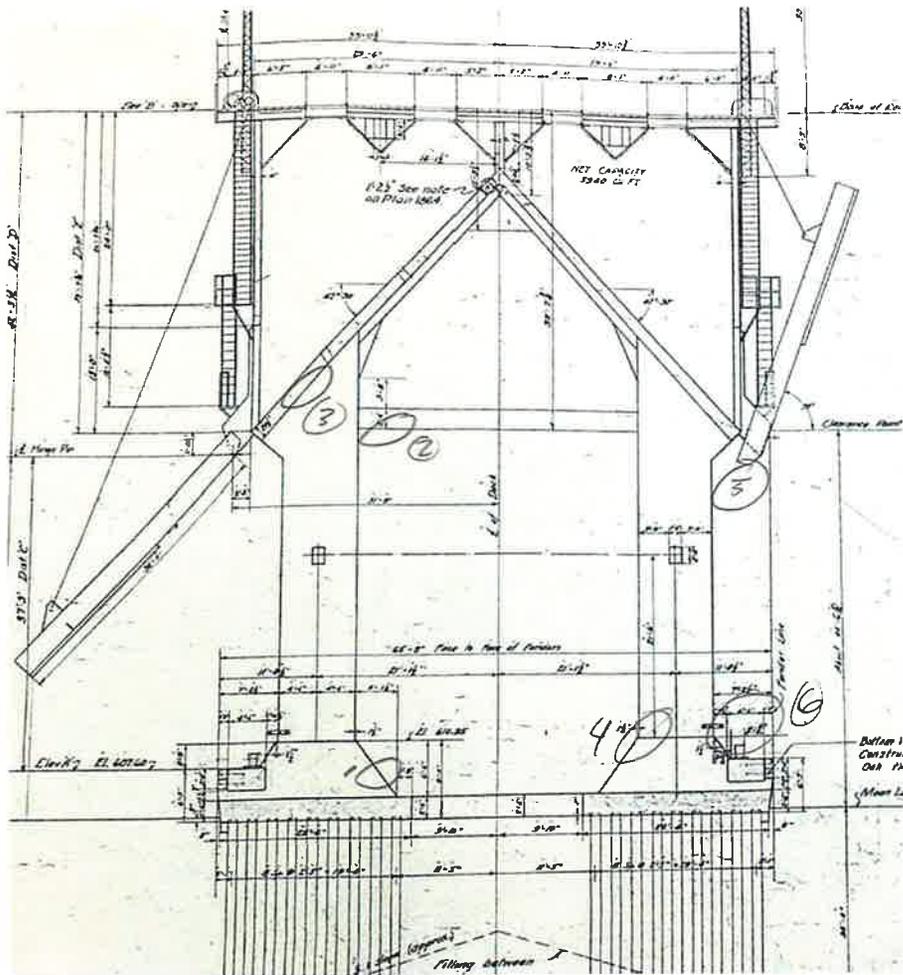
BENT #: 22

- ① Vertical Cracking on footing 11+12
- ② some Rebar visible
- ③ Between 22+23 Horizontal Cracking
- ④ Spalling between 22+23.  
Between 22+21 Cracking on North Walkway
- ⑤ 4468 - 4469 Vertical Cracking on Footing West side.
- ⑥ Horizontal Cracking 4471
- ⑦ Vertical Cracks 4484 on foot = up Vertical.  
Crack on South Walkway 21+22 4485

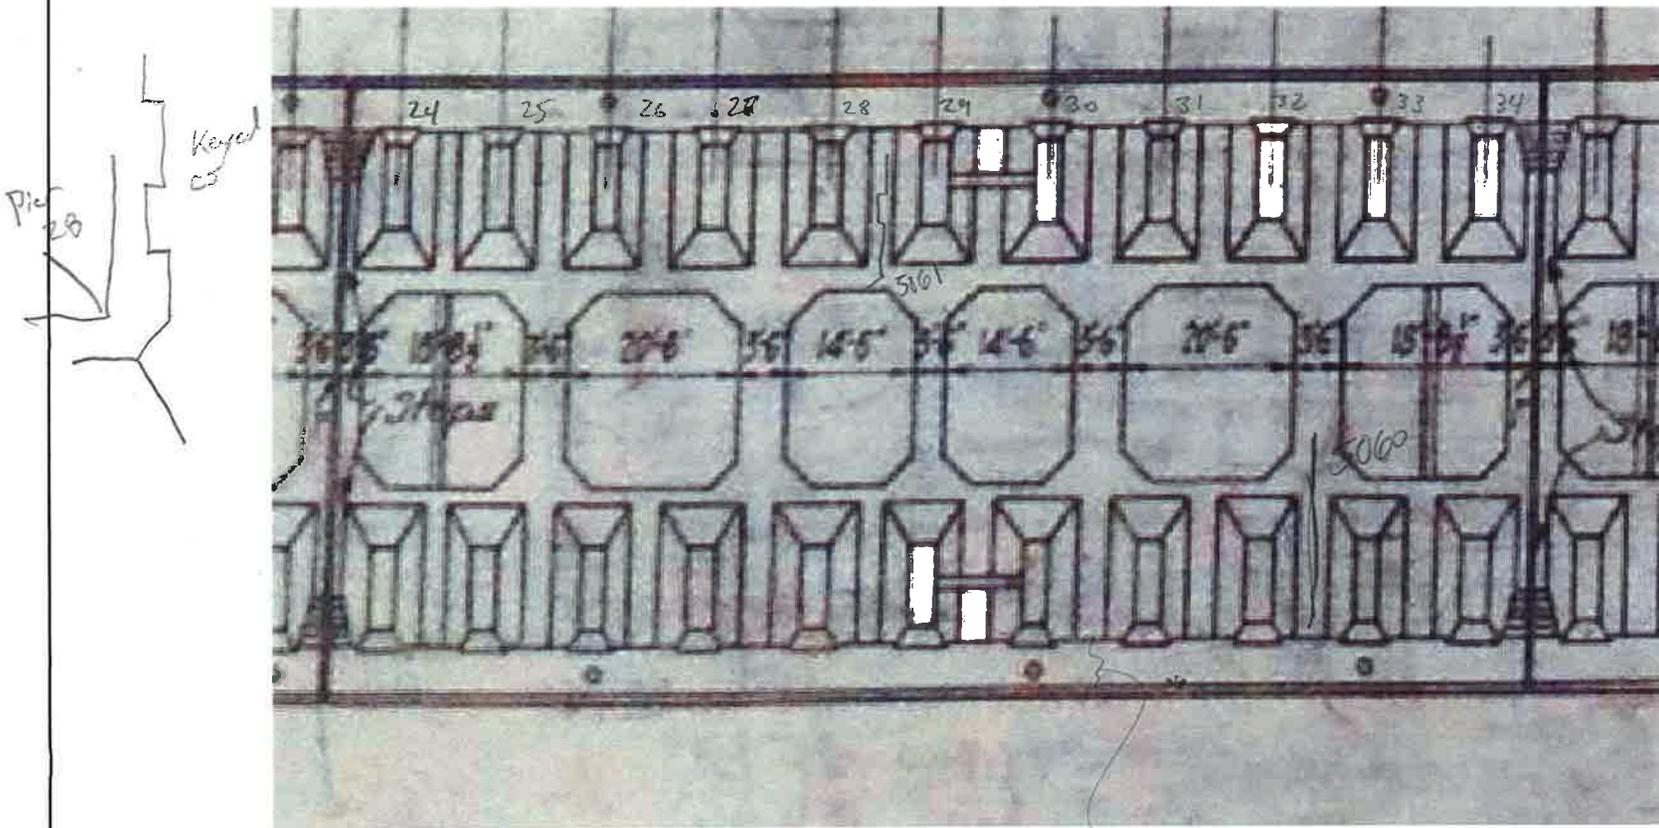
SECTION #: 3

Typical crack on fender

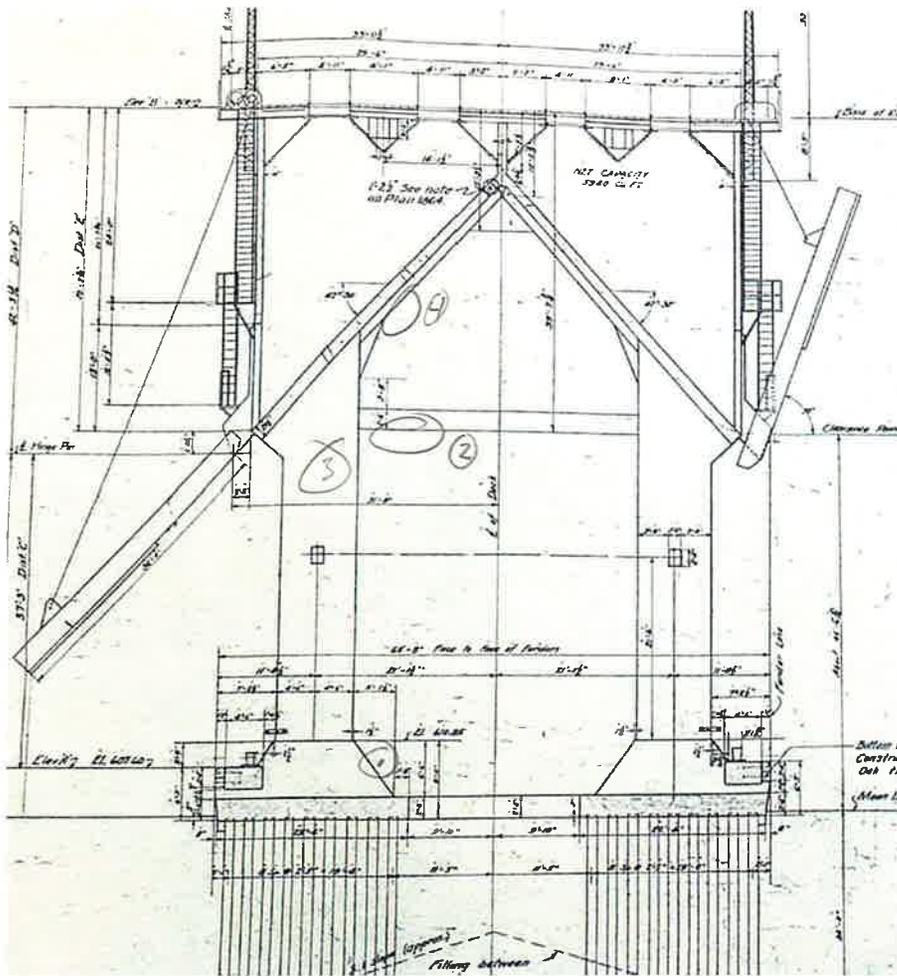
BENT #: 26

North Inside
① Spalling and Cracking occurring on base of foot (South side)
② Spalling w/ visible Rebar apparent 4527
③ Overpour on East Side of Vertical
Cracking on Crossbeam of 26-27 4528
④ Possible Horizontal Cracking
North Outer, Small spall at Cross beam 25-26 4555 4550
South Inner: Crossbeam has spalling and Rebar visible 26/27 4562
4583 crack in walkway
4584 "Happy Climber"
25-26 Rebar visible 4585

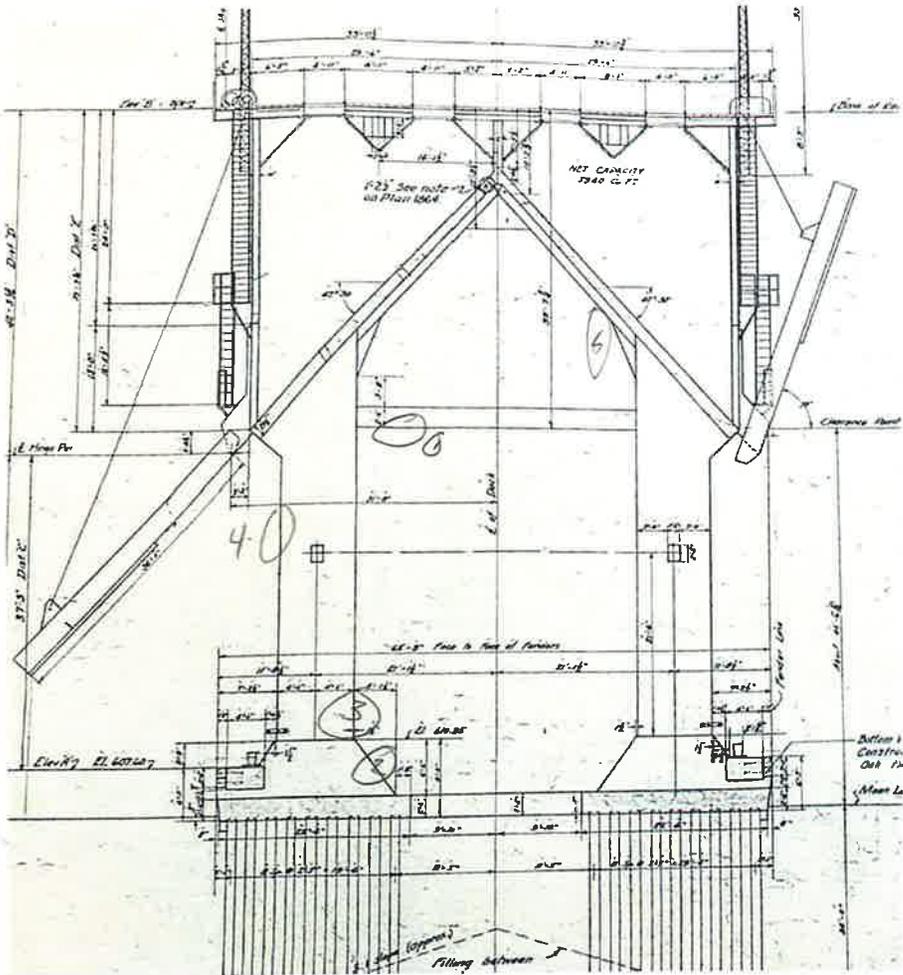
North Inside. (1) Some very slight
Poorly consolidated concrete.
(2) Some Spalling on South face of
footing.
(3) Spall w/ exposed Rebar @ top of foot. 4529
Note Possible Hazardous Lamp.
4551
North Outer: Cracking on 27-28 <del>at</del> North Walkway
(4) Spalling and visible Rebar 4552
and Minor spall on Cross beam of
27-28. 4553
South Inner - (5) Some minor Spalling
occurring on Ceiling / Truss
South Out - 4577 Crack in Walkway
27-28 4580 Exposed Rebar Cross beam

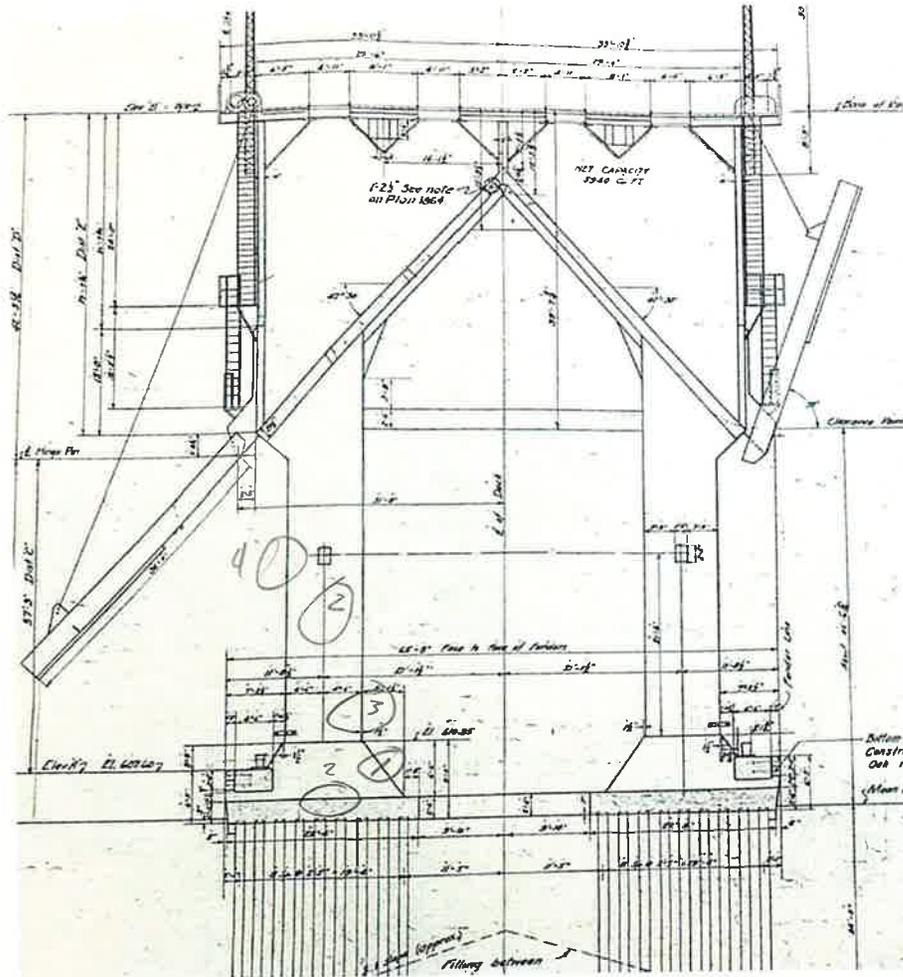
BENT #: 29

- North Inside, ① Minor spalling all over footing, some South some SW
- ② loose nails on West side of Foot along with up West of Vertical
- ③ Cracking on SE corner of Vertical.
- North Outs:
- ④ Spalling on NW Edge of Vert.
- Cracking on 28-29 North walkway 4574
- Minor Spalling on 28-29 crossbeam
- South Inner - Spalling w/ exposed Rebar on Cross beam of 28-29 4563
- Delamination as well on beam.
- Light Fixture Overhead. 4578
- South out 29-30
- 4576 Horizontal Cracking
- 4577 Crack walkway

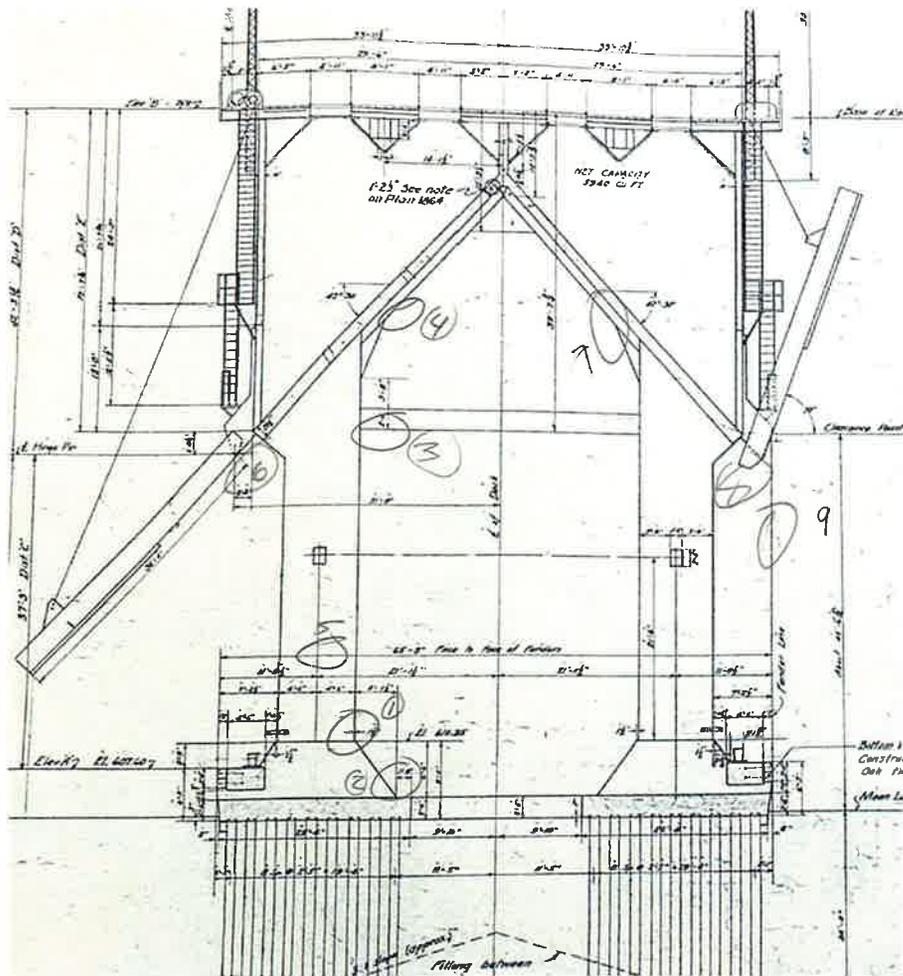
BENT #: 31

- ① on South face → SE Edge of Vertical spalling is apparent → Rebar is visible.
- ② Vertical Cracks on footing 4551
- ③ Poorly Consolidated Concrete.
- ④ Spalling has occurred. Rebar Possibly visible.
- ⑤ Spalling on East face of Vertical, North Outer.
- ⑥ Spalling once visible. Rebar. Between 30→31 Spalling on overhang 30→31 Cross beam Spalling → Rebar. 4447
- 30→31 Cracking on North Walkway. 4446 South Inner
- ⑦ 31→32 4564? Rebar exposed South Outer ④ 4574 Spill Walkway Spill 4575
- ⑧ 4586 Spill/delamination

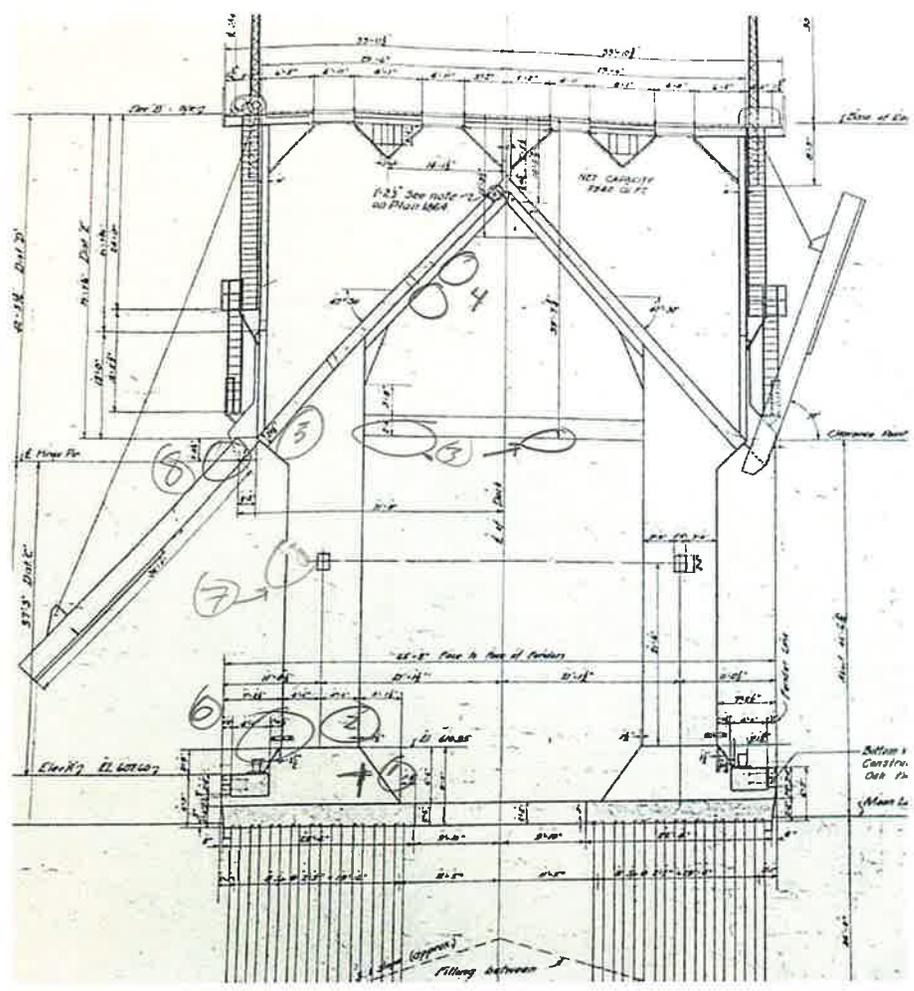
BENT #: 32

- ① Vertical Cracking on foot
- ② Spalled on upper foot SW Side.
- ③ Poorly Consolidated again/Rebar Visible
- ④ Markings in Ceiling, Possibility of Spall
- ⑤ Rebar visible on East of 32

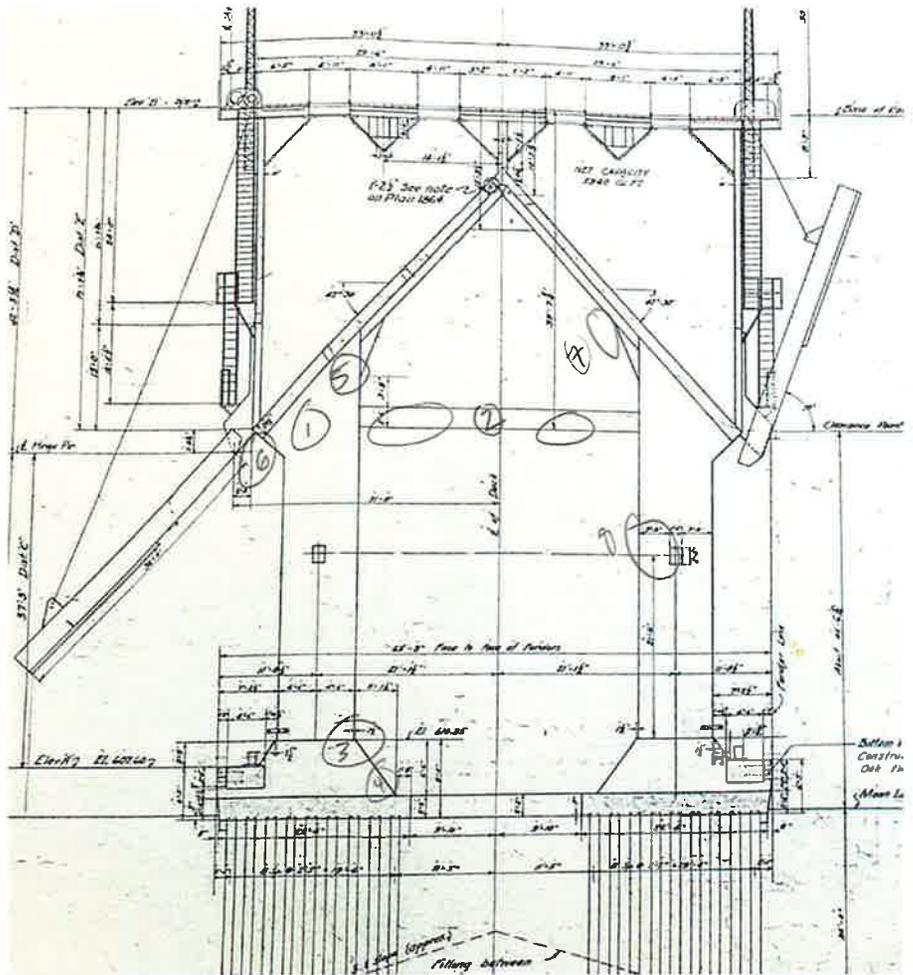
Spalling on West side of foot  
3553

North Inside (1) West Side of Vertical,  
Spalling and Rebar Visible.

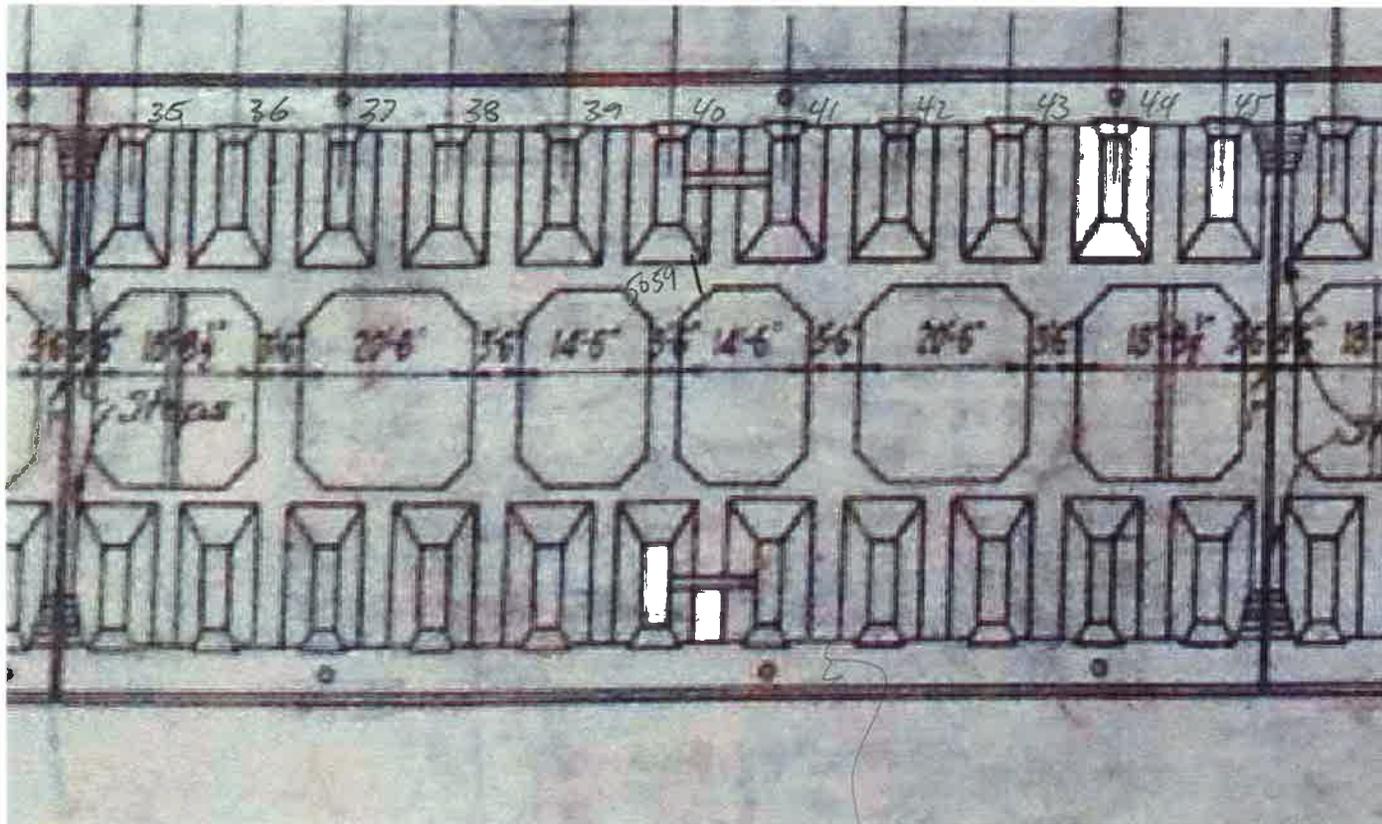
SECTION #: 4

Crack typical

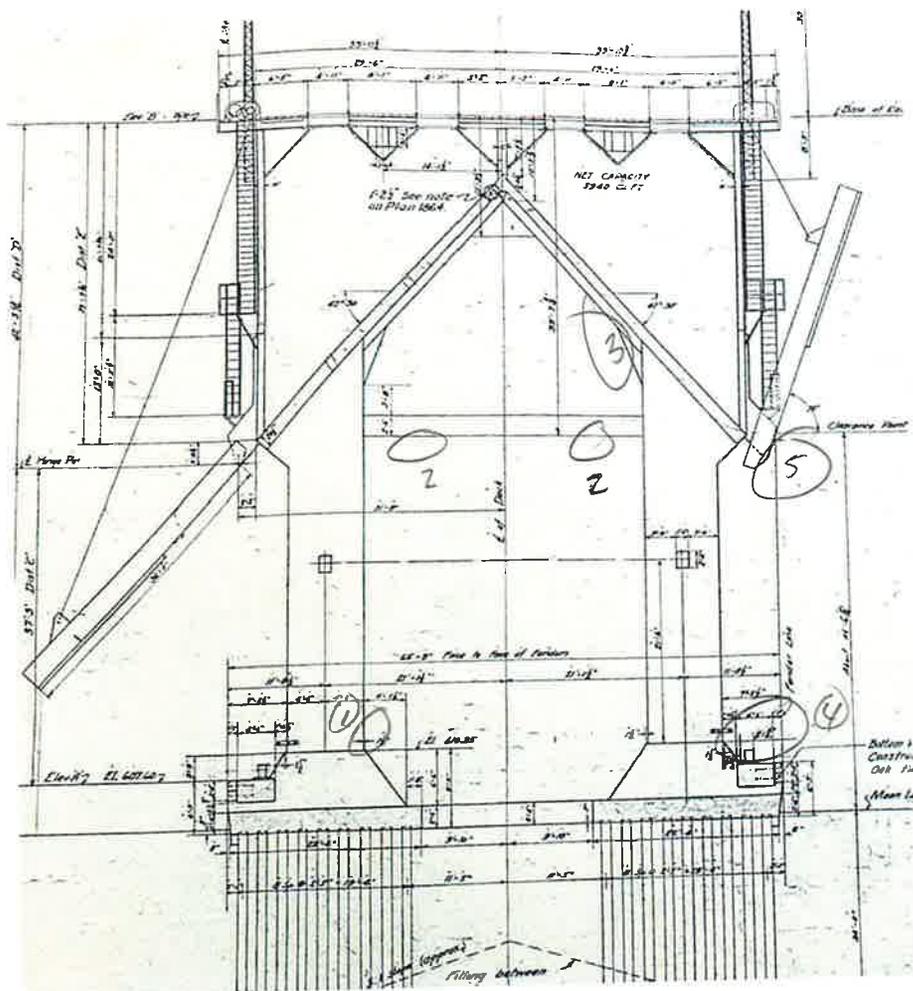
BENT #: 46

① Spalling SW Edge Top of Deck  
4599

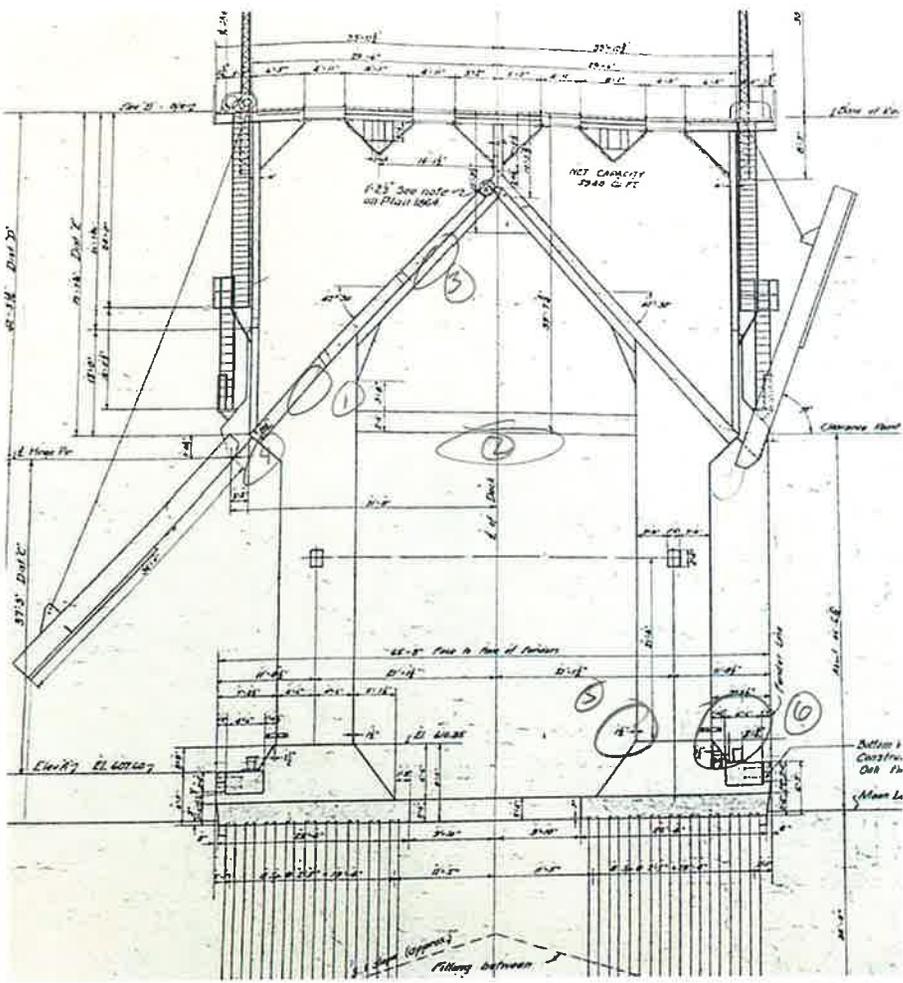
- 4611 ① Rebar visible between 43-44
- 4612 ① loose on foot rebar exposed.
- ② 4613 Rebar Cracking
- ③ 4614 Rebar exposed
- North Area
- 4622 Spalling/loose rebar on 44-45 cross beams
- ④ 4623 Spalling on shot South Inside
- ⑤ Small delamination on NW corner of foot
- 4715 Cracking on crossbeam of 44-45.
- 4716 ⑥ Spalling + Rebar on top of foot, SE + SW Edges. 4721-22
- ⑥ Protruding Rebar on West face

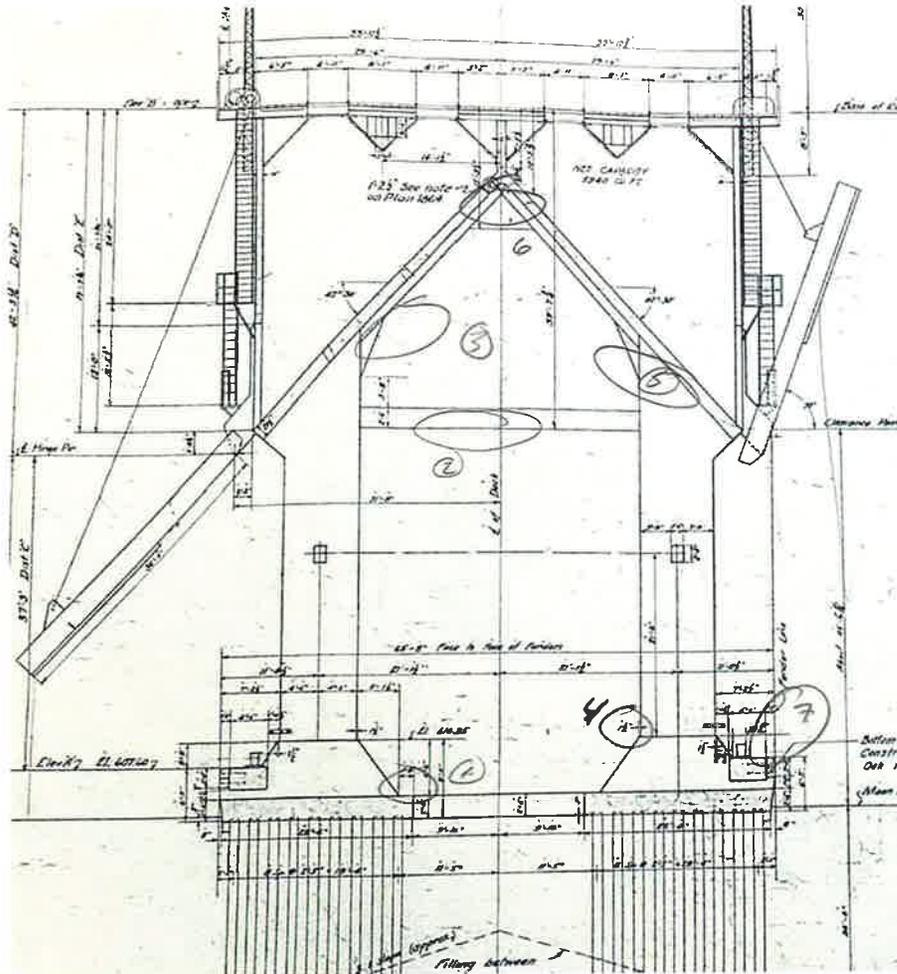
- 4743 North Side ① Spalling on NW Corner of foot.
- 4744 ② Possible Some Cracking on Column Head.
- 4745 ③ Rebar Visible in Several Areas of 46-47
- 4645 46-47 Cross Member has cracking and spalling.
- 4646 46-47 Crack in North Walkway.
- 4783 South Lanes: ④ Rebar visible NW edge of foot, as well as NE edge.
- 4784 ⑤ 46-47 on Slanted Face Rebar exposed. Cracking on 46-47 Crossbeam.
- 4785 ⑥ Rebar exposed in 46-47 Crotch South Outer
- 4831 46-47 Cracking in Cross Beam
- 4832 ⑦ Delamination in SE & SW Edges of foot. Lighting Fixture.
- 4833

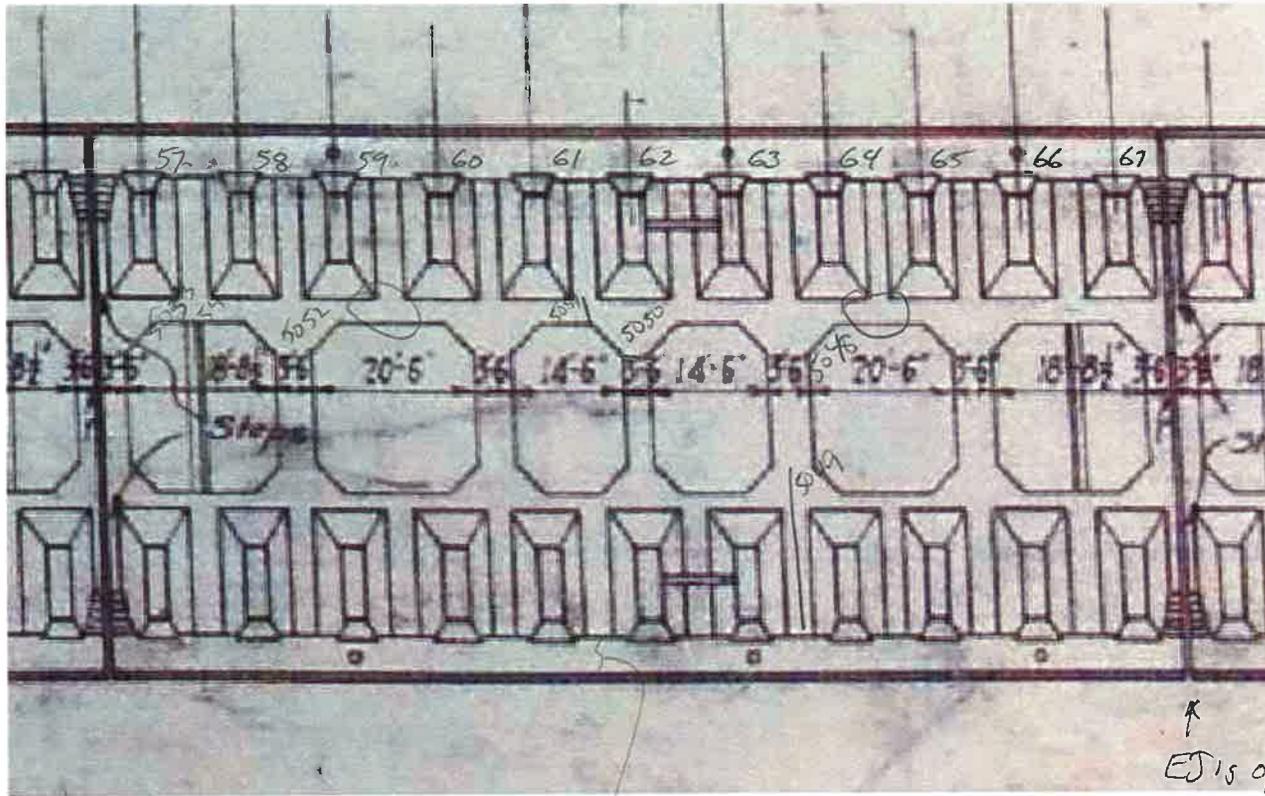
SECTION #: 6

Typical crack

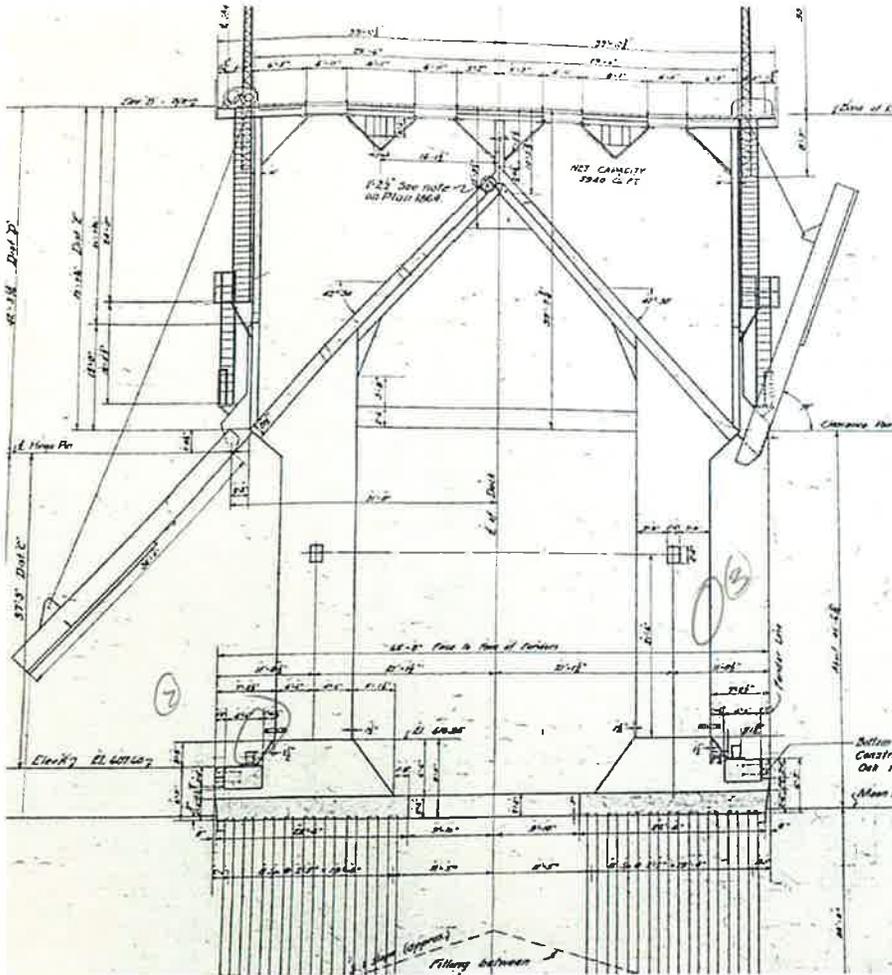
North Inside. 64-65 Crack in Cross Member
