## Lower Harbor Ore Dock Inspection Report

Marquette, Michigan

December 11, 2014

GEI Project No. 1330920

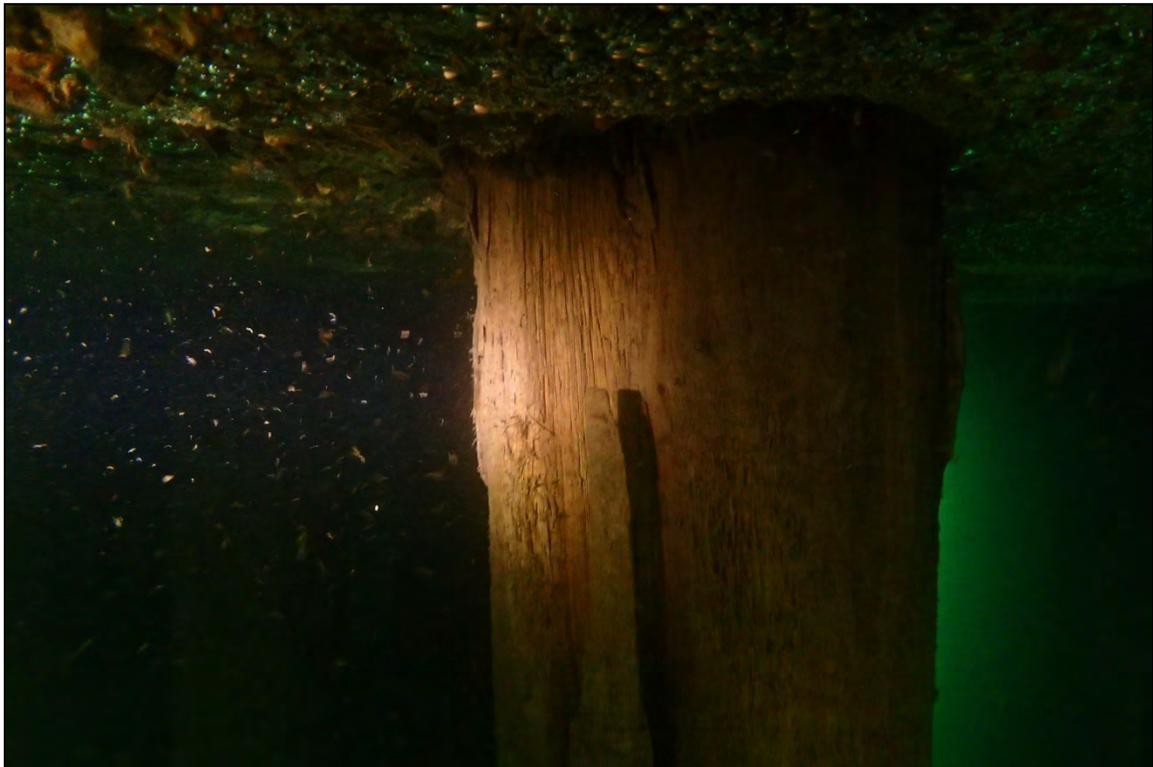
Photograph 8: View of delamination of outer shell at Pile 35J in Section 7.

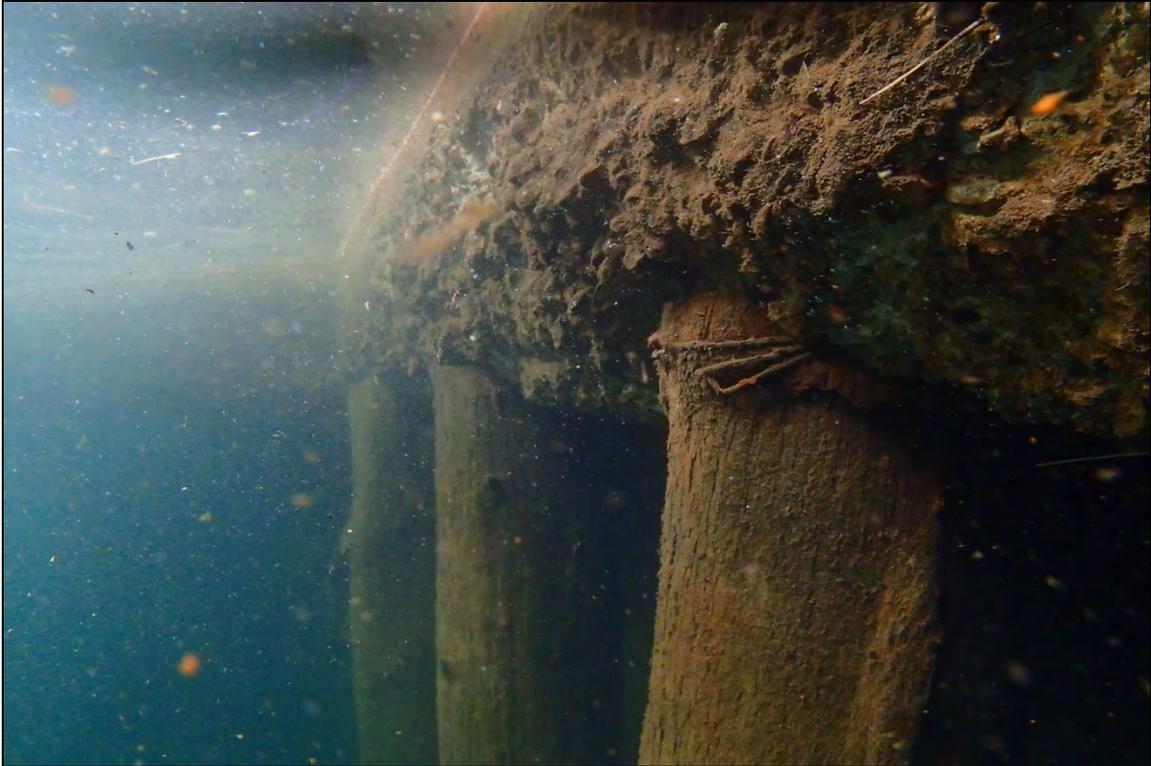
Photograph 11: View of loss of bearing at Piles 9 through 11I in Section 3.

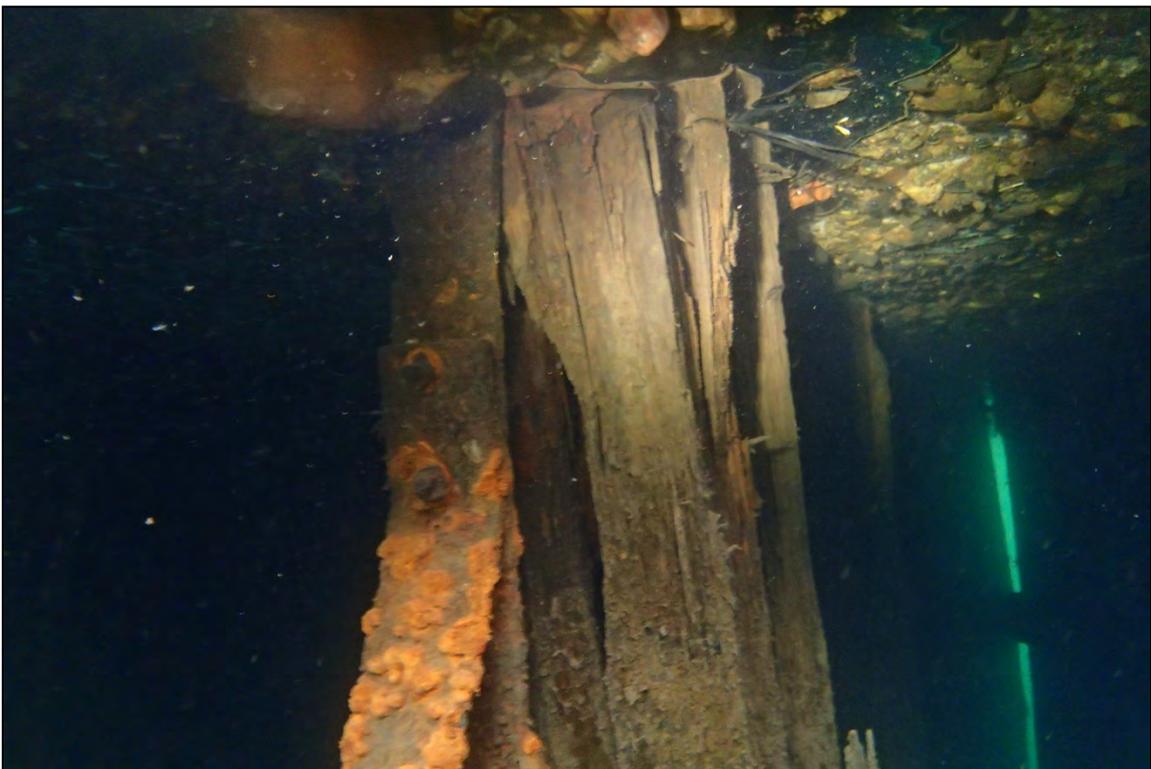
Photograph 12: View of delamination of outer shell at Pile 33I in Section 3.

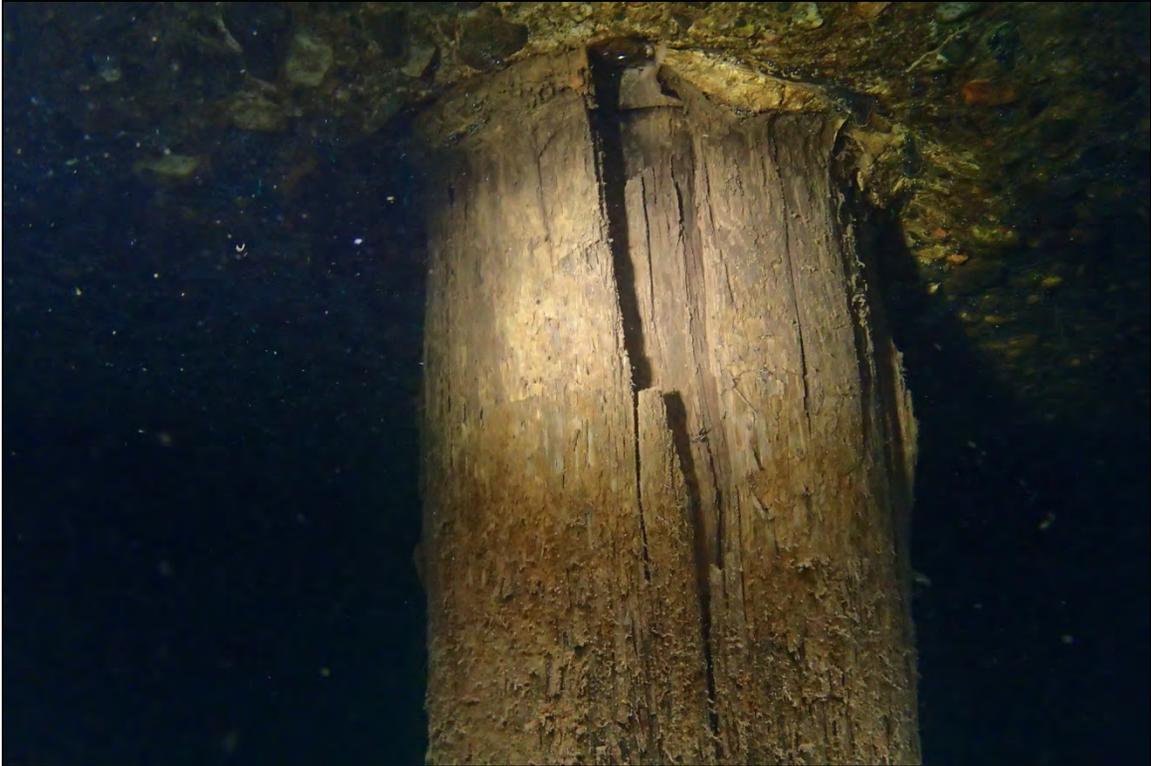
Photograph 13: View of delamination of outer shell at Pile 35I in Section 3.

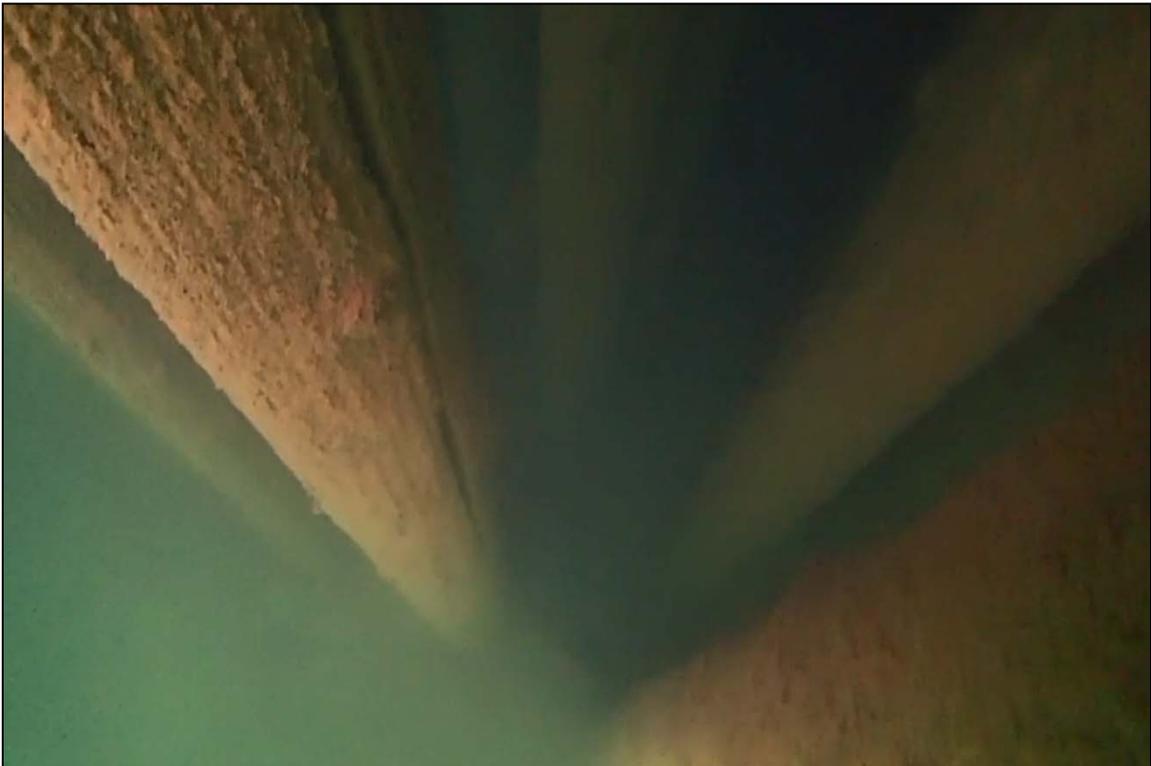
Photograph 14: View of split at Pile 5R in Section 7.

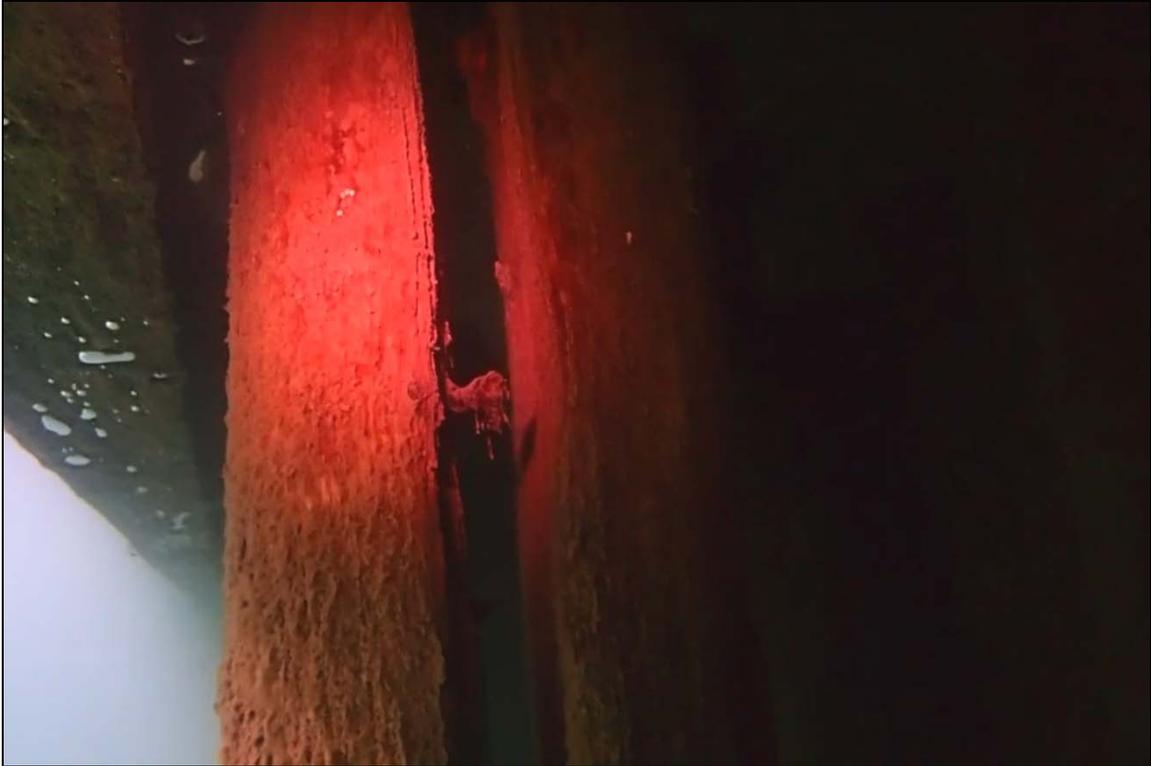
Photograph 15: View of split at Pile 19R in Section 7.

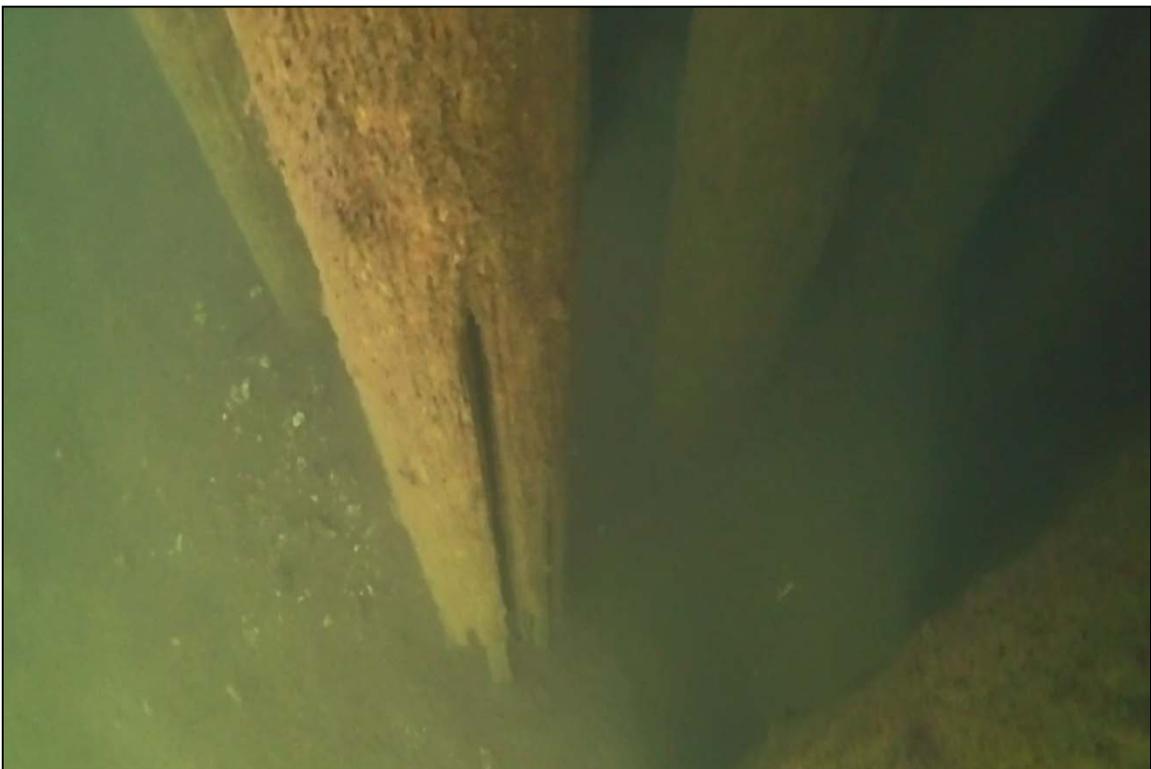
Photograph 16: View of delamination and split at Pile 22R in Section 7.

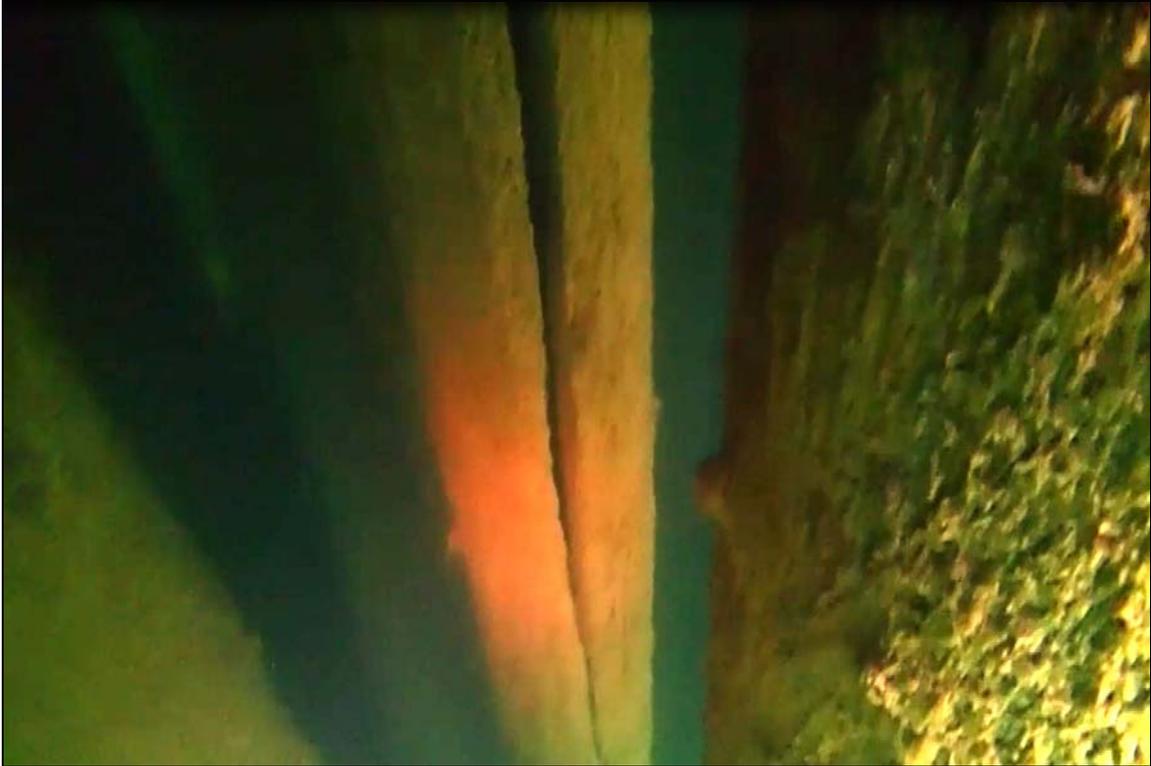
Photograph 17: View of split at Pile 25Q in Section 7.

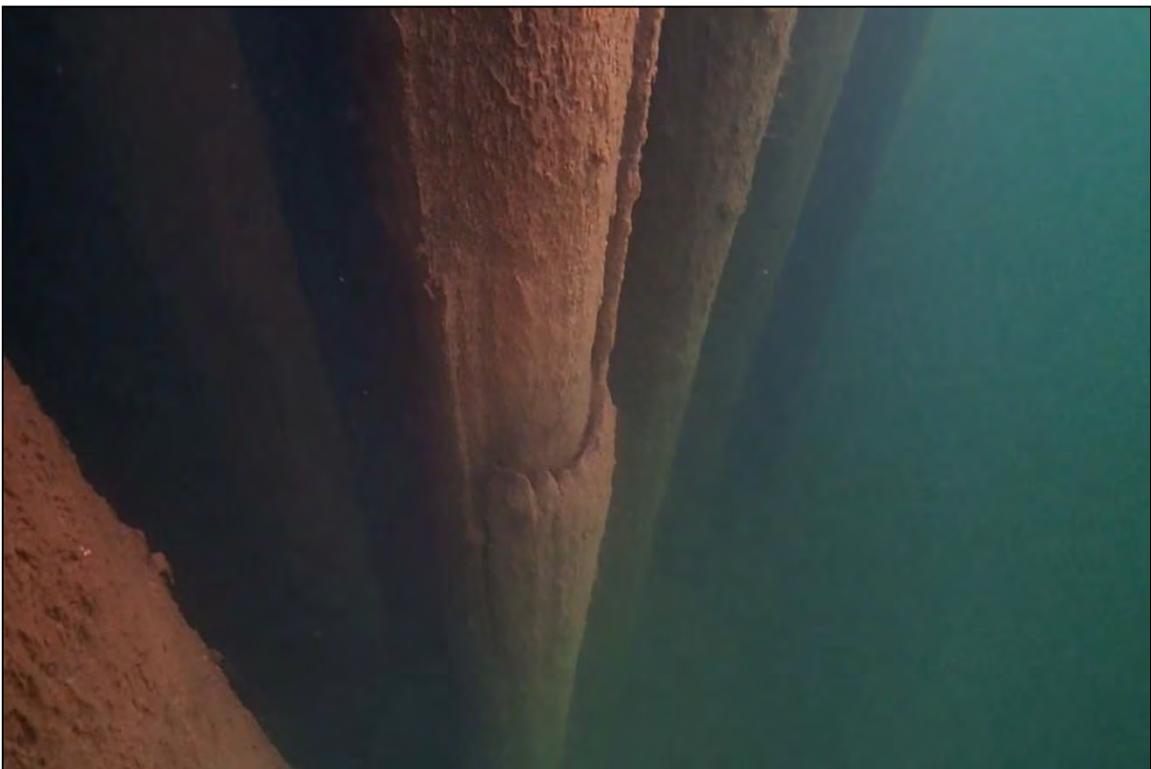
Photograph 18: View of loss of outer shell at Pile 40R in Section 6.

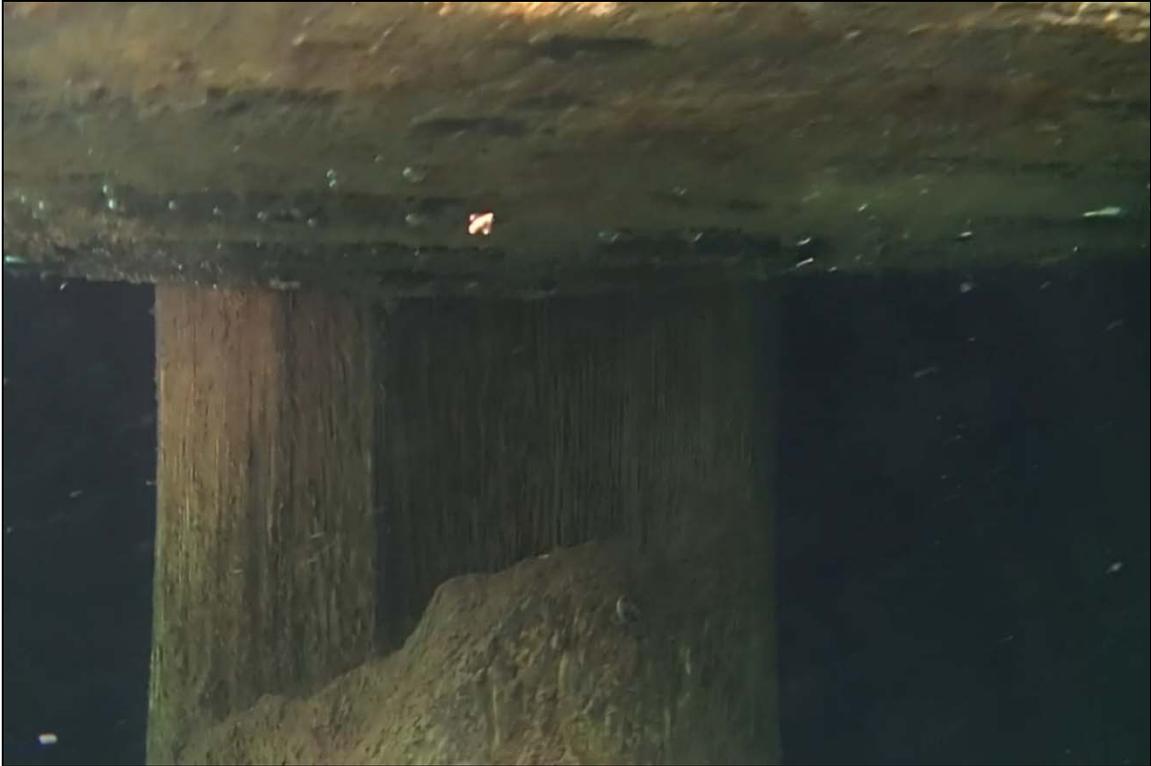
Photograph 21: View of section loss at Pile 39A in Section 4.

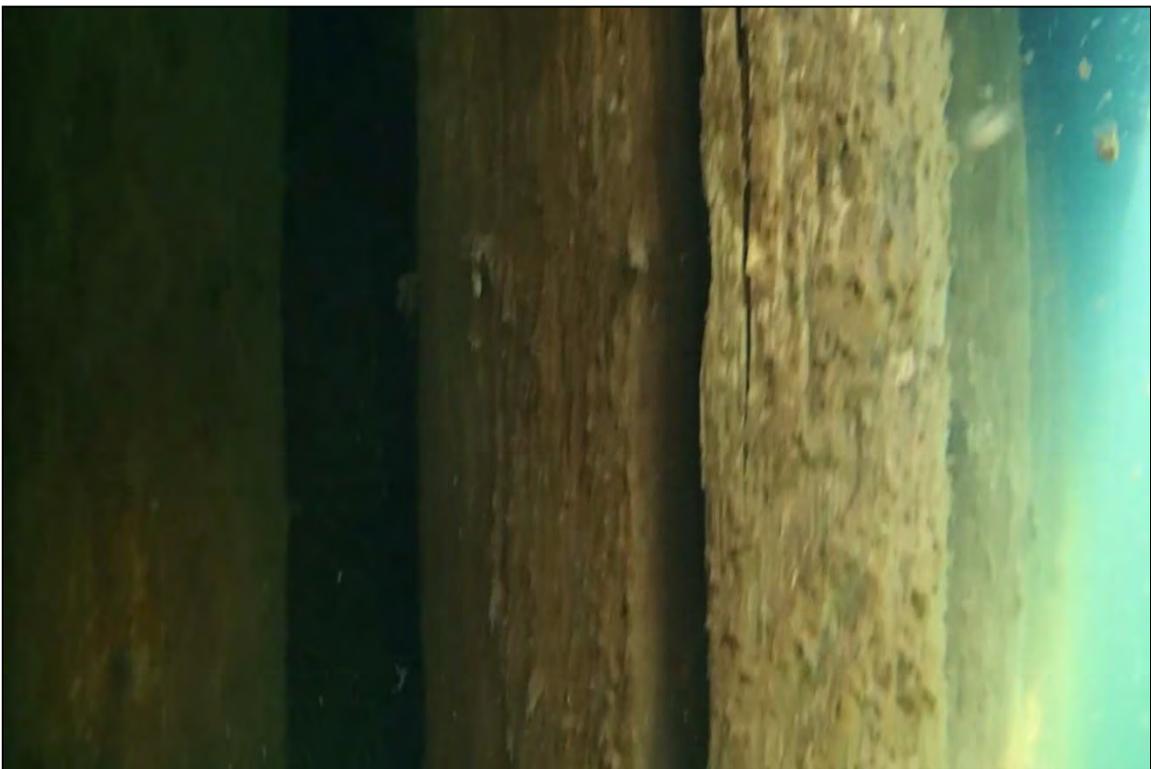
Photograph 22: View of split in Pile 35A in Section 7.

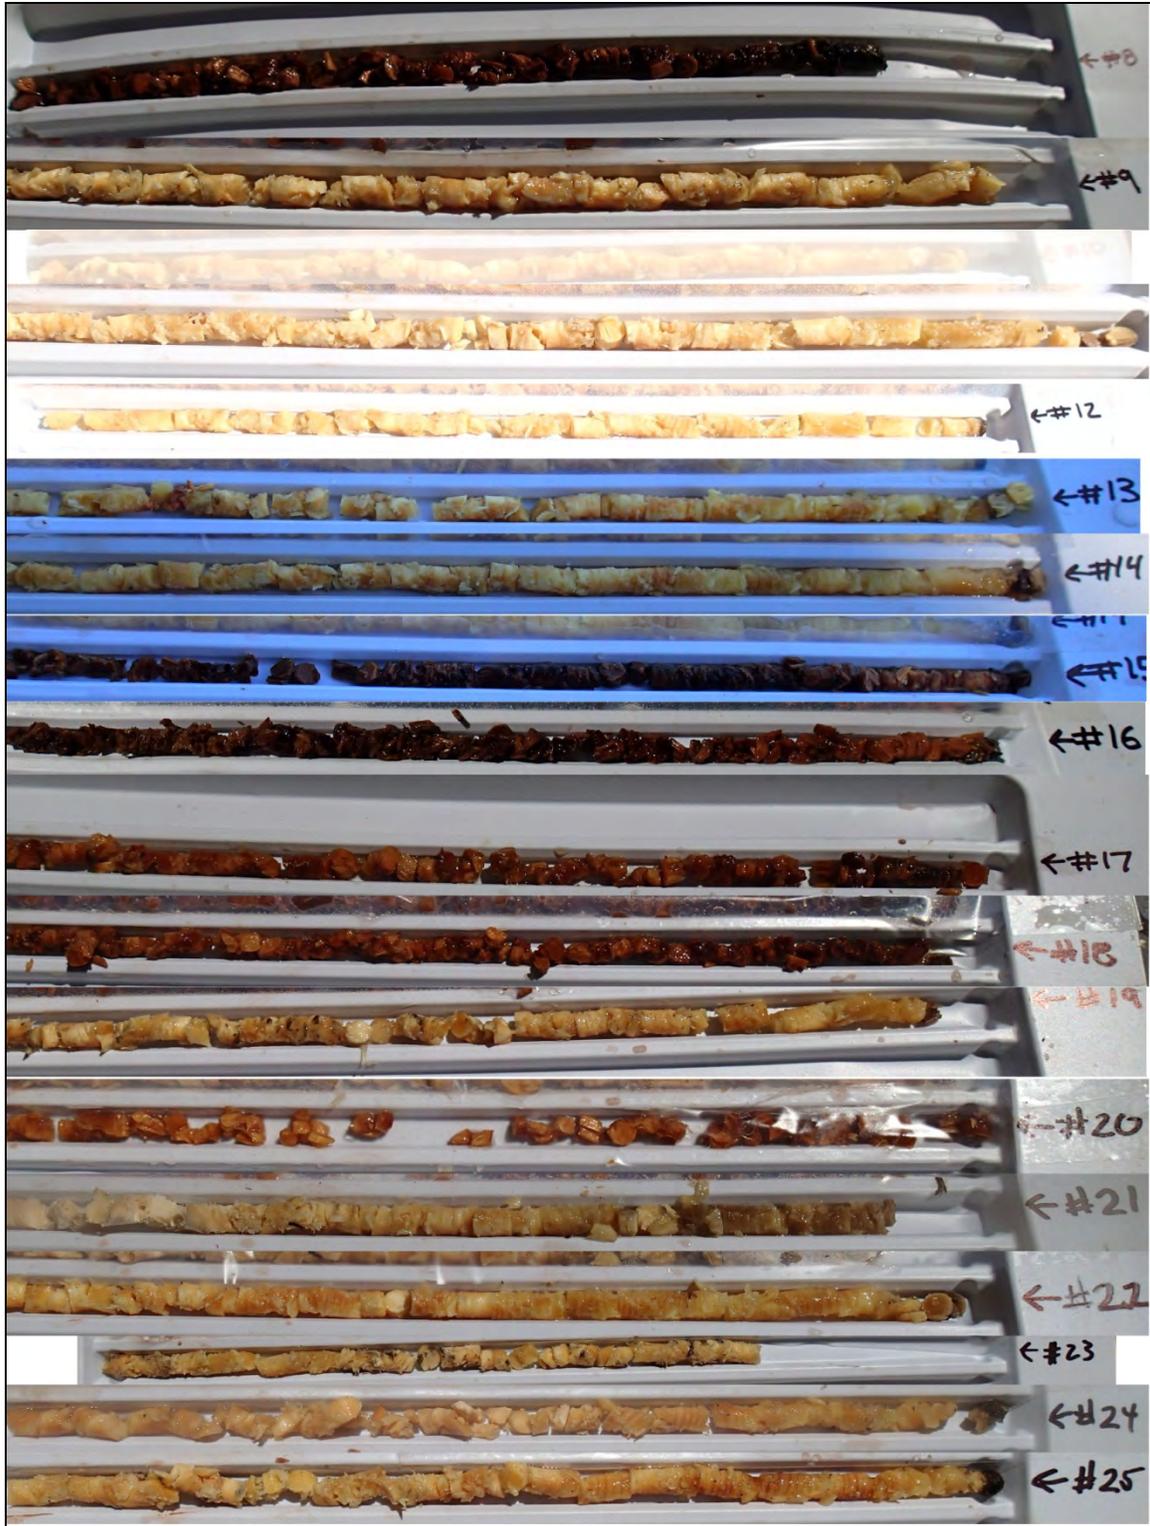
wood in the samples sent to them. See Photographs 29 and 30 in Appendix A for pictures of the timber cores.

Photograph 30: View of increment core numbers 8 through 25 from the dock exterior.

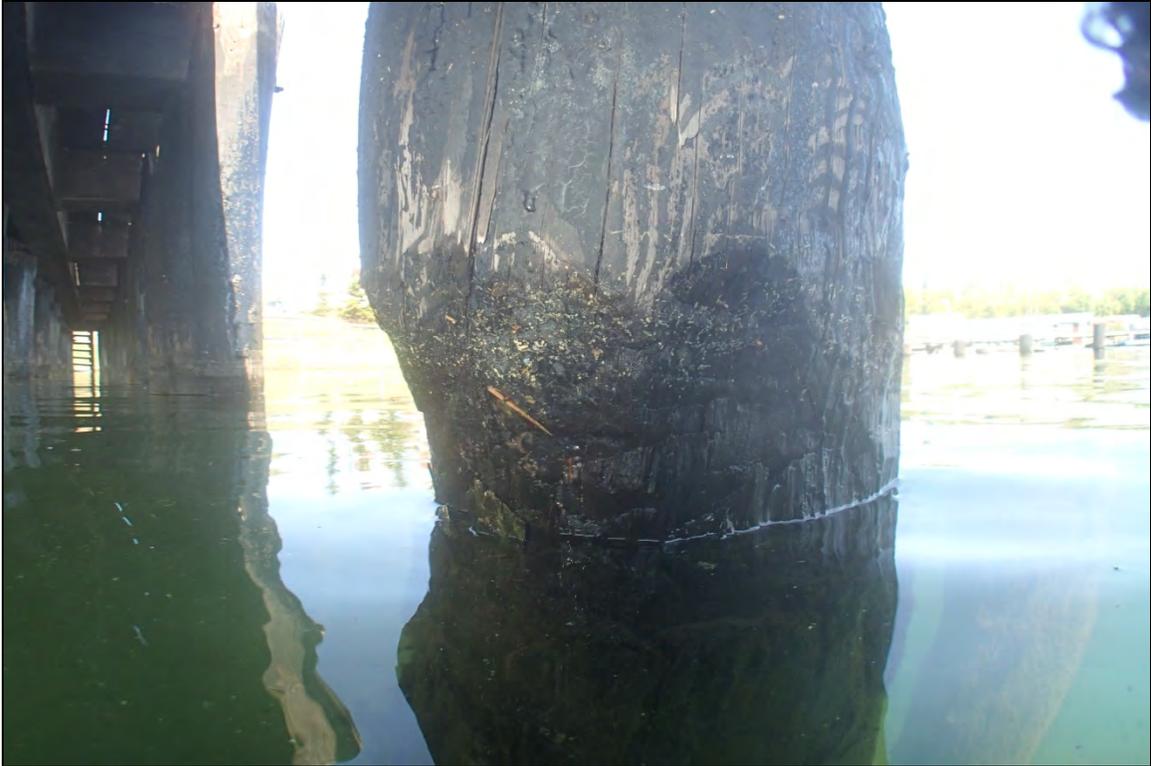
The timber piles of the pedestrian approach were in satisfactory condition with moderate weathering and random minor splits and checks in the splash zone. The 10<sup>th</sup> pile from the shore in the north row exhibited necking from 1.5 ft above to 1 ft below the waterline with approximately 25% loss of section. The 11<sup>th</sup> pile from the shore in the south row exhibited delamination of the outer 2 in. of the shell from 2 ft above to 2 ft below the waterline. See Photographs 8 through 23 in Appendix A for views of the dock structure timber defects. See Photographs 31 through 34 in Appendix A for views of the pedestrian approach piles.

Photograph 33: 10<sup>th</sup> pile from shore in the north row of Pedestrian Approach, looking north.

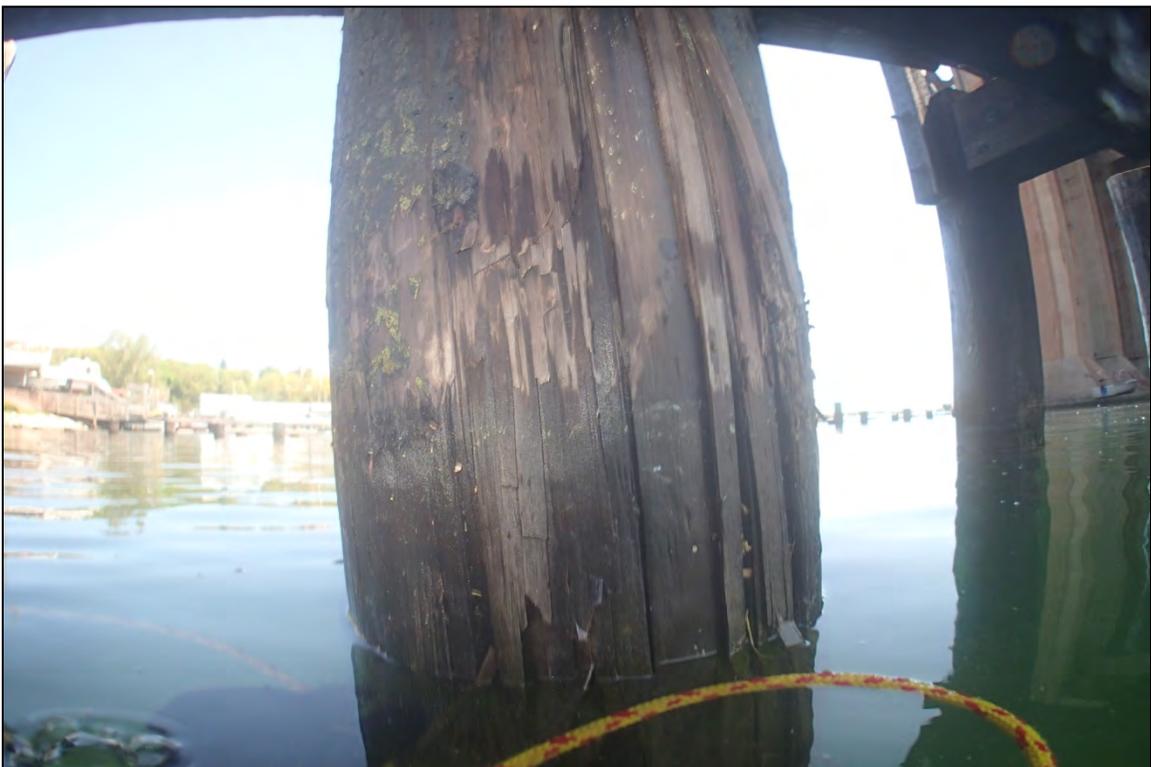
Photograph 34: 11<sup>th</sup> pile from shore in the south row of Pedestrian Approach, looking south.

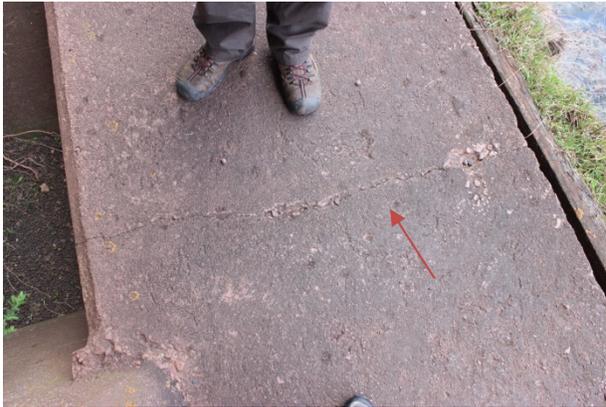
Cracks were regularly observed transverse to the fender. They were approximately mid span between bent columns. The cracks were tight with occasional localized scaling. Photos 1-1 and 1-2 depict the typical condition of the cracks on the walkway. The timber bumper on either side of this section has substantially deteriorated. Brush and plants are growing within the rotten wood. Photo 1-3 shows the condition of the timber bumper.

*Photo 1-1: Shrinkage crack in walkway between Bents 10 and 11, on the north side of the dock. Note deteriorated timber bumper.*

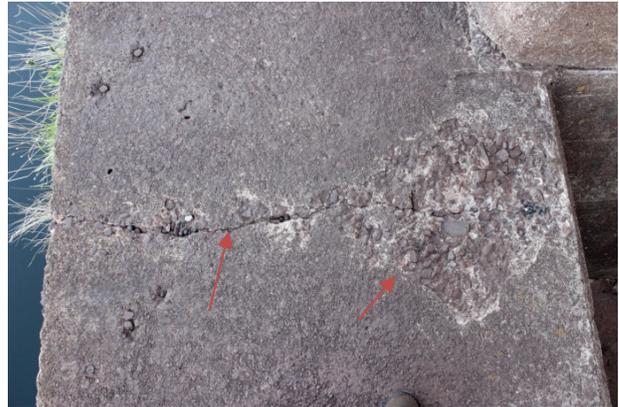
*Photo 1-2: Shrinkage crack in walkway between Bents 2 and 3, on the south side of the dock. Note localized surface scaling.*

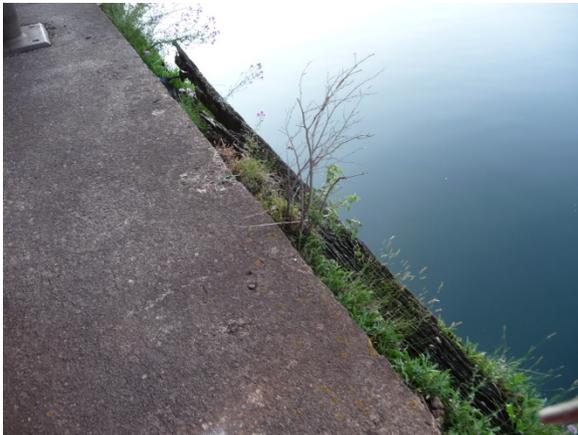
*Photo 1-3: Brush and vegetation growing in rotten timbers on fenders.*

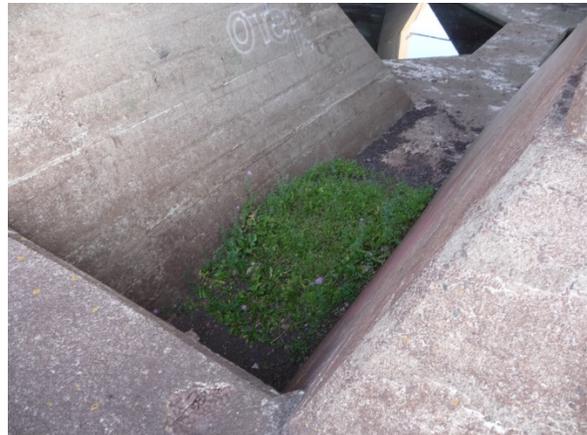
Minor cracking and some localized areas of minor scaling were observed on top of the pile cap, or floor of the ore dock. Piles of iron ore pellets are present at localized areas between the bents. Some of these piles have vegetation and brush growing within them (Photo 1-4).

*Photo 1-4: Vegetation growing in deposit of iron ore pellets.*

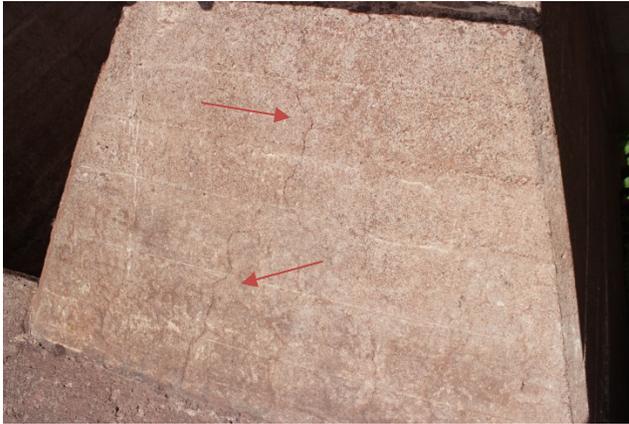
In localized areas, minor spalling has occurred due to shallow concrete cover over the steel reinforcement. This deterioration generally occurred on the upper corners of the footing, as shown in Photo 1-5. Minor shrinkage cracking is visible in localized areas of the footings (Photo 1-6).

*Photo 1-5: Shrinkage cracks on face of south base of Bent 7.*

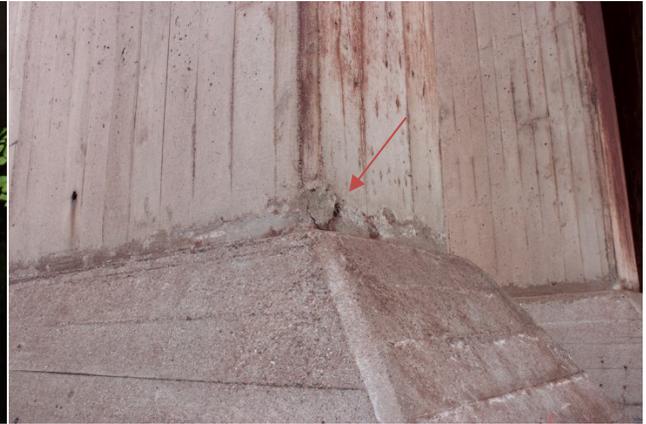
*Photo 1-6: Small localized area of delamination with rebar visible on Bent 6, north side.*

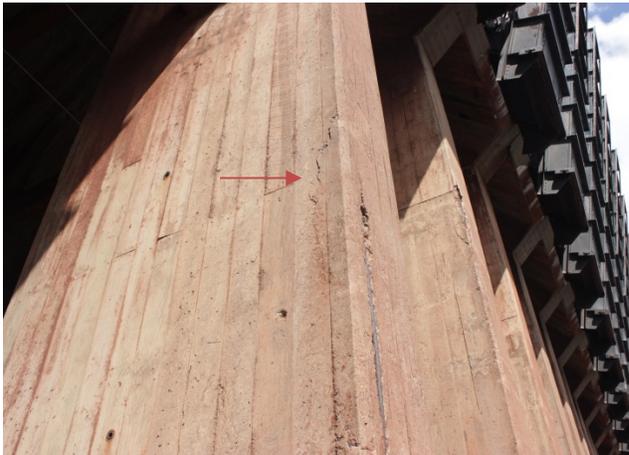
On the bents, occasional areas of spalling concrete with exposed reinforcing were observed, particularly on the corners of the columns (Photo 1-7 & 1-8). The concrete cover over the reinforcement in these areas was thin.

*Photo 1-7: Delamination/spalling on Bent 9, south side. Note exposed reinforcement with no concrete cover.*

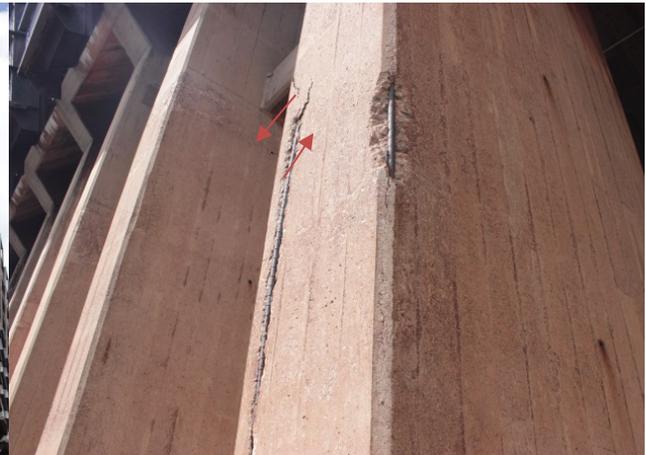
*Photo 1-8: Delamination/spalling on Bent 10, south side. Note exposed reinforcement with no concrete cover.*

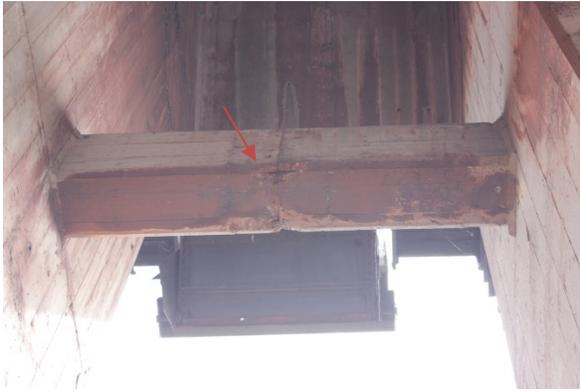
Spalling concrete with exposed shallow reinforcement was observed on many of these beams. Cold joints were occasionally observed mid-span. Photos 1-9 and 1-10 show the worst-case examples of beam deficiencies.

*Photo 1-9: Spalling with exposed reinforcement between Bents 5 and 6 on the south side. Note the cold joint mid-span on the beam.*

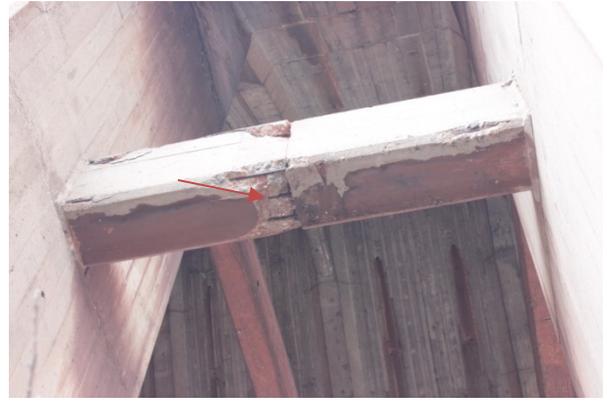
*Photo 1-10: Spalling with exposed reinforcement between Bents 5 and 6 on the north side. Note the cold joint mid-span on the beam.*

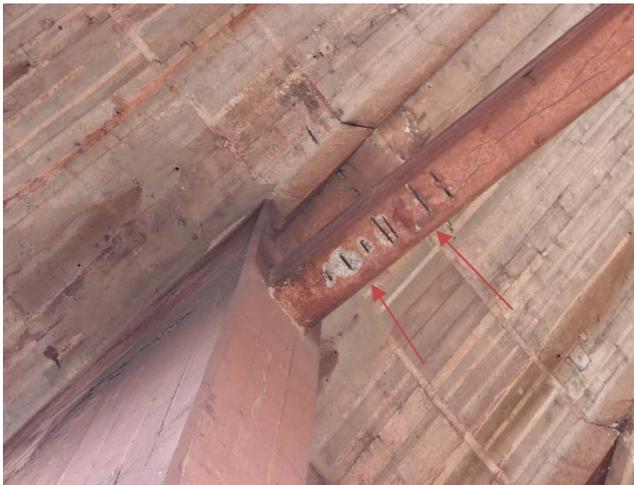
These beams typically exhibit spalling and superficial rebar (rebar with no concrete cover), such as in Photo 1-11. Some localized areas of poorly consolidated concrete were observed (Photo 1-12). Generally these types of deficiencies occur near the ends of the beams, near the bents. Photo 1-13 represents the worst-case deficiencies observed within Bent 1.

*Photo 1-11: Spalling with exposed reinforcement in the transverse beam at the north side of Bent 9.*

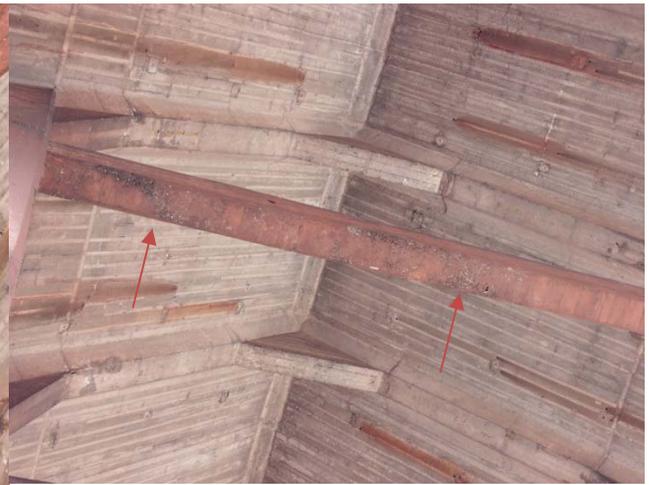
*Photo 1-12: Honeycombing in transverse beam at Bent 10.*

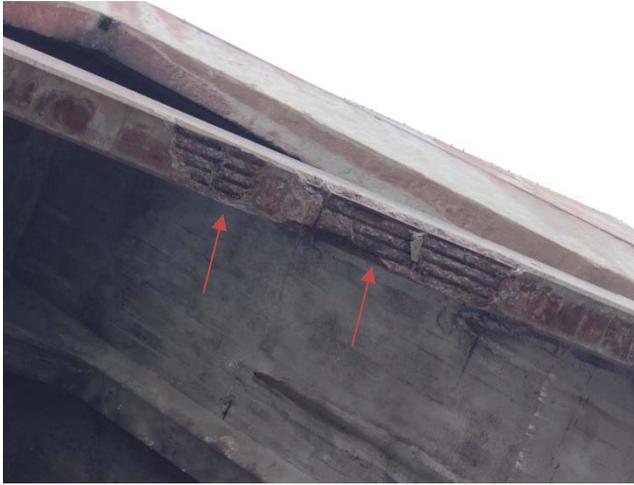
*Photo 1-13: Worst-case deterioration observed in the transverse beam at Bent 1.*

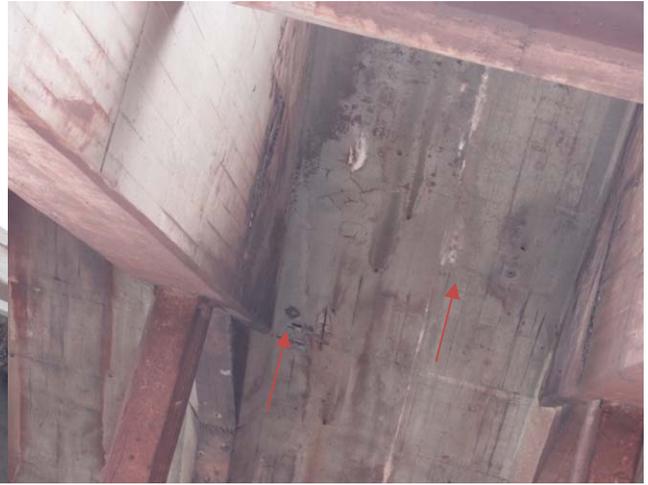
*Photo 1-14: View of ceiling between Bents 4 and 5 showing small spalls, exposed reinforcement, and holes penetrating the pocket slab.*

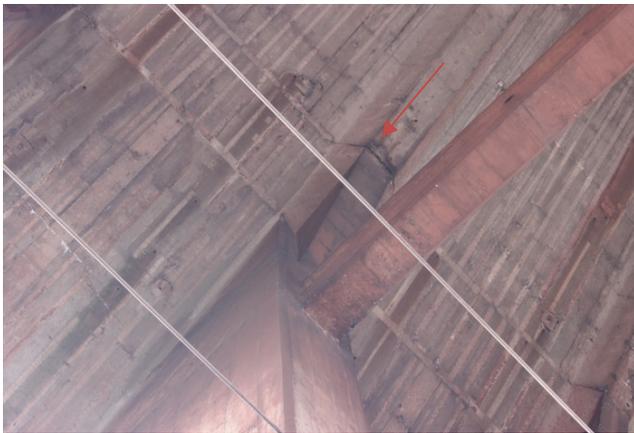
*Photo 1-15: Chamfer section of ceiling at south side of Bent 8 showing exposed rebar.*

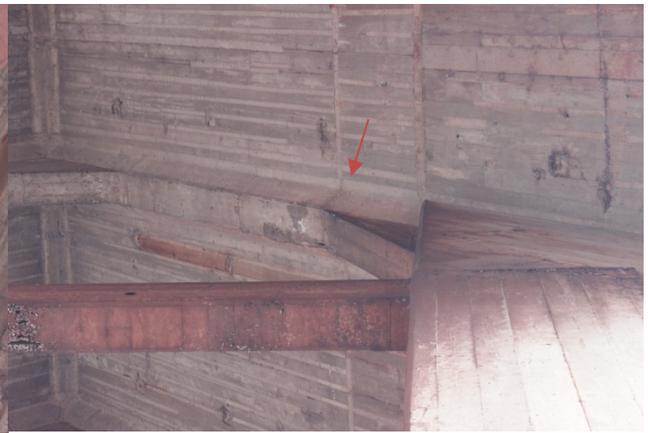
The underside of the iron ore pockets is the ceiling as observed from the pile cap floor. This surface was in good condition with only minor areas of poorly consolidated concrete, tight cracks with minor efflorescence, cold joints mostly near the expansion joints, small spalls, and some areas of exposed rebar, as shown in Photo 1-14. In every pocket, the ceiling contained numerous small holes that penetrated the slab. These holes appear to be part of the original construction, and are evident by water staining (Photo 1-15). The chamfers typically exhibited some spalling and exposed rebar. Photos 1-16 & 1-17 portray the average deficiencies of this element.

*Photo 1-16: Another example of exposed rebar at a honeycombed area on the transverse beam and at the chamfer section of Bent 12.*

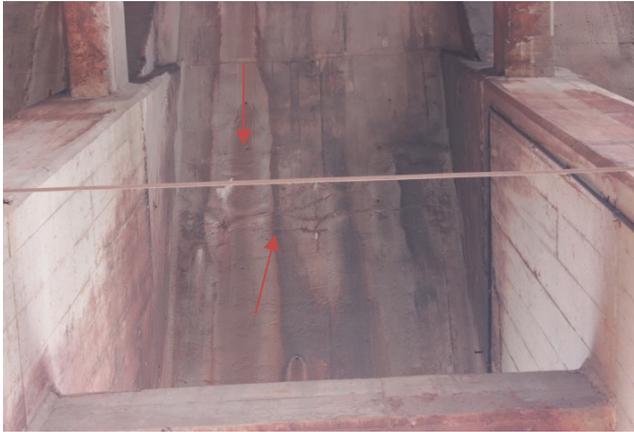
*Photo 1-17: Horizontal cracking on ceiling between Bents 3 and 4. Note minor efflorescence.*

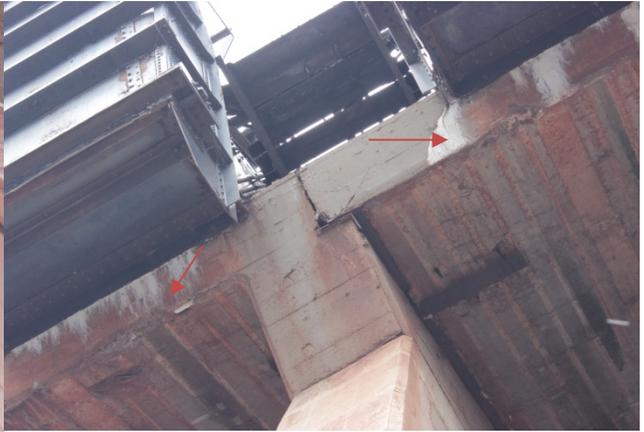
The overhangs are the bottom of the pocket slab and lowest part of the ceiling. These areas were observed to have areas of poorly consolidated concrete, evidence of miscellaneous debris (possible trash that was dropped in the bottom of the formwork during original construction), and cracking with efflorescence. The cracks were typically associated within the chute steel imbeds. Photos 1-18 and 1-19 show examples of these deficiencies.

*Photo 1-18: View of expansion joint between Section 1 and 2 at Bent 12. Note localized spalled concrete, honeycombed concrete is common. Cracking with some efflorescence is also observed at the location of chute steel imbeds.*

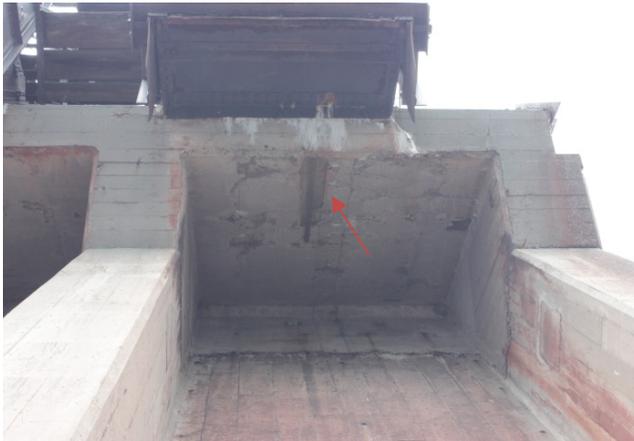
*Photo 1-19: View of cracks with efflorescence, with spalling and exposed rebar between Bents 1 and 2, north side.*

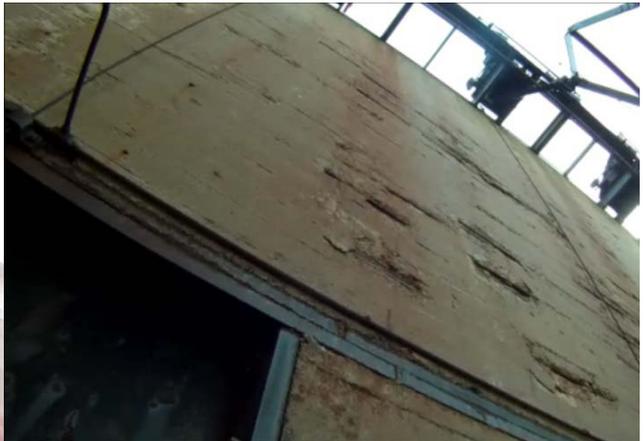
The pocket walls were inspected from the elevated walkway along the base of the chutes, and from the top of the dock at two stair locations in this Section. The interior pocket walls and floors of the pockets were observed to be in good condition with no cracking, spalling, or exposed reinforcement. The exterior walls on the north and south sides of the dock did exhibit various degrees of spalled concrete with exposed rebar (Photo 1-20 and 1-26). Generally, the south pocket wall exhibited greater spalling than the north side.

*Photo 1-20: Pocket wall showing spalling and rebar.*

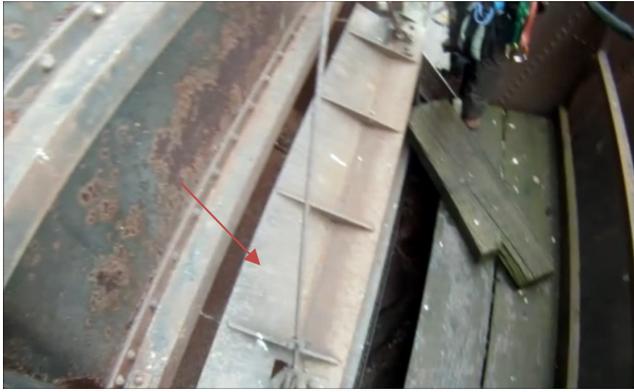
*Photo 1-21: Additional steel top member found on pocket doors 1 through 27.*

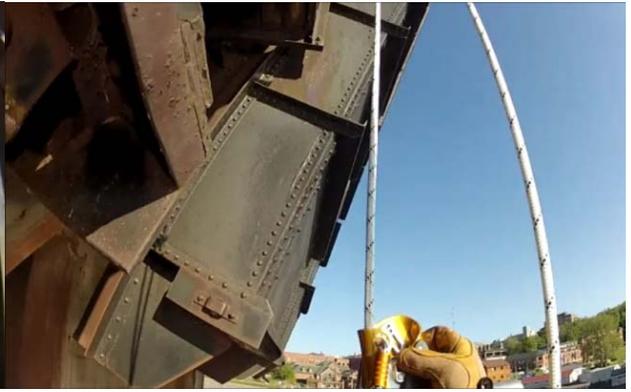
*Photo 1-22: Side view of chute 4 showing hinge pin.*

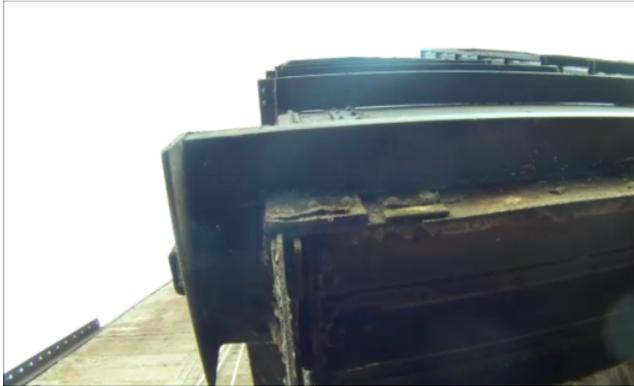
All of the chutes were inspected from the walkway at the base of the chutes. The chutes were observed to be identically constructed and in good condition, with minimal deterioration observed. Measurements of the member sizes of various components of Chute 1 were documented, and were found to be consistent with the record drawings. In addition, the member sizes of the pocket Gate 1 were documented, and were found to be consistent with the record drawings. The pocket gates were observed to be in good condition and substantially identical, with the only noted difference being the top of the gate. Gates 1 through 27 on the south side have an additional member on top of the gate (Photo 1-21). This member does not have an apparent structural benefit, but may have prevented overflow of iron ore pellets. At the locations where the inspectors ascended and descended the access ropes, close-up inspections of the steel pins at the base of the chutes were inspected. These inspections were limited to Chute 1 and Chute 6 (Photo 1-22). The steel construction in the areas of the pins was observed to be consistent with the record drawings. Minor deterioration was noted, with no excessive wear on the pin or associated steel plate. Slight bending of the steel in the areas of the pins was noted. Photo 1-23 shows the condition of the chutes and gates.

*Photo 1-23: Close-up view of the underside of chute 1 showing hinge pin connection.*

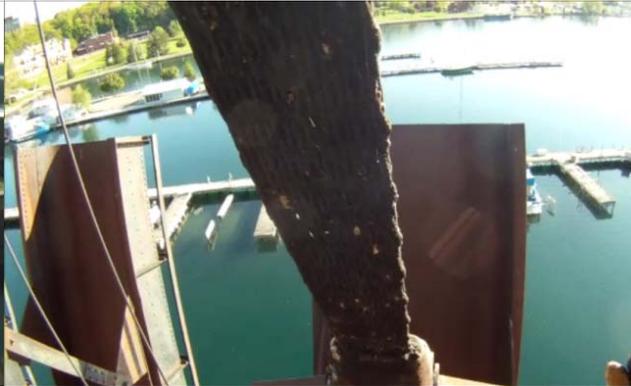
All of the chutes are abandoned in an upright condition, and held in place by the braded steel belt, associated attachments to the chute, and individual hoists located on the top of the dock. Close-up inspections of the belts, connections and hoists were conducted from the two stairs. The belt was observed to be in good condition with no fraying corrosion or deterioration noted. The members that connect the steel belt to the chute were observed to be in good condition, and were measured on Chute 6. The measurements found the members to be consistent with the record drawings. The hoists were observed to be securely bolted to the deck steel frame. Each hoist real locks the steel belt in place through the use of a key or stop in the cogs of the main hoist real. Through some linkage controlled by levers, the hoist can also operate the pocket gates. The hoists are attached to a drive shaft, that is powered by an electric motor. Photos 1-24, 1-25 and 1-26 show the condition of the steel belt and hoists.

*Photo 1-24: Close-up view of braded steel belt for hoisting chute 5.*

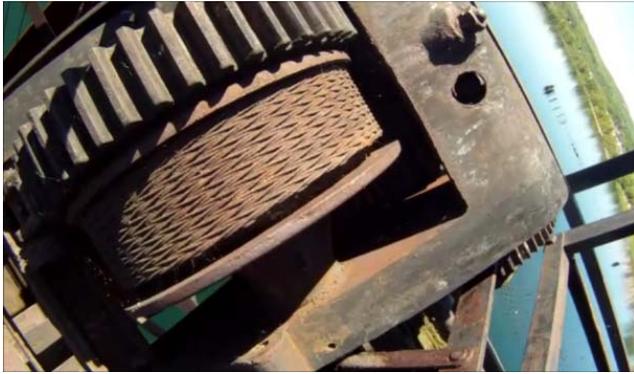
*Photo 1-25: View of hoist for chute 3 with braded steel belt.*
