## Lower Harbor Ore Dock Inspection Report

Marquette, Michigan

December 11, 2014

GEI Project No. 1330920

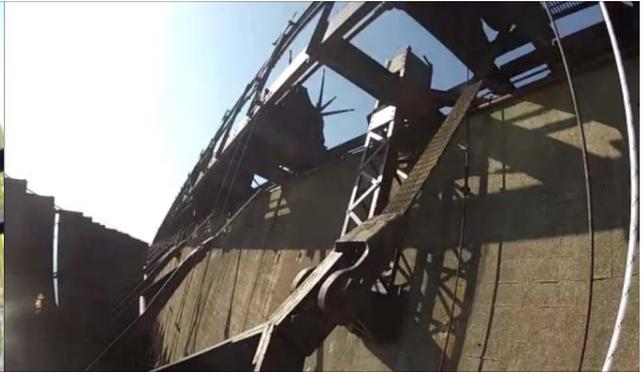
All of the chutes are abandoned in an upright condition, and held in place by the braded steel belt, associated attachments to the chute, and individual hoists located on the top of the dock. Close-up inspections of the belts, connections and hoists were conducted from the two stairs. The belt was observed to be in good condition with no fraying corrosion or deterioration noted. The members that connect the steel belt to the chute were observed to be in good condition, and were measured on Chute 6. The measurements found the members to be consistent with the record drawings. The hoists were observed to be securely bolted to the deck steel frame. Each hoist real locks the steel belt in place through the use of a key or stop in the cogs of the main hoist real. Through some linkage controlled by levers, the hoist can also operate the pocket gates. The hoists are attached to a drive shaft, that is powered by an electric motor. Photos 1-24, 1-25 and 1-26 show the condition of the steel belt and hoists.

*Photo 1-26: Close-up view of hoist belt connection to chute 6. Note good condition of pocket wall.*

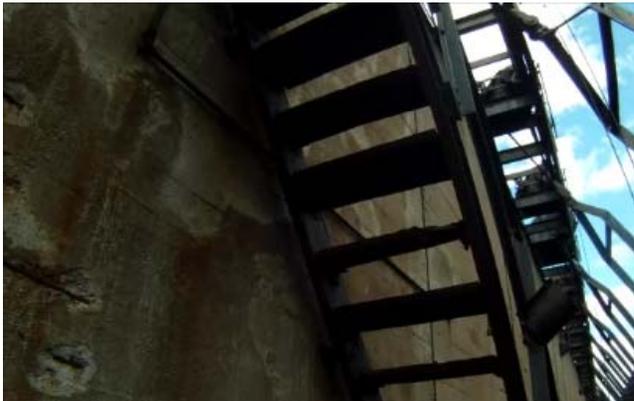
The walkway above the chutes is supported on the imbedded elements of the base of the chutes, which is consistent with the record drawings. Measurements of the walkway members were conducted at Chute 1, and were also consistent with the record drawings. The walkway railings and support steel members were observed to be in good condition with little to no evidence of deterioration. Occasional top railings were bent, likely due to impacts from falling objects. Two stairs (one on the north and one on the south side of the dock) are present within this section. The stair framing and attachments to the pocket walls were observed to be consistent with the record drawings. The members and attachments were observed to be in good condition with little to no evidence of deterioration. The timber decking used for both the walkways and stairs was in poor to good condition. Some timbers were in good condition with sound attachments to the steel members, while others were completely deteriorated or missing. Photos 1-27 & 1-28 show the condition of the walkway and stairs within this Section.

*Photo 1-27: View of upper portion of southwest stairs. Note spalled concrete and exposed rebar on pocket wall.*

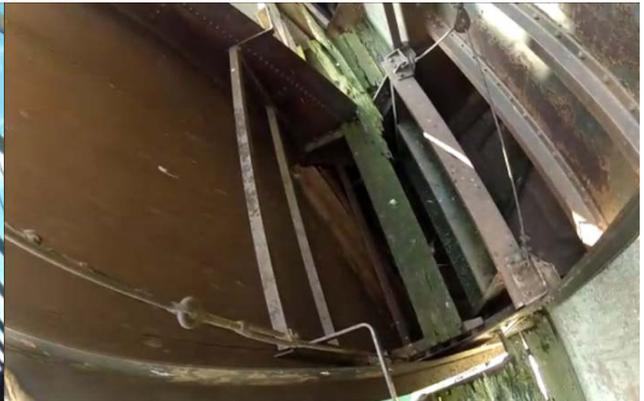
*Photo 1-28: Typical view of pocket gate, walkway, and chute.*

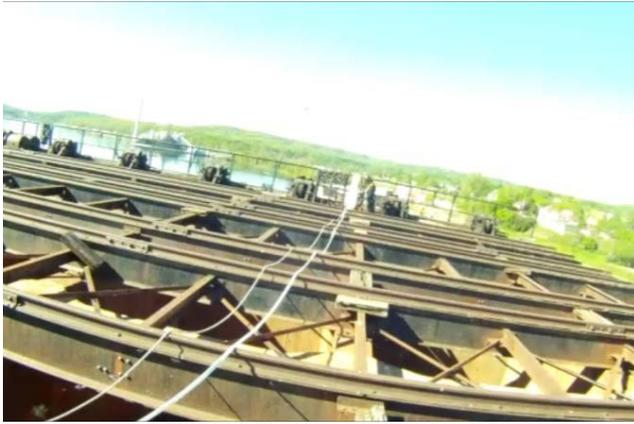
The top of the dock was observed at the locations of the stairs on both the north and south sides of this Section. The framing was observed to be in good condition with little to no deterioration noted. However, some members were observed to be bent, and some localized areas of corrosion were noted. The geometry of the deck framing was not measured, but was observed to be not consistent with the record drawings. Measurements of the deck framing members was conducted, and found to be consistent with the record drawings.

*Photo 1-29: View looking south across top of the west end of the dock showing steel framing.*

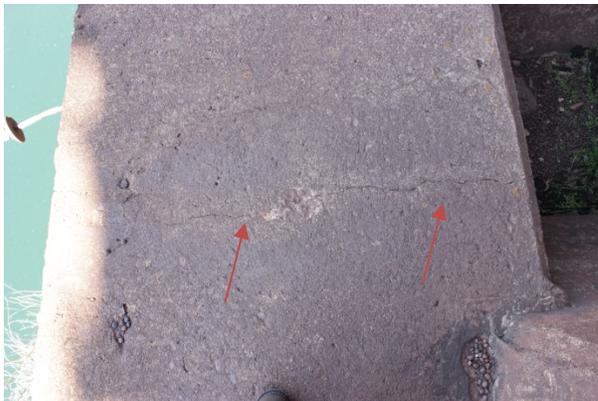
Cracks were regularly observed transverse to the fender. They were approximately mid span between bent columns. The cracks were tight with occasional localized scaling. Photos 2-1 through 2-3 depict the typical condition of the cracks and scaling on the walkway. The timber bumper on either side of this section has substantially deteriorated. Brush and plants are growing within the rotten wood.

*Photo 2-1: This photo shows cracking on the south side of the fender between Bents 14 and 15.*

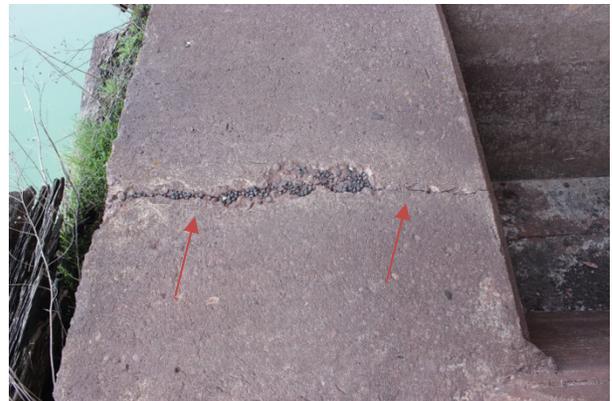
*Photo 2-2: Cracking on south side of fender with some spalling coming from the crack, between Bents 17 and 18.*

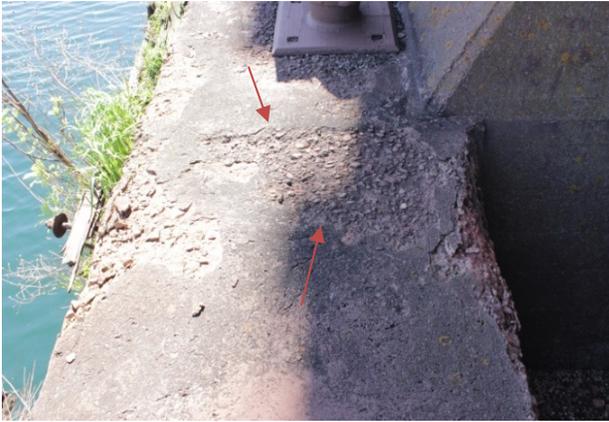
*Photo 2-3: Medium-size scaling on north side of fender, between Bents 13 and 14. Note rotten timber fender.*

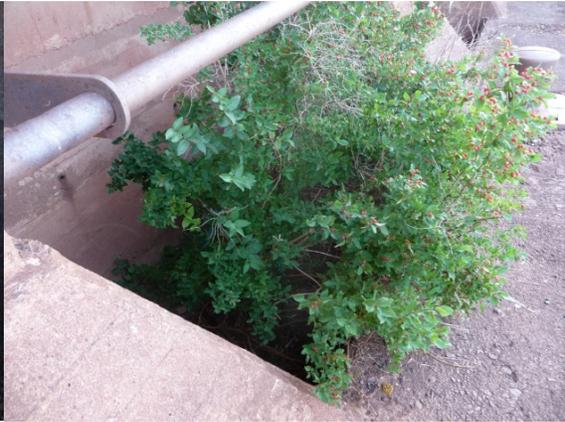
Minor cracking and some localized areas of minor scaling were observed on top of the pile cap, or floor of the ore dock. Piles of iron ore pellets are present at localized areas between bents, some of which have trees and brush growing within them (Photo 2-4).

*Photo 2-4: Small tree growing in iron ore pellet pile between bent bases.*

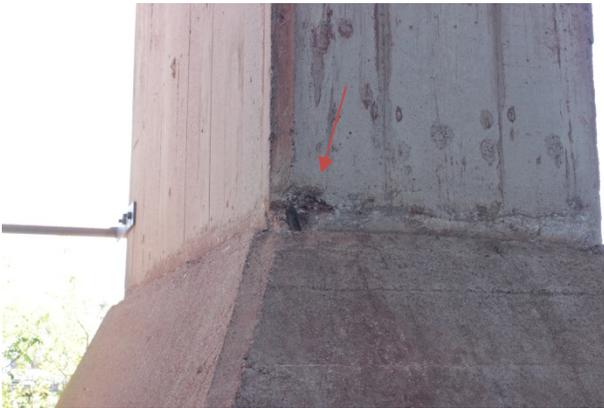
Minor spalling has occurred on the upper corners of the base, as shown in Photo 2-5. Minor shrinkage cracking is also visible in localized areas of some of the bases (Photo 2-6.)

*Photo 2-5: Top of bent bases often have small spalls with rebar visible, this one is located on the north side of Bent 17.*

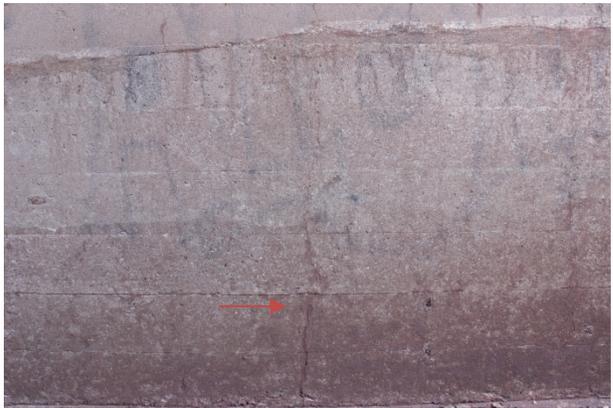
*Photo 2-6: Shrinkage cracking on Bent 23 base on south side of dock.*

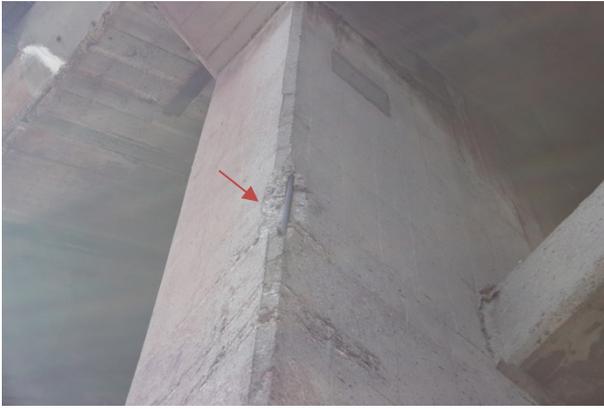
On the Bents, delaminated and spalled concrete (Photos 2-7 & 2-8) are not as apparent compared to Section 1. A few protruding rebar ties were observed on some of the bents (Photo 2-9). Occasional tight vertical shrinkage cracks were observed towards the base of these bents (Photo 2-10).

*Photo 2-7: Spalls on Bent 23 on the north side of the dock.*

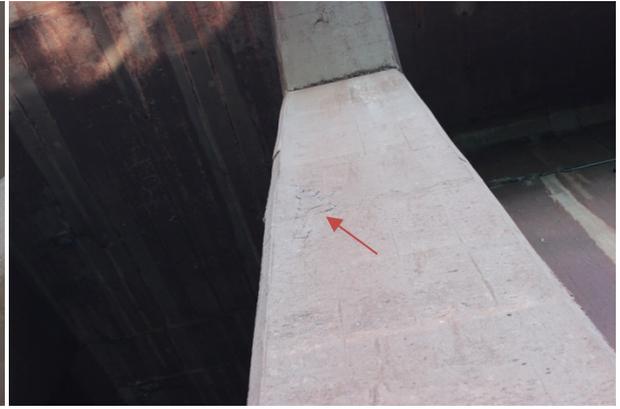
*Photo 2-8: Delamination of Bent 18 on the south side of the dock.*

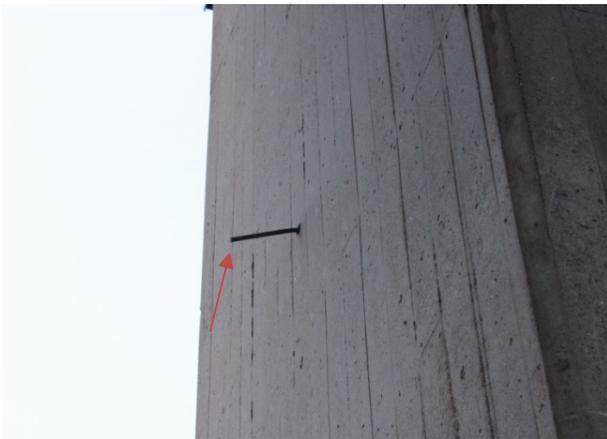
*Photo 2-9: Protruding steel bar from the face of Bent 14 on the south side of the dock.*

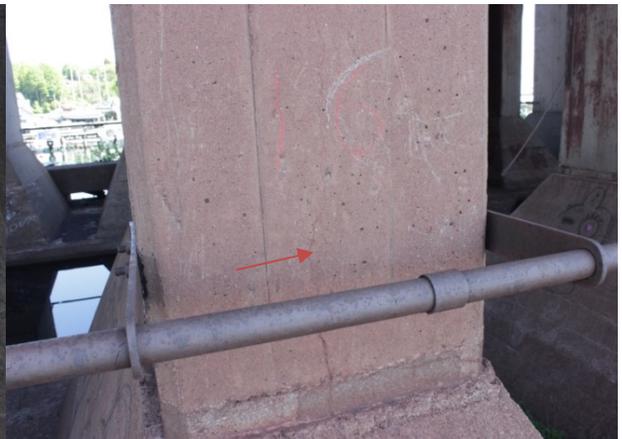
*Photo 2-10: Cracking at the base of Bent 16 on the south side of the dock.*

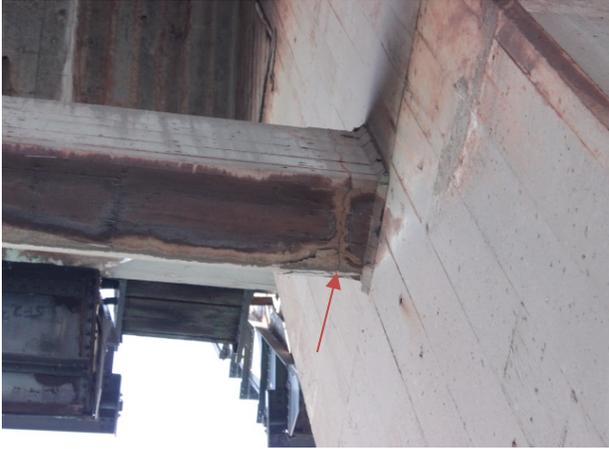
The longitudinal beams contained some tight cracks in localized areas (Photo 2-11) and localized spalling and exposed rebar (Photo 2-12).

*Photo 2-11: Delamination cracking in the longitudinal beam between Bents 15 and 16 located on the north side of the dock.*

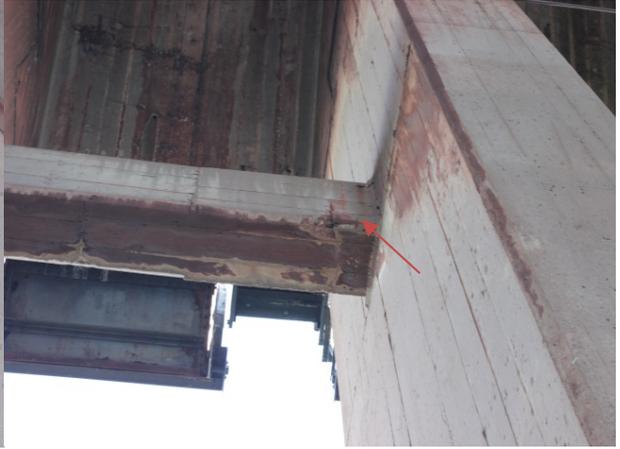
*Photo 2-12: Delamination cracking with small spalls in longitudinal beam of Bent 13 with visible rebar on the south side of dock.*

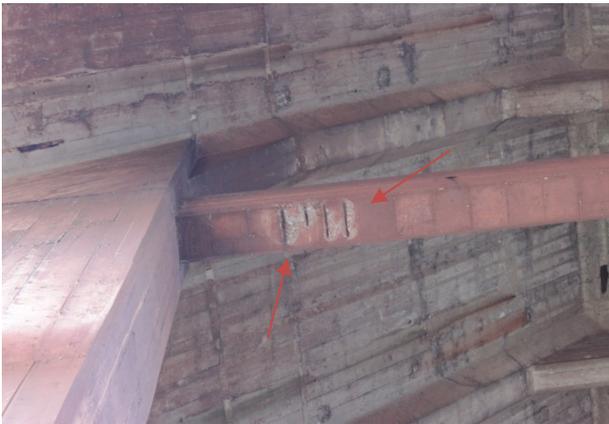
Superficial rebar was common along the bottoms of these beams (Photo 2-13). These types of deficiencies occur in localized areas towards the bents both the north and/or south sides.

*Photo 2-13: Spalls with rebar visible on transverse members, on the north side of Bent 21.*

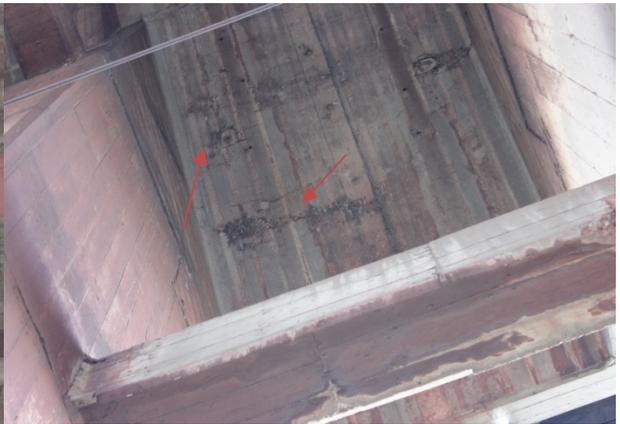
The ceilings show minor sections of poorly consolidated concrete, cracking, and rebar as shown in Photo 2-14. Cold joints appear in this section in localized area as photo 2-15 shows. Rebar is most common in the chamfer section of this ceiling. Photo 2-16 portrays the average deficiencies of this chamfer area, and rebar is also visible in the top of the ceiling.

*Photo 2-14: Honeycombing shown on the ceiling between Bents 13 and 14 on the south side of the dock.*

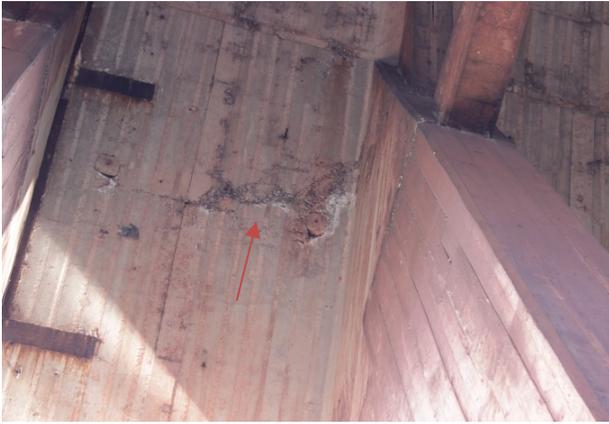
*Photo 2-15: Cold joint shown on the expansion joint in this section between Bents 12 and 13 on the north side of the dock.*

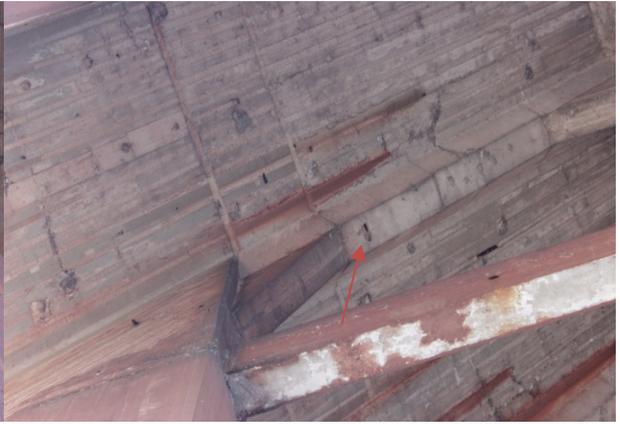
*Photo 2-16: Cracking with rebar showing on the chamfer section of Bent 15 on the north side of the dock.*

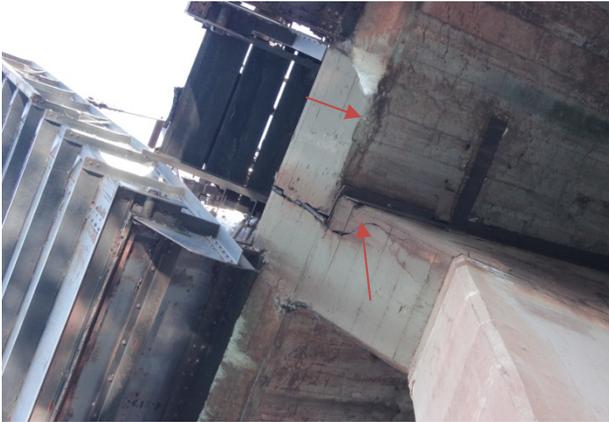
The overhangs are the bottom of the pocket slab and lowest part of the ceiling. These areas were observed to have areas of poorly consolidated concrete, evidence of miscellaneous debris (possible trash that was dropped in the bottom of the formwork during original construction), and cracking with efflorescence. The cracks were typically associated within the chute steel imbeds. Photos 2-17 and 2-18 show examples of these deficiencies.

*Photo 2-17: Cracking on chute base of Bent 23 near the expansion joint on south side.*

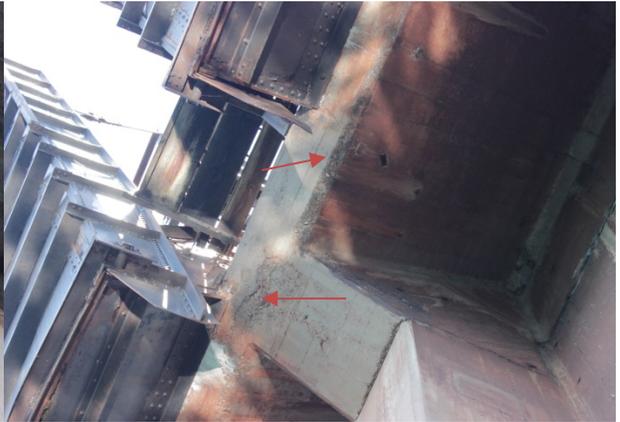
*Photo 2-18: Delaminations with small spalls on chute base of Bent 18 on the south side of the dock.*

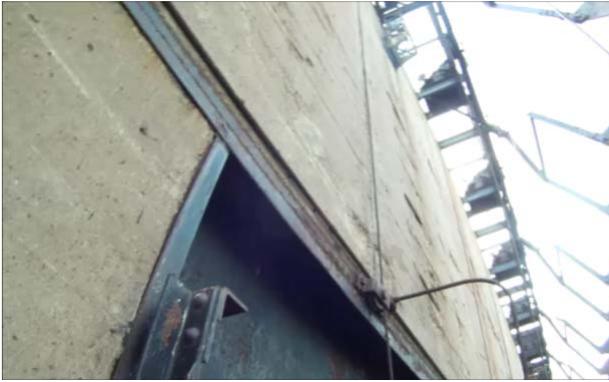
The pocket walls were inspected from the elevated walkway along the base of the chutes. The exterior walls on the north and south sides of the dock exhibited various degrees of spalled concrete with exposed rebar (Photo 2-19). Generally, the south pocket wall exhibited greater spalling than the north side.

*Photo 2-19: Pocket wall where superficial thin spalls and rebar is apparent.*

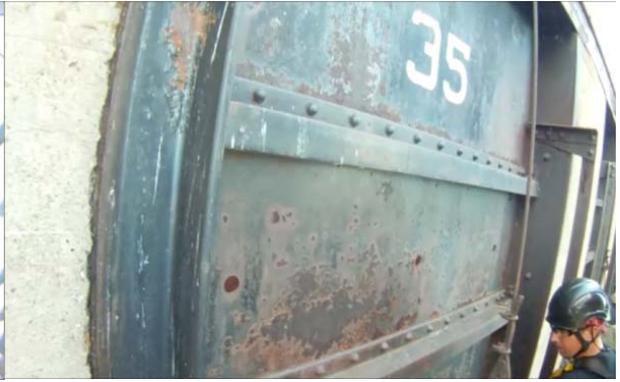
All of the chutes were inspected from the walkway at the base of the chutes. The chutes were observed to be identically constructed and in good condition, with minimal deterioration observed. The pocket gates were observed to be in good condition and substantially identical, with the only noted difference being the top of the gate. Photos 2-20 & 2-21 show the condition of the chutes and gates.

*Photo 2-20: Fixed portion of pocket door 35. Note good condition of steel with remaining paint coating.*

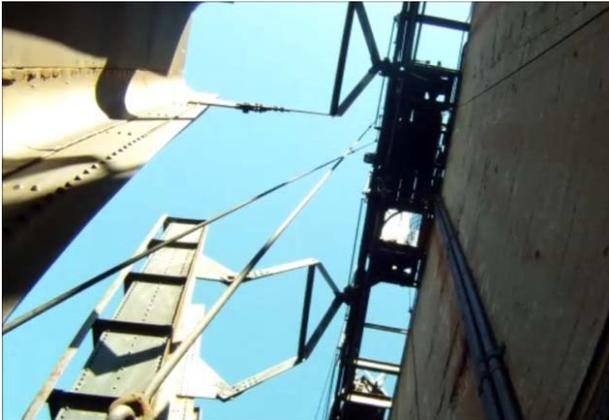
*Photo 2-21: Typical view looking up at chutes and hoisting appurtenances.*

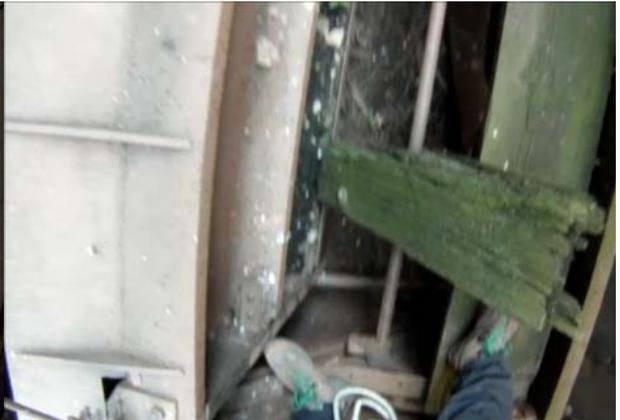
The walkway above the chutes is supported on the imbedded elements of the base of the chutes, which is consistent with the record drawings. The walkway railings and support steel members were observed to be in good condition with little to no evidence of deterioration. Occasional top railings were bent, likely due to impacts from falling objects. Stairs are not located in this section. The timber decking used for the walkways was in poor to good condition. Some timbers were in good condition with sound attachments to the steel members, while others were completely deteriorated or missing. Photo 2-22 shows the condition of one area of the walkway within this Section.

*Photo 2-22: View looking down at pocket gate and walkway timbers.*

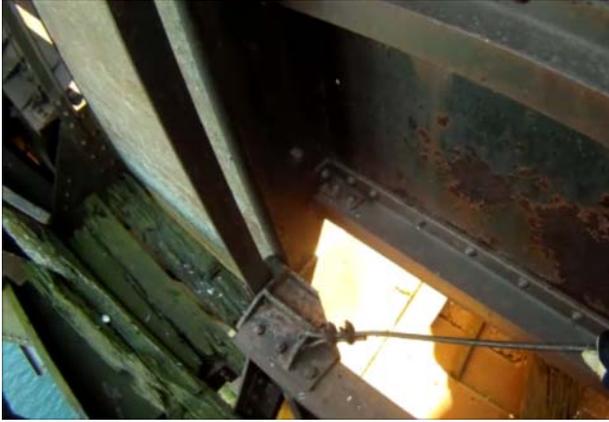
*Photo 2-23: View of pocket gate, showing hoist connection on gate and gate guides. Note condition of walkway between chutes.*

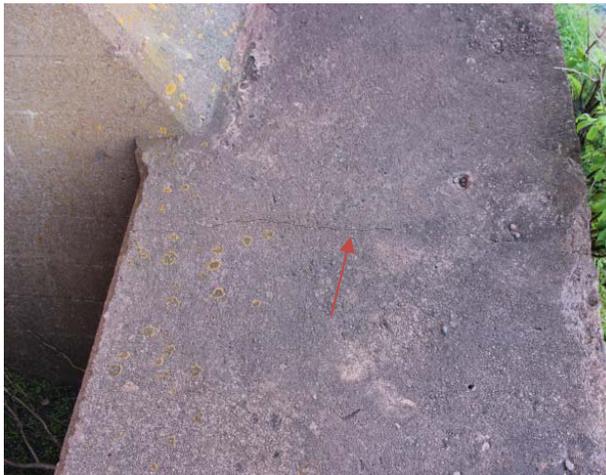
Cracks are regularly observed perpendicular to the fender. They are approximately mid span between bent columns. The cracks were tight with occasional localized scaling. Photos 3-1 and 3-2 depict the typical condition of the cracks in the fender section.

*Photo 3-1: Cracking on fender between Bents 25 and 26 on the north side of the dock.*

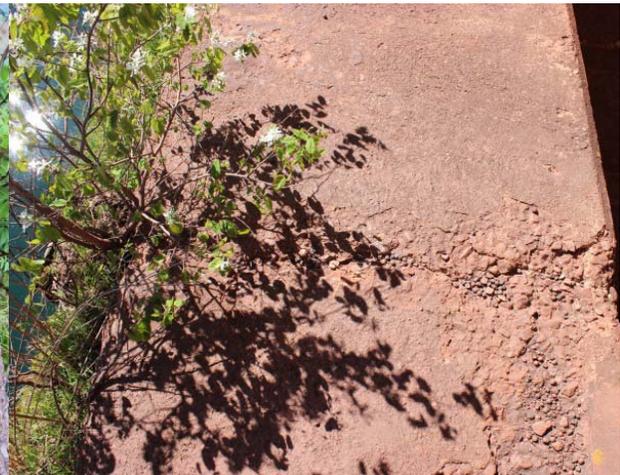
*Photo 3-2: Showing fender between Bents 26 and 27 with scaling on the south side of the dock. Note tree growing in rotten timber fender.*

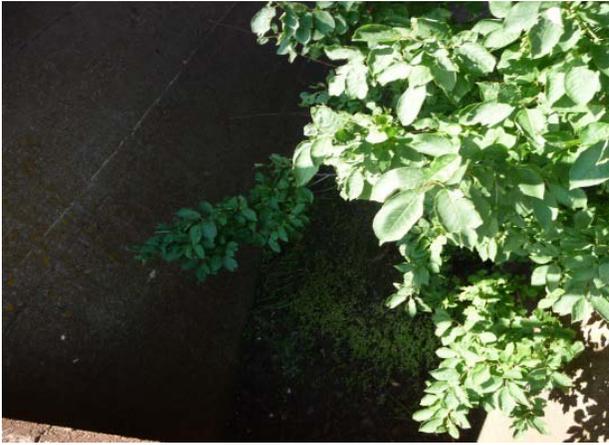
Minor cracking and some localized areas of minor scaling were observed on top of the pile cap, or floor of the ore dock. Piles of iron ore pellets are present at localized areas between bents, some of which have trees and brush growing within them (Photo 3-3).

*Photo 3-3: Trees growing in a pile of iron ore pellets on pile cap/floor.*

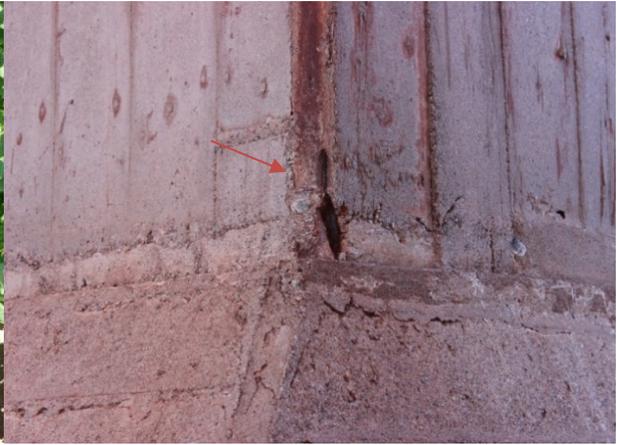
Some localized areas of minor spalling with visible rebar was observed. Photos 3-4 through 3-6 depict the typical conditions encountered.

*Photo 3-4: Spalls with visible rebar apparent at the top edges of Bent 28 base on the north side of the dock.*

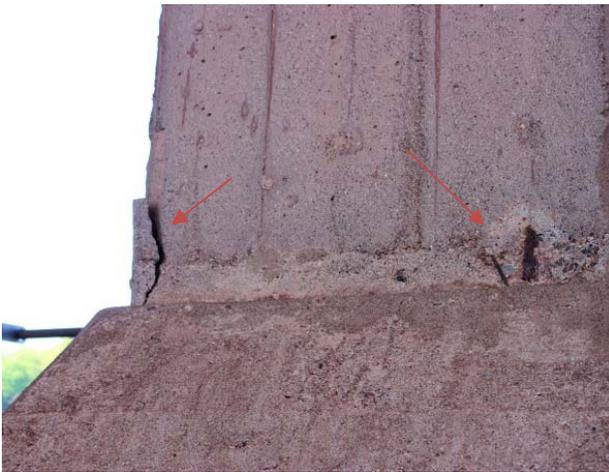
*Photo 3-5: Delaminations and spalling on the bottom of Bent 34 located on the north side of the dock.*

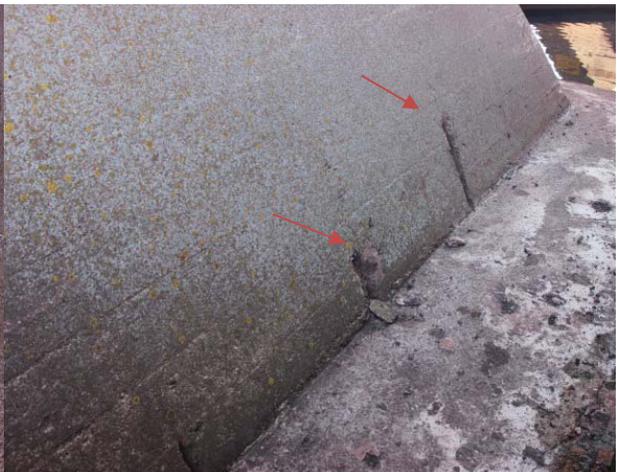
*Photo 3-6: Spalls on the north face of Bent 34 base with shallow rebar exposed.*

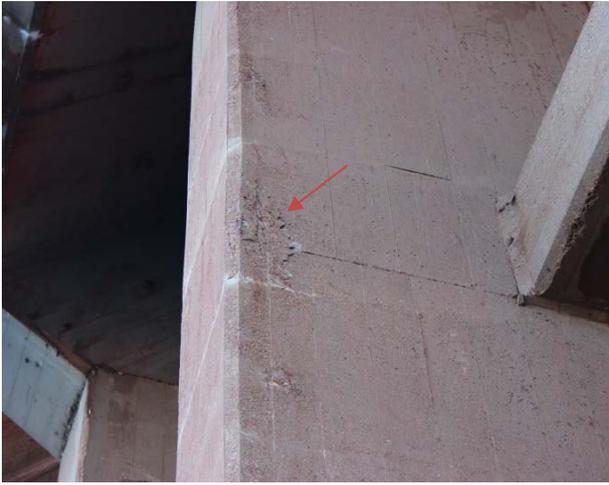
On the bents, occasional areas of spalling concrete with exposed reinforcing were observed, particularly on the corners of the columns (Photo 3-7 & 3-8). The concrete cover over the reinforcement in these areas was thin.

*Photo 3-7: Delaminations on Bent 29 on the north side of the dock.*

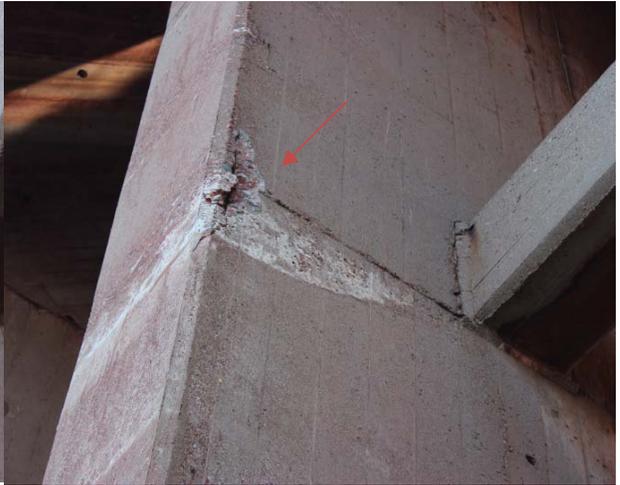
*Photo 3-8: Small spall with some visible rebar on Bent 28 on the north side of the dock.*

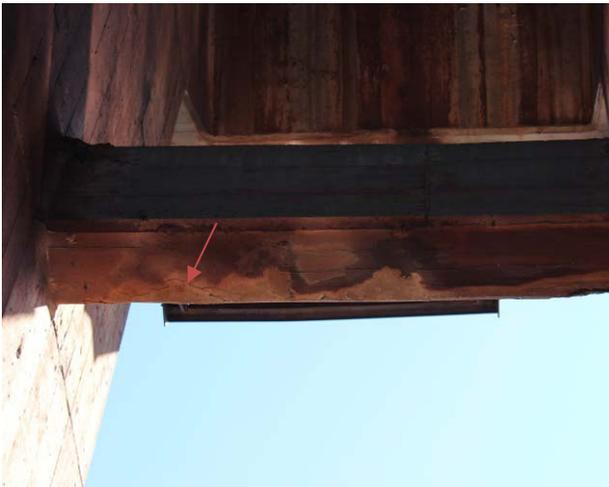
On the longitudinal beams between bents are subject to delamination (Photo 3-9). Spalling of concrete with exposed rebar in localized areas of the beam is fairly regular (Photo 3-10).

*Photo 3-9: Delamination on cross beam between Bents 25 and 26 on the south side of the dock.*

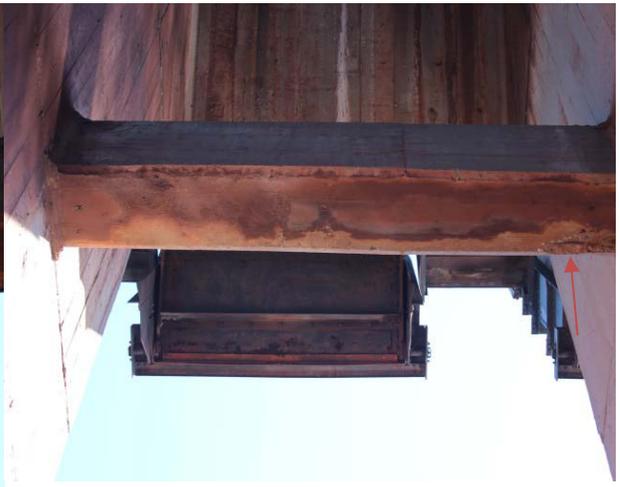
*Photo 3-10: Shallow rebar on the cross beam of Bents 26 and 27 on the south side of the dock.*

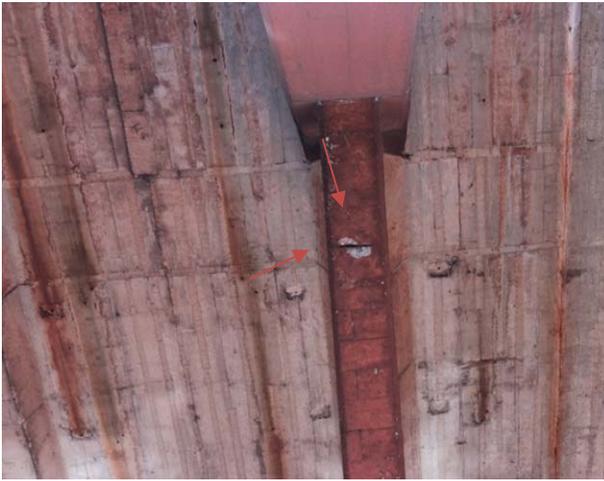
Transverse beams reveal superficial rebar (Photo 3-11). These beams also show poorly consolidated concrete in some areas (Photo 3-12). Generally these types of deficiencies occur near the north and south bents.

*Photo 3-11: Shallow rebar on the underside of the transverse beam on Bent 26.*

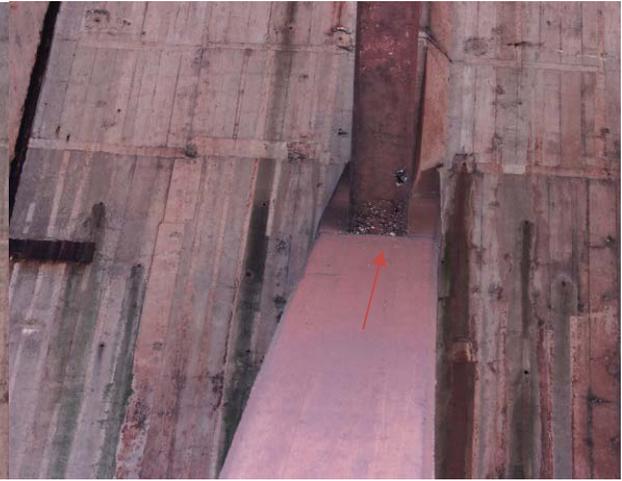
*Photo 3-12: Small sections of honeycombing in transverse beam of Bent 24.*

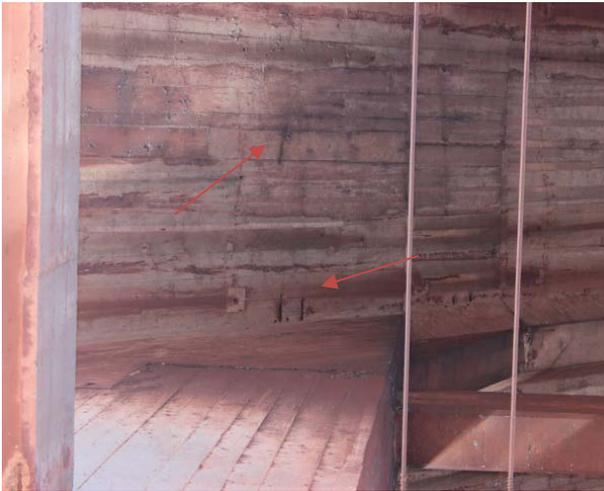
The underside of the ceilings are subject to minor areas of poorly consolidated concrete, surface cracking, cold joints, small spalls and visible rebar (3-13). Deficiencies are most common in localized areas between bents (Photo 3-14).

*Photo 3-13: Rebar visible on ceiling between Bents 24 and 25 on south side of dock.*

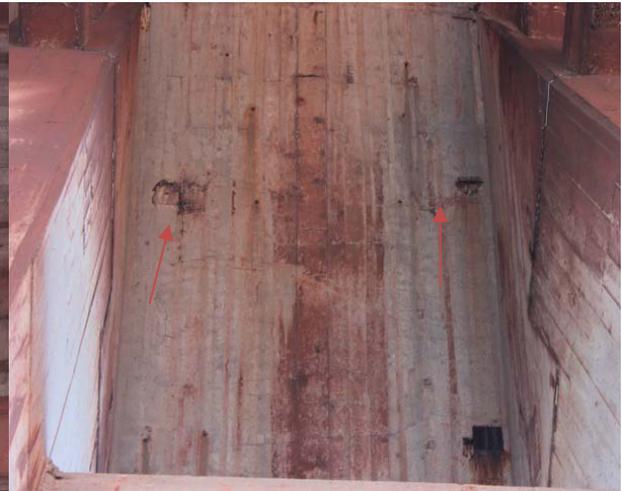
*Photo 3-14: Spalling and delaminations with some exposed rebar between Bents 34 and 35 on the north side of the dock.*

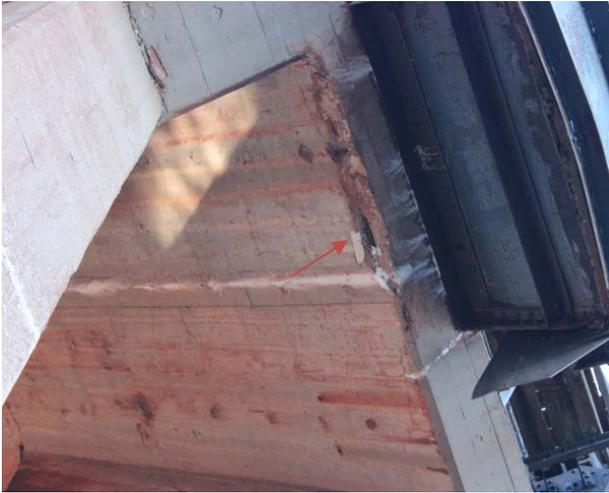
*Photo 3-15: Spalls with shallow rebar on overhang between Bents 27 and 28 on the north side of the dock.*

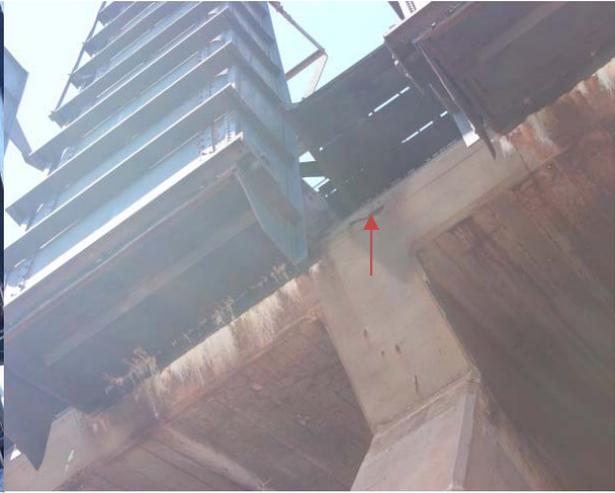
*Photo 3-16: Delaminations and exposed rebar on overhang of Bent 32 on the south side of the dock.*

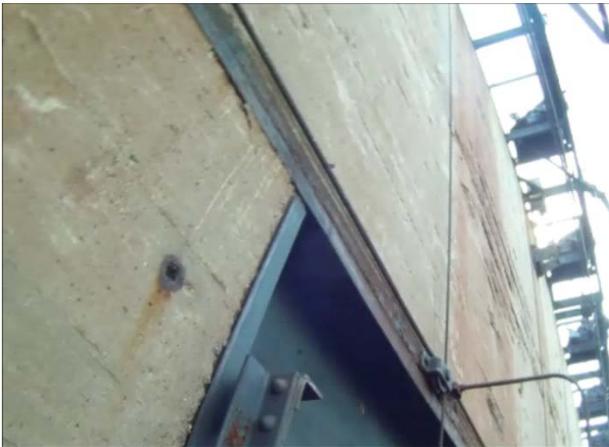
*Photo 3-17: Pocket wall where superficial thin spalls and rebar is apparent.*

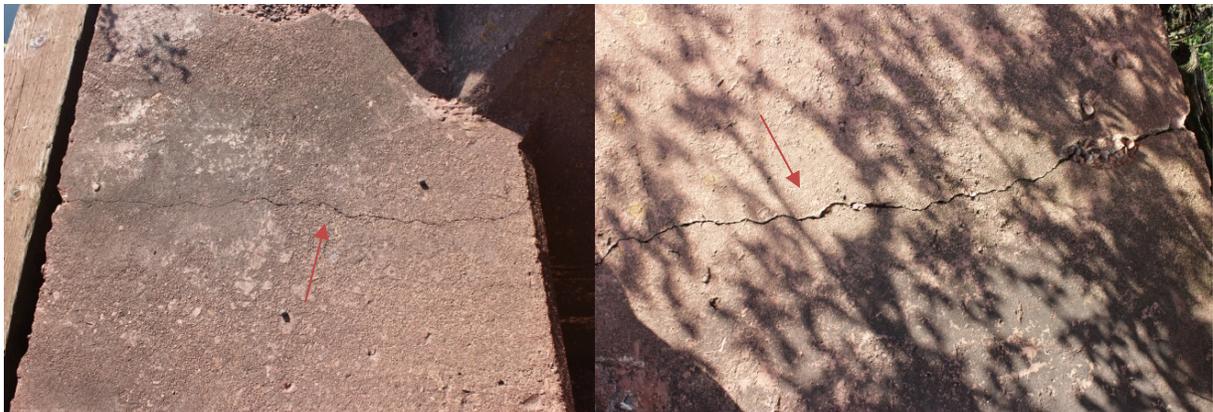
Cracks are regularly observed perpendicular to the fender (Photos 4-1 and 4-2). They are approximately mid span between bent columns. The cracks were tight with occasional localized scaling. An area of scaling with exposed rebar was observed as shown in Photo 4-3. One of the cleats was observed to be broken as shown in Photo 4-4.

*Photo 4-1: Crack in fender between Bents 36 and 37 on the north side of the dock.*

*Photo 4-2: Crack in fender on north side between Bents 39 and 40.*

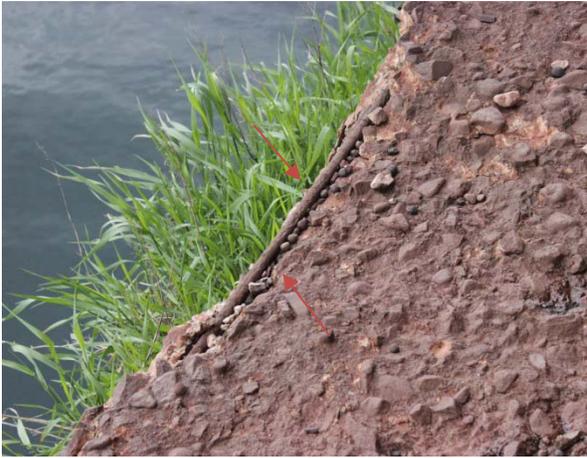
*Photo 4-3: Scaling with exposed rebar in fender between Bents 40 and 41 on the south side of the dock. Note missing/rotted timber fender with grass growing in it.*

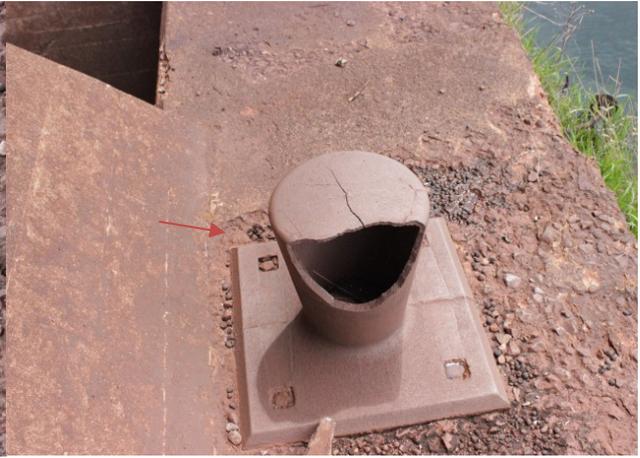
*Photo 4-4: Broken cleat on Bent 37 on the south side of the ore dock.*

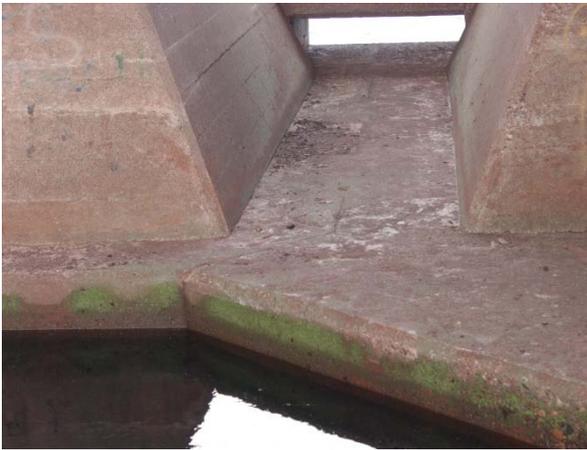
Minor cracking and some localized areas of minor scaling were observed on top of the pile cap, or floor of the ore dock. Piles of iron ore pellets are present at localized areas between bents, some of which have trees and brush growing within them. Photo 4-5 shows the general condition of the pile cap/floor.

*Photo 4-5: Construction joint in pile cap floor between Bents 40 and 41.*

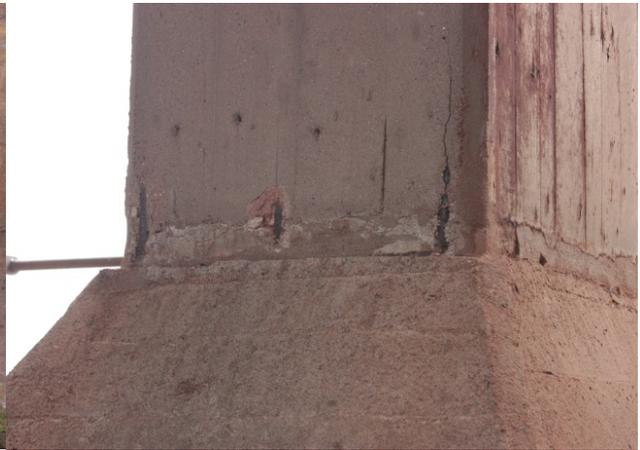
Some localized areas of minor spalling with visible rebar were observed. The quantity of spalling was noticeably less than Sections 1 through 3. Photo 4-6 depicts the typical conditions encountered.

*Photo 4-6: Spalls on base of Bent 36 with shallow rebar present on the south side of the dock.*

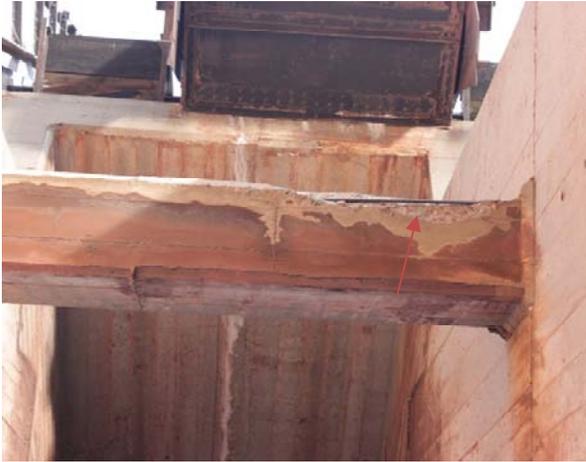
The longitudinal beams between bents are subject to delamination and spalling of concrete with exposed rebar is regularly evident (Photo 4-7).

*Photo 4-7: Spall with rebar visible on longitudinal beam between Bent 37 and 38 on the north side of the ore dock.*

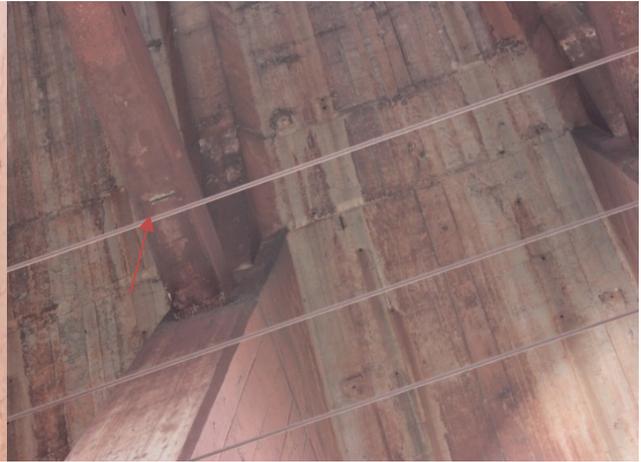
Transverse beams reveal superficial rebar (Photo 4-8). Generally these types of deficiencies occur near the north and south bents.

*Photo 4-8: Rebar visible on transverse beam between Bents 38 and 39 on the south side of the dock.*

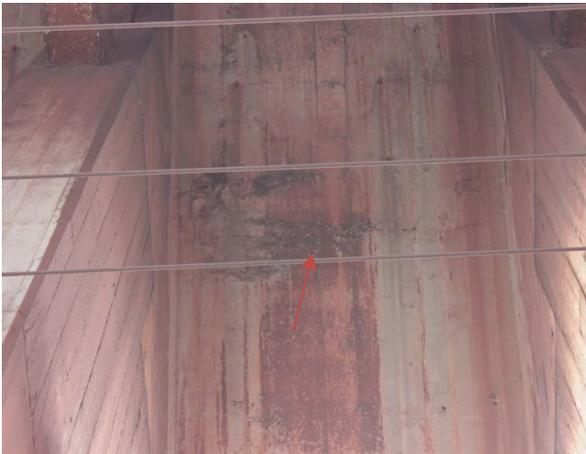
*Photo 4-9: Ceiling that contains a cold joint with horizontal cracking and honeycombing between Bents 36 and 37 on the south side of the dock.*

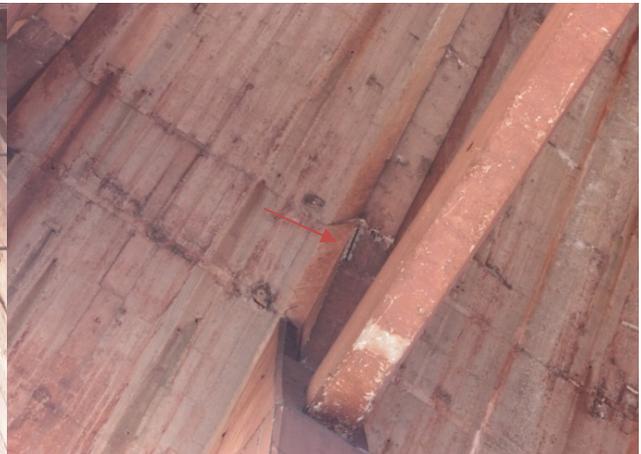
*Photo 4-10: Rebar visible in the chamfer on Bent 37 on the north side of the dock.*

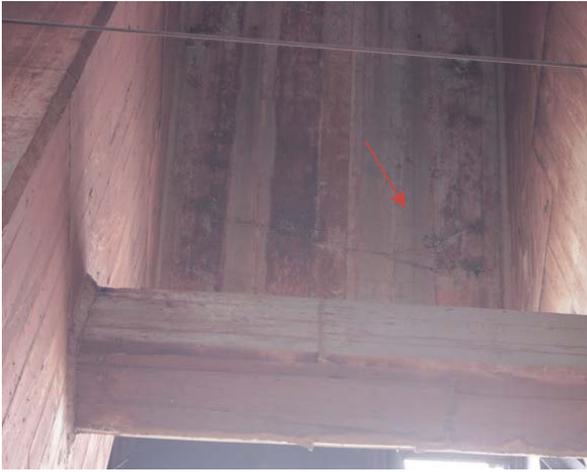
The underside of the ceilings was observed to be in good shape, and in better condition than observed in Sections 1 through 3. Localized minor areas of poorly consolidated concrete, surface cracking, cold joints, small spalls and visible rebar were observed (Photo 4-9). Exposed rebar is common in the chamfer section of this ceiling (Photo 10). A localized area of cracking was noted between Bents 39 and 40 (Photo 4-11).

*Photo 4-11: Horizontal cracking in ceiling between Bents 39 and 40 on the south side of the dock.*

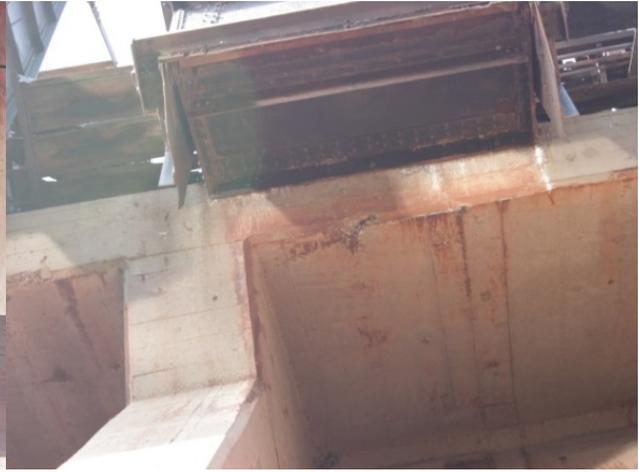
The overhangs were observed to be in better condition than observed in Sections 1 through 3. These areas were observed to have areas of honeycombing and tight cracks with some efflorescence. The cracks were typically associated within the chute steel imbeds. Photo 4-12 shows an example of these deficiencies.

*Photo 4-12: Overhang with honeycombing and cracking on Bent 41 on the north side of the dock.*

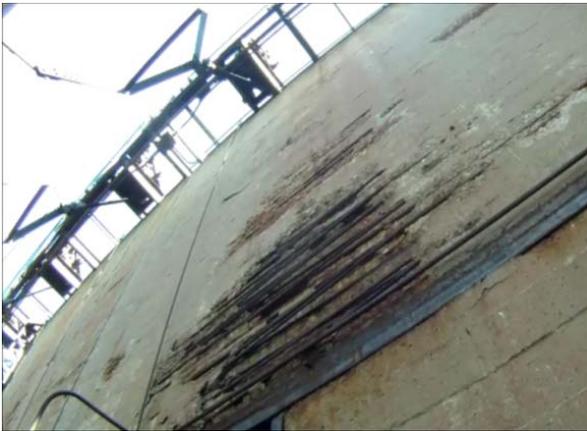
*Photo 4-13: Area of heavy spalling with large quantity of exposed rebar on pocket wall at chute 89 on the south side.*

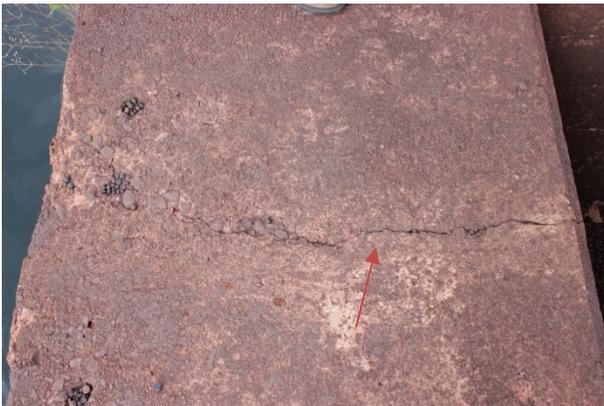
Transverse cracking is commonly found mid span between the bents in the fender. These cracks were tight and often experienced surface scaling (Photo 5-1). Scaling had occurred in other localized areas such as shown in Photo 5-2. The timber fenders were found deteriorated and rotted away with shrubbery growing from existing timber bumper.

*Photo 5-1: Crack in fender between Bents 49 and 50 on the south side of the dock.*

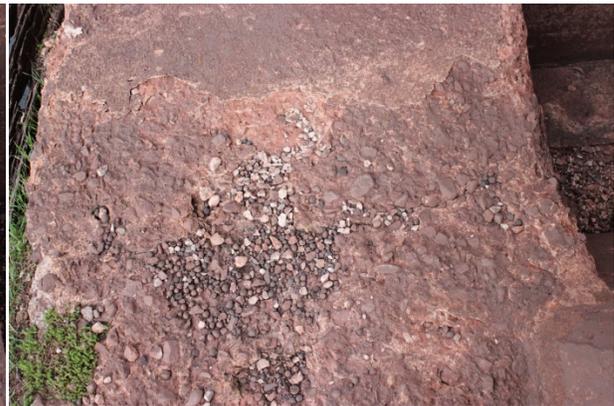
*Photo 5-2: Crack and scaling on south fender between Bents 51 and 52.*

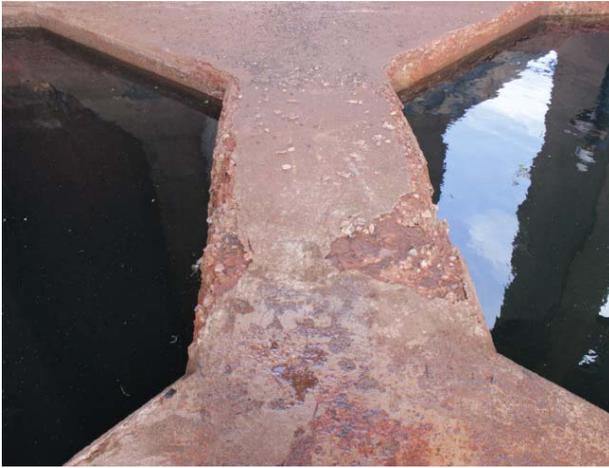
Minor cracking and some localized areas of minor scaling were observed on top of the pile cap, or floor of the ore dock (Photo 5-3). Piles of iron ore pellets are present at localized areas between bents, some of which have trees and brush growing within them.

*Photo 5-3: Spalling on pile cap floor between Bents 52 and 53.*

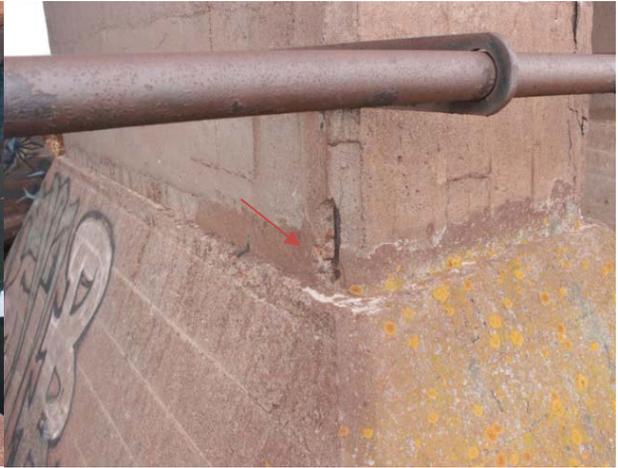
At the base of the bents, minor spalling had occurred with visible rebar in localized areas due to shallow concrete cover (Photo 5-4). Shrinkage cracking is also visible in regions of the base (Photo 5-5). Minor popouts were noticeable in this section (Photo 5-6).

*Photo 5-4: Bottom of Bent 47 showing shallow spall and exposed rebar on the north side of the dock.*

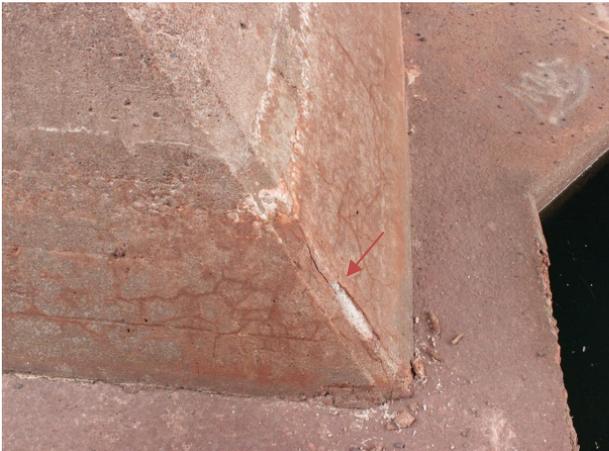
*Photo 5-5: Delamination crack noted, and pater cracking at bottom of base of Bent 49 on north side of dock.*

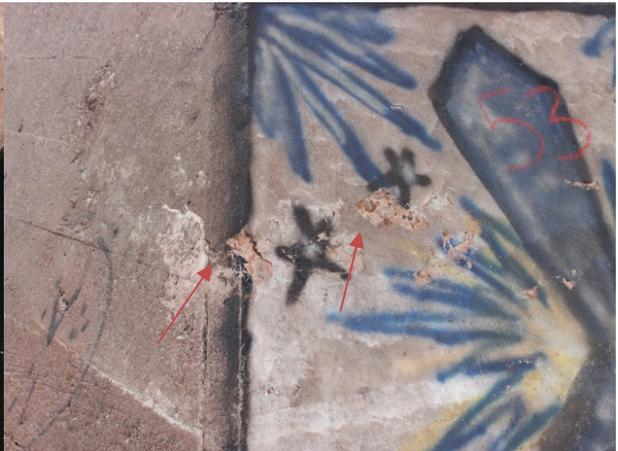
*Photo 5-6: Small popouts on face of bent base of Bent 53 on the north side of the dock.*

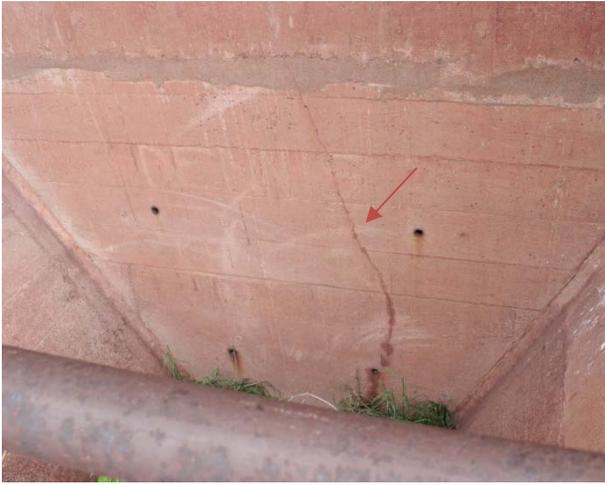
*Photo 5-7: Vertical cracking in Bent 52.*

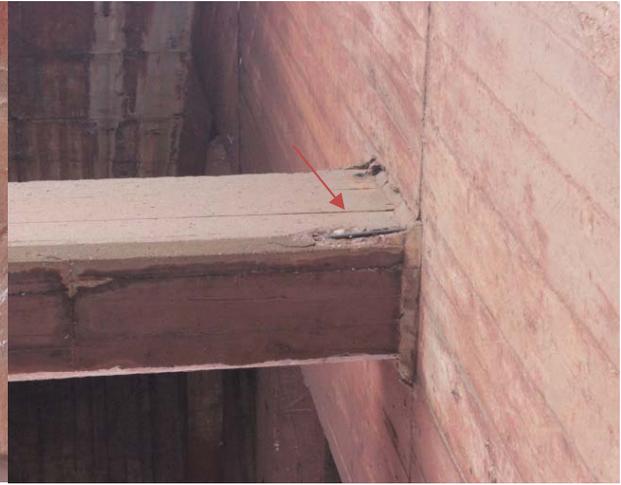
Longitudinal beams have localized areas of delamination cracking and spalling (Photo 5-8 to 5-10).

*Photo 5-8: Spalling with shallow rebar visible in corner of longitudinal beam between Bents 50 and 51 on the south side of the ore dock.*

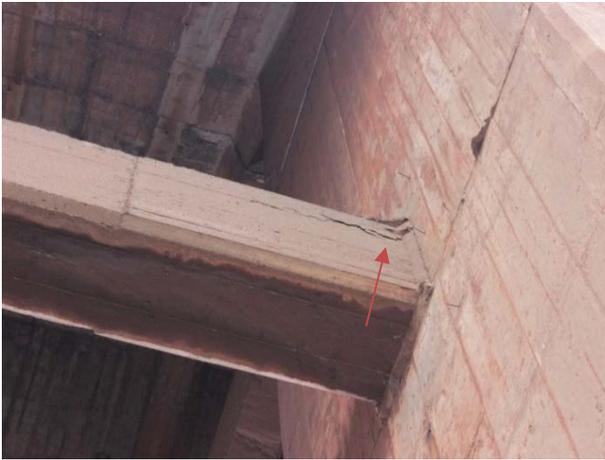
*Photo 5-9: Delamination on the south longitudinal beam between Bents 49 and 50.*
