## Lower Harbor Ore Dock Inspection Report

Marquette, Michigan

December 11, 2014

GEI Project No. 1330920

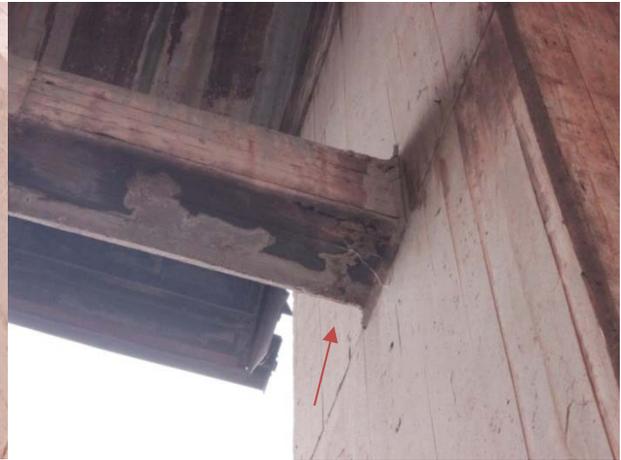
Longitudinal beams have localized areas of delamination cracking and spalling (Photo 5-8 to 5-10).

*Photo 5-10: Delamination cracking on the north longitudinal beam between bent 49 and Bent 50.*

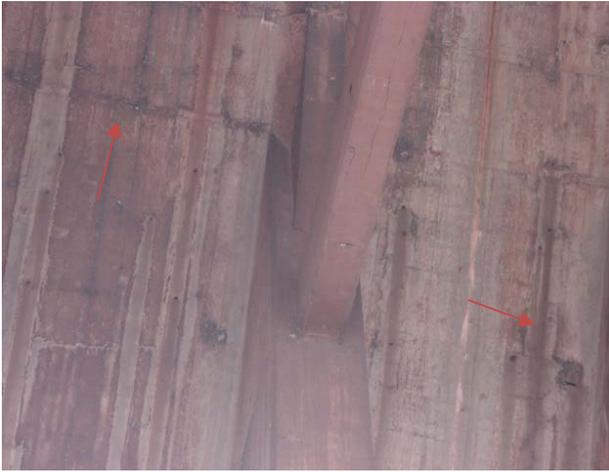
The underside of the ceilings are subject to minor sections of poorly consolidated concrete, surface cracking, cold joints, small spalls, and visible rebar as shown in Photos 5-11 through 13. Exposed rebar is most common in the chamfer section of this ceiling.

*Photo 5-11: Horizontal cracking on north ceiling between Bents 54 and 55.*

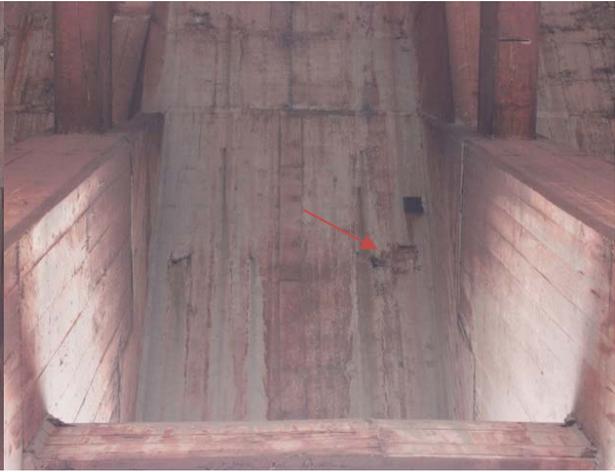
*Photo 5-12: Popouts with horizontal cracking on north side of the ceiling between Bents 55 and 56.*

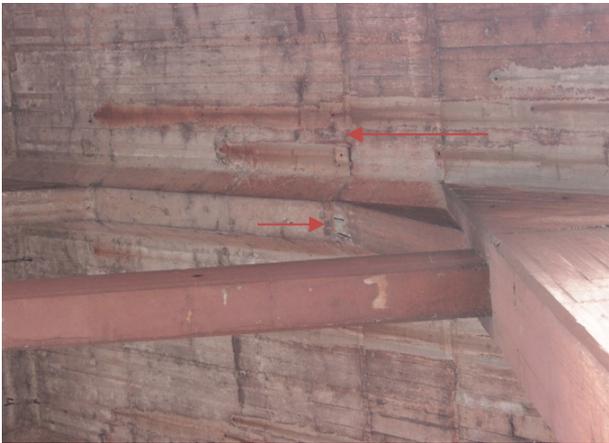
*Photo 5-13: Rebar visible in the chamfer section of the south side of the ceiling on Bent 47.*

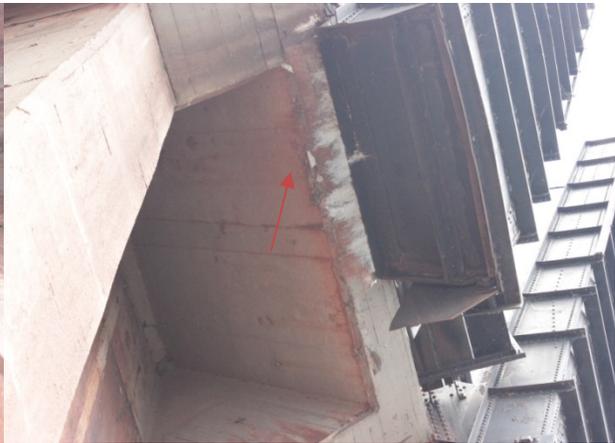
The overhangs were observed to be in better condition than observed in Sections 1 through 3. These areas were observed to have areas of honeycombing and tight cracks with some efflorescence. The cracks were typically associated within the chute steel imbeds. Photo 5-14 shows an example of these deficiencies.

*Photo 5-14: Cracking and minor spalls on north chute base between Bents 52 and 53.*

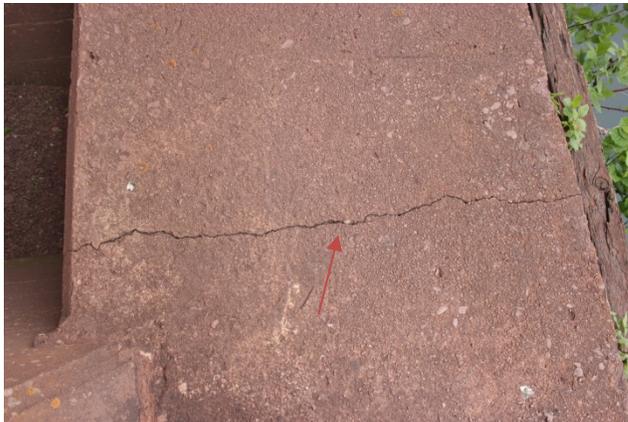
Transverse cracking is commonly found mid span between the bents in the fender. These cracks were tight and often experienced surface scaling (Photos 6-1 and 6-2). The timber fenders were found deteriorated and rotted away with shrubbery growing from existing timber bumper. Photo 6-3 shows how the fender spans between the bent bases.

*Photo 6-1: Transverse crack in the north fender between Bents 58 and 59.*

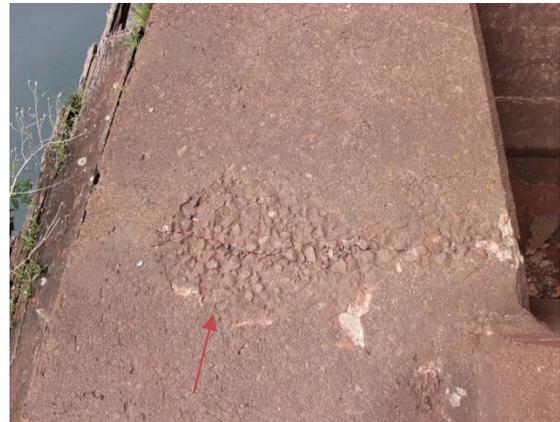
*Photo 6-2: Transverse crack and scaling on the north fender between Bents 59 and 60.*

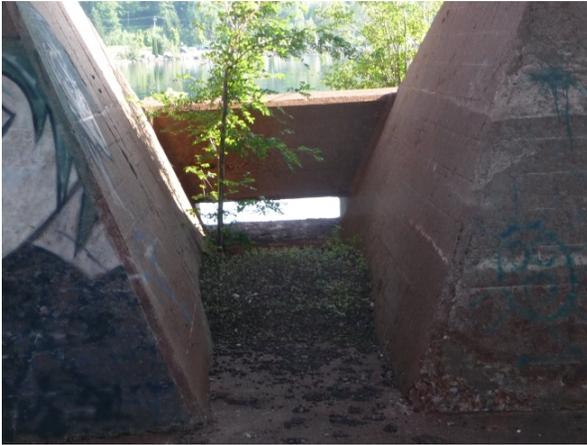
*Photo 6-3: View of tree growing in iron ore pile on north side of dock. Note elevated fender spanning between bent bases.*

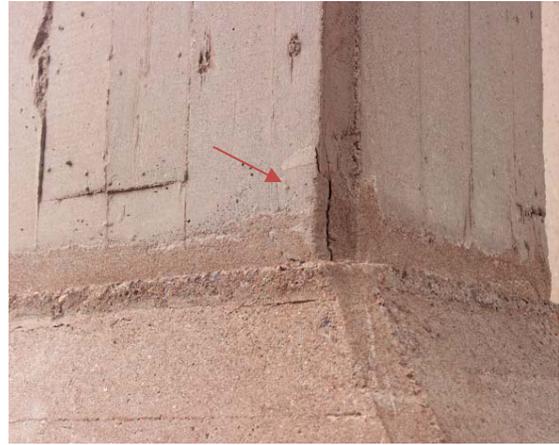
*Photo 6-4: Small delamination on south side at the bottom of Bent 57.*

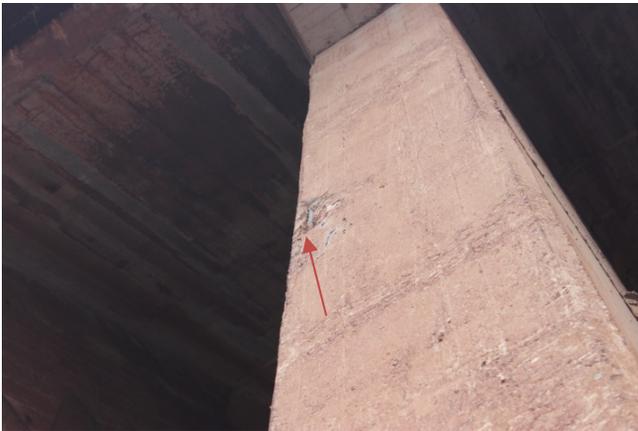
*Photo 6-5: Spall with exposed rebar on the south side of ore dock between Bents 59 and 60.*

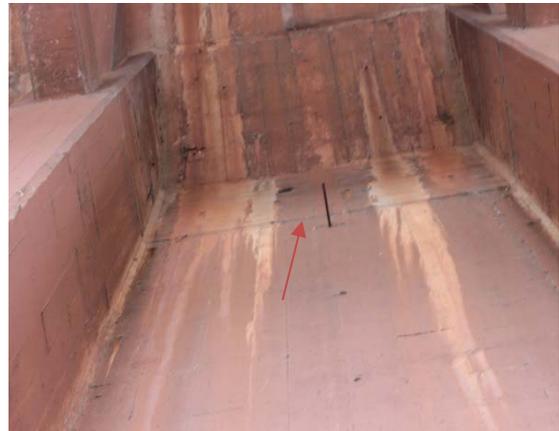
*Photo 6-6: View of good condition of shear wall between Bents 62 and 63 on the north side of the ore dock. Note protruding steel bar (possible form tie).*

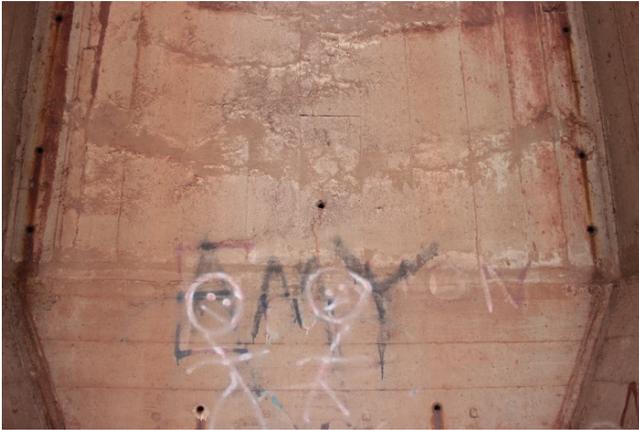
*Photo 6-7: View of good condition of shear wall between Bents 62 and 63 on the south side of the ore dock.*

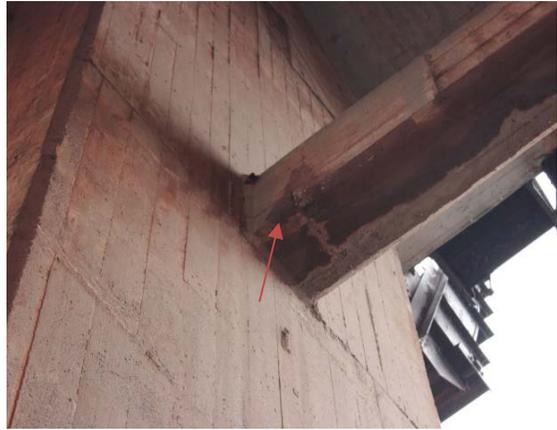
*Photo 6-8: Spall with exposed rebar and cracking in corner of longitudinal beam between Bents 59 and 60 on the north side of dock.*

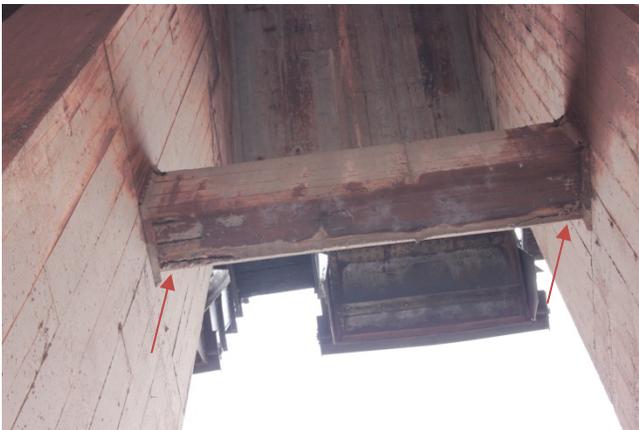
*Photo 6-9: Exposed rebar and delamination visible on underside of the north longitudinal beam between Bents 63 and 64.*

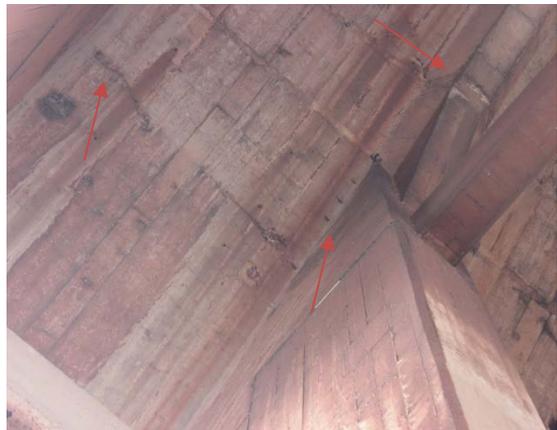
*Photo 6-10: Small spalls on south ceiling along with minor honeycombing between Bents 56 and 57.*

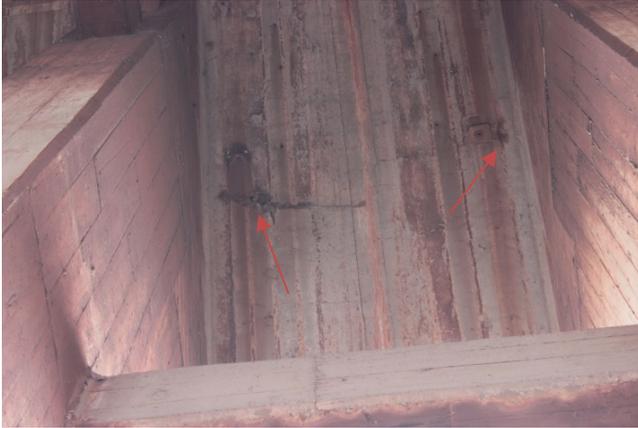
*Photo 6-11: Minor honeycombing and exposed rebar on north side ceiling between Bents 63 and 64.*

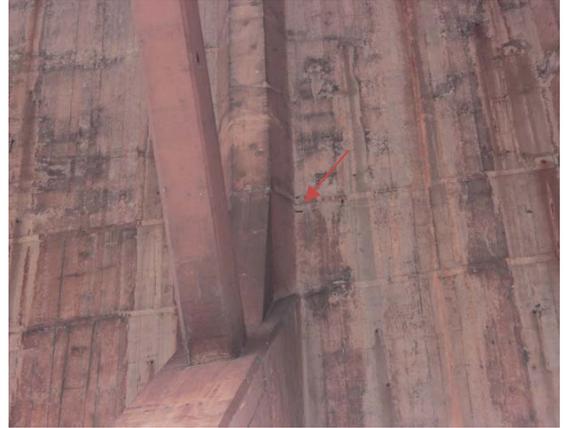
*Photo 6-12: Minor honeycombing and exposed rebar in north side of ceiling between Bents 60 and 61.*

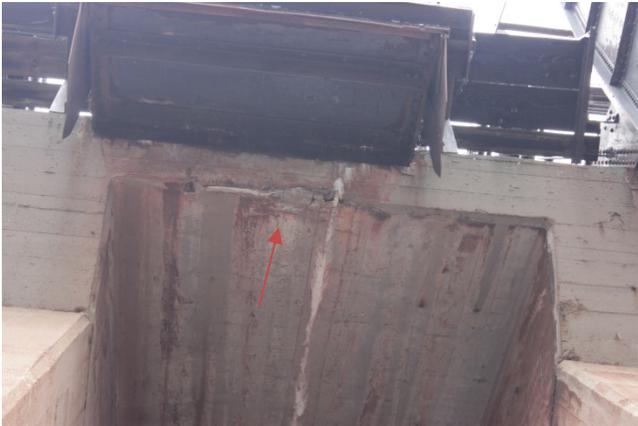
*Photo 6-13: Delamination cracking and spalled concrete at overhang between Bents 59 and 60 on north side of ore dock.*

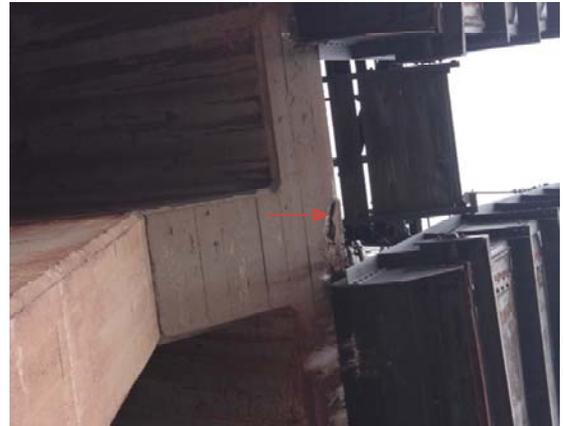
*Photo 6-14: Small delamination of concrete on the chute base between Bents 59 and 60 on the south side of the dock.*

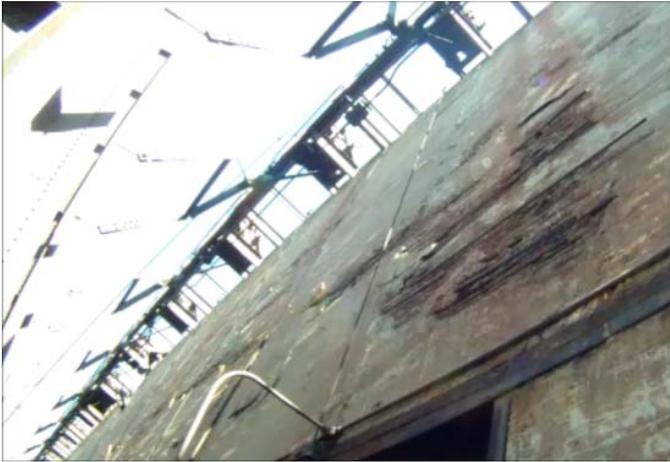
*Photo 6-15: View of pocket wall above pocket 111 on the south side of the dock showing large area of spalling with exposed rebar.*

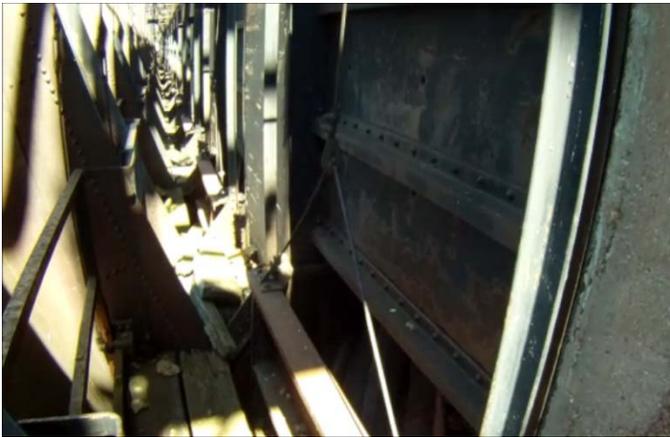
The walkway above the chutes is supported on the imbedded elements of the base of the chutes, which is consistent with the record drawings. The walkway railings and support steel members were observed to be in good condition with little to no evidence of deterioration. Occasional top railings were bent, likely due to impacts from falling objects. Stairs are not located in this section. The timber decking used for the walkways was in poor to good condition. Some timbers were in good condition with sound attachments to the steel members, while others were completely deteriorated or missing. Photo 6-17 shows the condition of the walkway within this Section.

*Photo 6-17: View looking down walkway showing the pocket gates, and the bottom of the chutes.*

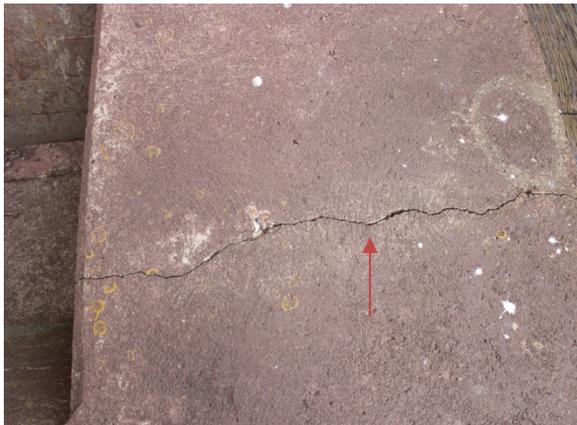
Transverse cracking is commonly found mid span between the bents in the fender. These cracks were tight and often experienced surface scaling (Photos 7-1 through 7-3). The timber fenders were found deteriorated and rotted away with shrubbery growing from existing timber bumper (Photo 7-4).

*Photo 7-1: Shallow cracking on north side of fender between Bents 72 and 73.*

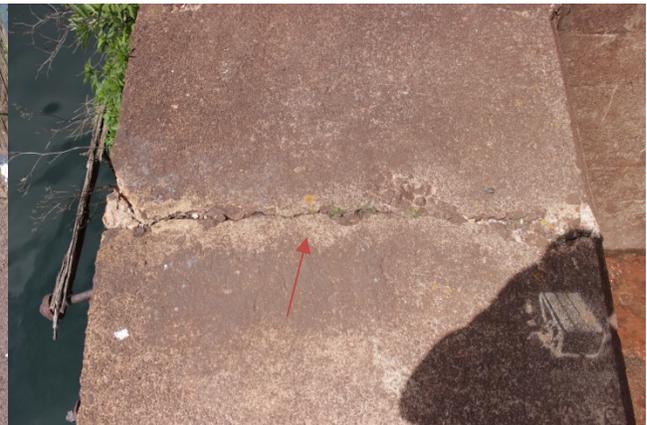
*Photo 7-2: Cracking on south side of fender between Bents 72 and 73.*

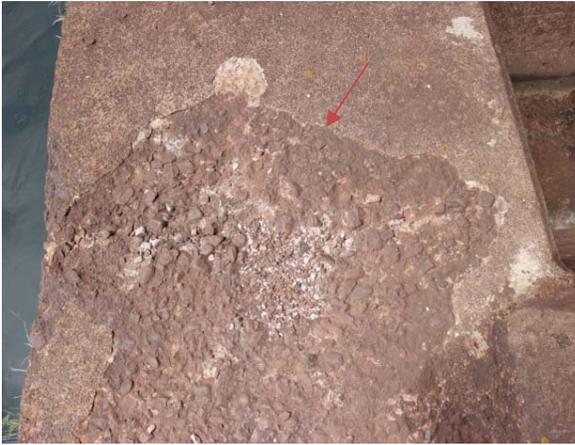
*Photo 7-3: Scaling on south side fender between Bents 69 and 70.*

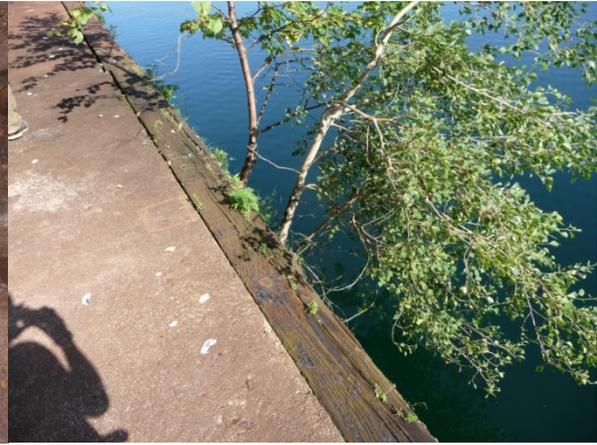
*Photo 7-4: Trees growing in rotten timber fender.*

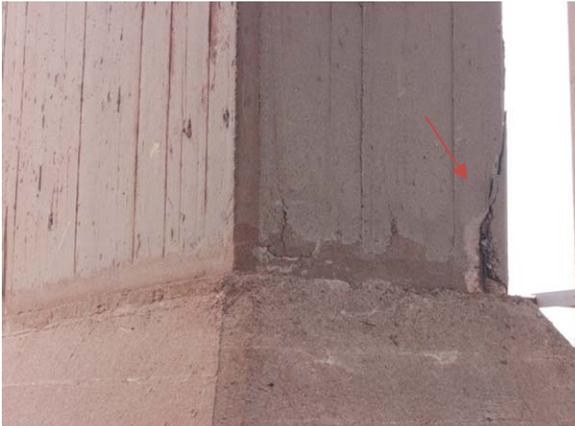
The bents have no major deficiencies, other than minor localized areas of spalling (Photo 7-5). On the shear walls between Bents 62 and 63, no indication of structural distress was observed (Photos 7-6).

*Photo 7-5: Spall on south base of Bent 68 exposing rebar.*

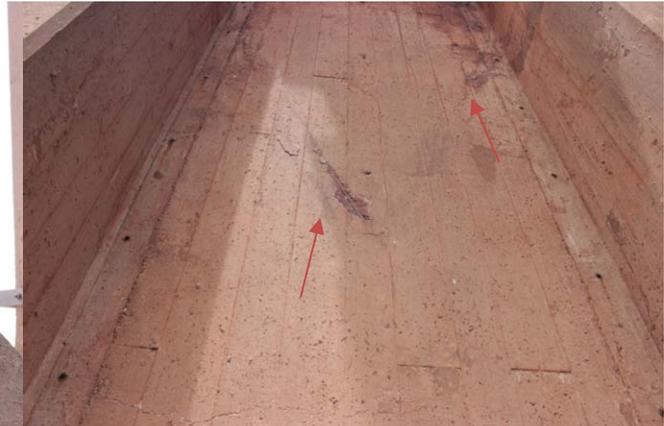
*Photo 7-6: Delamination cracking and spalling on the south shear wall between Bents 75 and 76.*

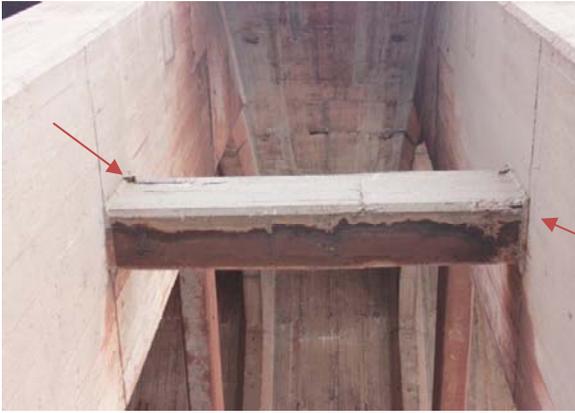
The longitudinal beams have localized areas of delamination cracking and spalling (Photos 7-7 and 7-8).

*Photo 7-7: Cracking and delaminations in corners of south longitudinal beam between Bents 72 and 73.*

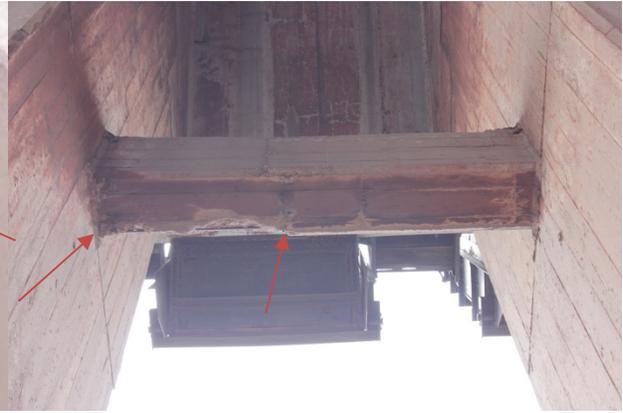
*Photo 7-8: Spalls with visible rebar in sections of south longitudinal beam between Bents 72 and 73.*

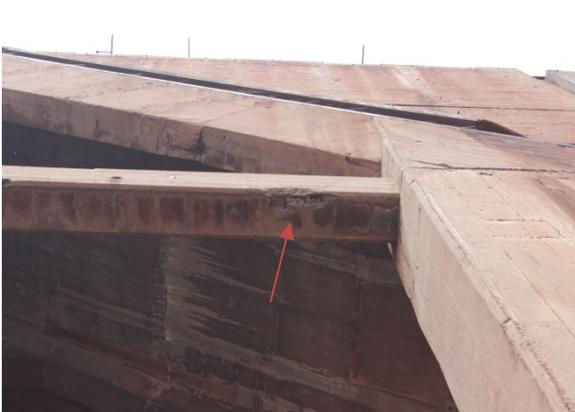
These beams were observed to be in good condition, with only infrequent spalling (Photos 7-9 and 7-10).

*Photo 7-9: Rebar apparent on underside of transverse beam on Bent 76 on the north side of the dock.*

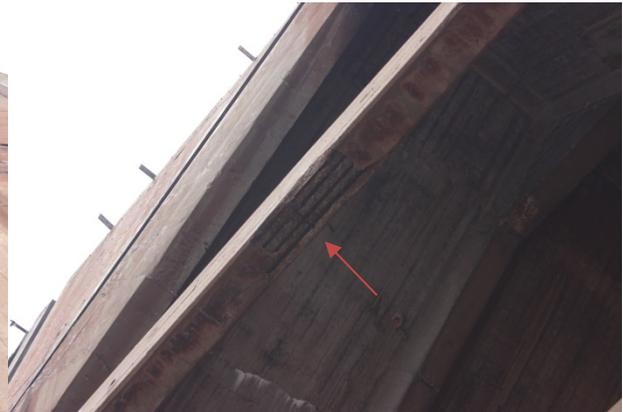
*Photo 7-10: Shallow rebar visible on bottom of transverse beam on Bent 76.*

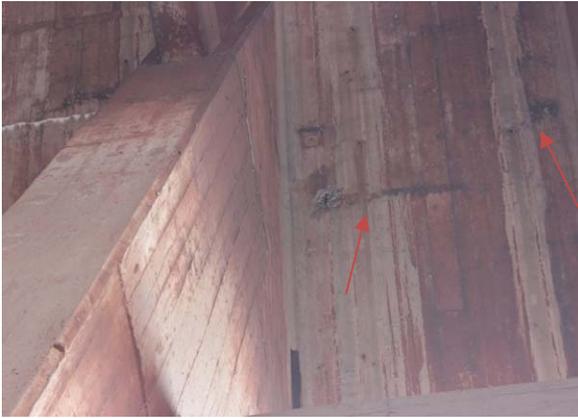
The underside of ceilings are subject to localized areas of poorly consolidated concrete, surface cracking, cold joints, small spalls, and visible rebar (Photos 7-11 and 7-12).

*Photo 7-11: Spalls along with horizontal honeycombing along south side ceiling between Bents 69 and 70.*

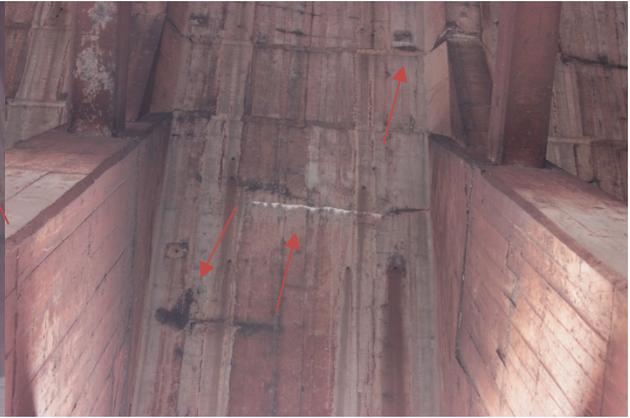
*Photo 7-12: Cracking with efflorescence and exposed rebar in ceiling between Bents 68 and 69 on south side of dock.*

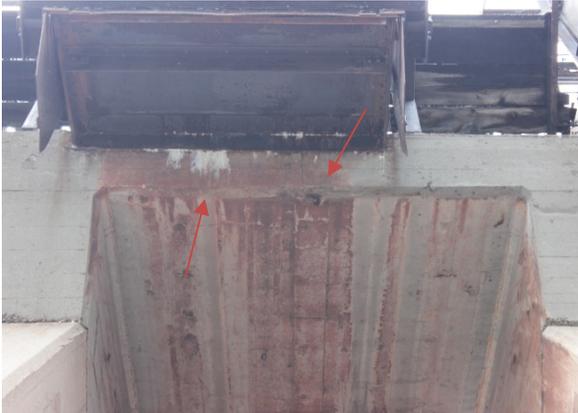
The overhangs were observed to have areas of poorly consolidated concrete, spalling, and tight cracks with efflorescence. The cracks were typically associated within the chute steel imbeds. Photo 7-13 shows an example of these deficiencies.

*Photo 7-13: Chute base with minor cracking with exposed rebar between Bent 70 and 71 on south side of dock.*

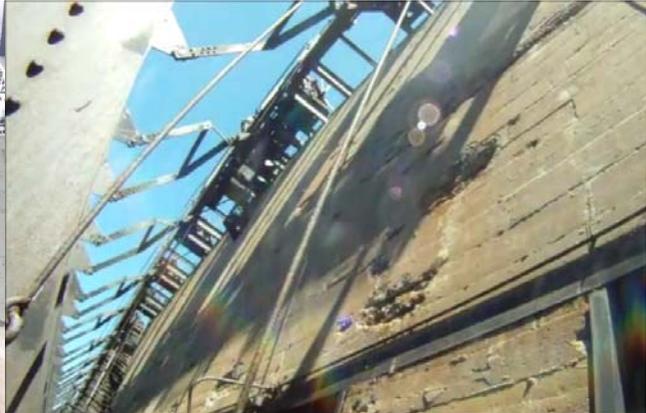
The pocket walls were inspected from the elevated walkway along the base of the chutes, and from the top of the dock at two stair locations in this Section. The interior pocket walls and floors of the pockets were observed to be in good condition with no cracking, spalling, or exposed reinforcement. The exterior walls on the north and south sides of the dock did exhibit various degrees of spalled concrete with exposed rebar (Photos 7-14). Generally, the south pocket wall exhibited greater spalling than the north side.

*Photo 7-14: View of pocket wall at chute 149 on the south side of the dock showing large area of spalling with exposed rebar.*

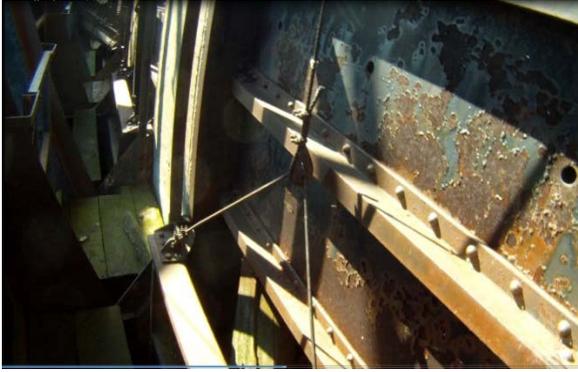
All of the chutes were inspected from the walkway at the base of the chutes. The chutes were observed to be identically constructed and in good condition, with minimal deterioration observed. At the locations where the inspectors ascended and descended the access ropes, close-up inspections of the steel pins at the base of the chutes were inspected. These inspections were limited to Chute 149 and Chute 150. The steel construction in the areas of the pins was observed to be consistent with the record drawings. Minor deterioration was noted, with no excessive wear on the pin or associated steel plate. Photo 7-15 shows the condition of the chutes and gates.

*Photo 7-15: View of gate 142.*

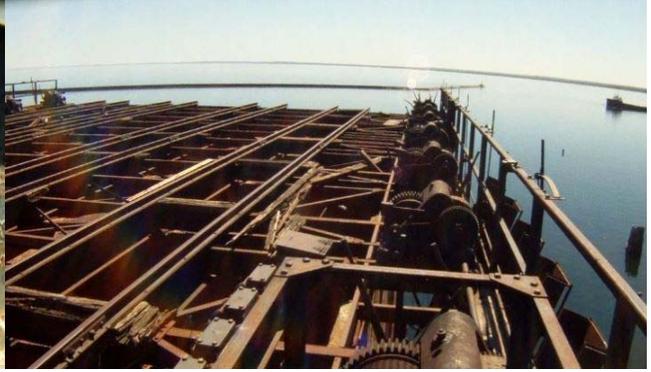
The top of the dock was observed at the locations of the stairs on both the north and south sides of this Section. The framing was observed to be in good condition with little to no deterioration noted. The geometry of the deck framing was not measured, but was observed to be consistent with the record drawings. Photo 7-16 shows the east end of the ore dock.

*Photo 7-16: Top of deck at east end of the dock looking east.*

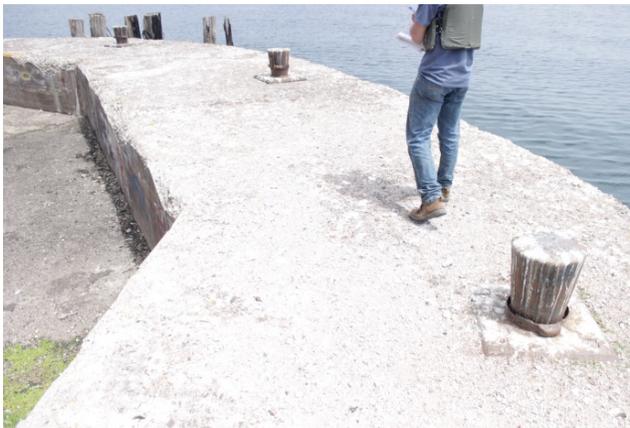
Photo 8-1 depicts the typical condition of the scaling on the fender. The timber bumper on either side of this section has substantially deteriorated. No exposed reinforcement was identified. Photo 8-2 shows the condition of the timber bumper. These timbers are unstable and are easily rocked.

*Photo 8-1: Section at the end of the ore dock in which major scaling has taken place.*

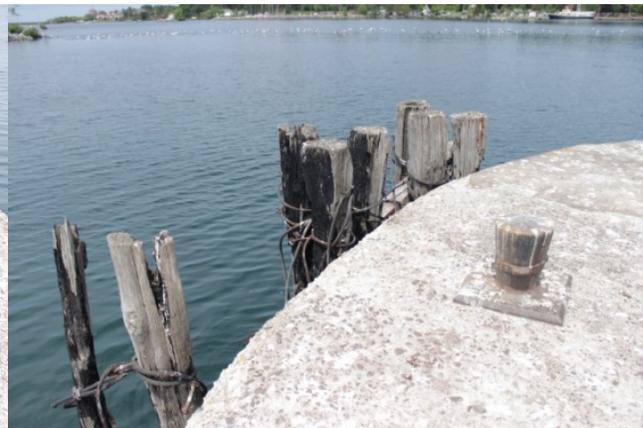
*Photo 8-2: Piles at the end of the ore dock that have become rotten and loose.*

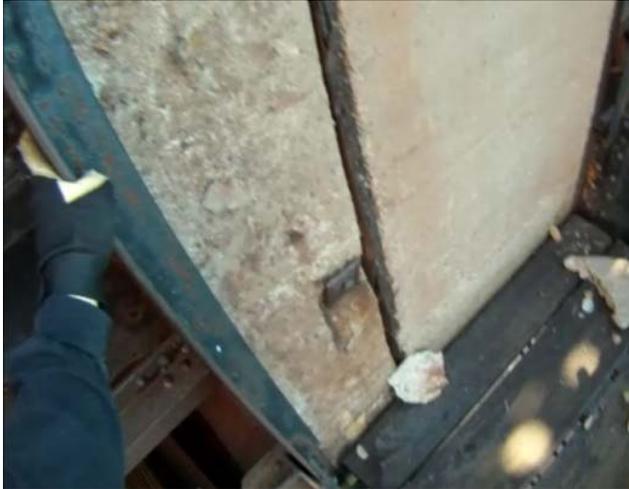
The expansion joint was observed at various locations. On the pile cap/floor, the joint was observed to be open with no expansion joint material, and was measured to be 1.25 inches wide. The joint was observed at the overhangs between the chutes. The steel imbeds were observed to be in contact and in good condition. The joint was observed from the walkway on the north and south sides to contain expansion joint material. The joint width was observed to be consistent, with no measureable offset or differential movement. Photos 9-1 through 9-3 show the condition of the expansion joint.

*Photo 9-1: View of the expansion joint between Sections 1 and 2 from the walkway on the south side of the structure. Note presence of expansion joint material.*

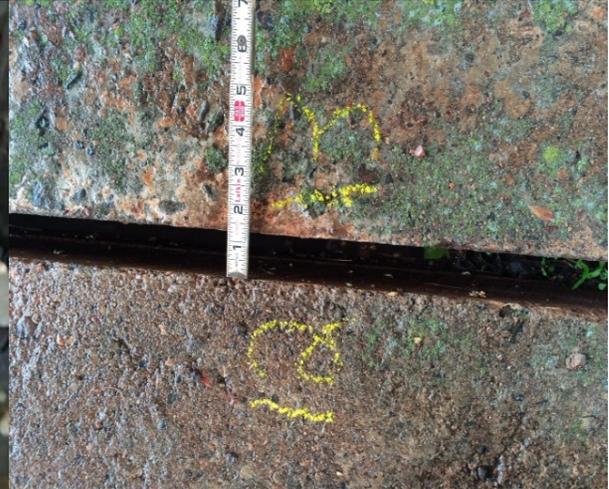
*Photo 9-2: Expansion joint on pile cap floor between Sections 1 and 2. Note no expansion joint material contained within joint.*

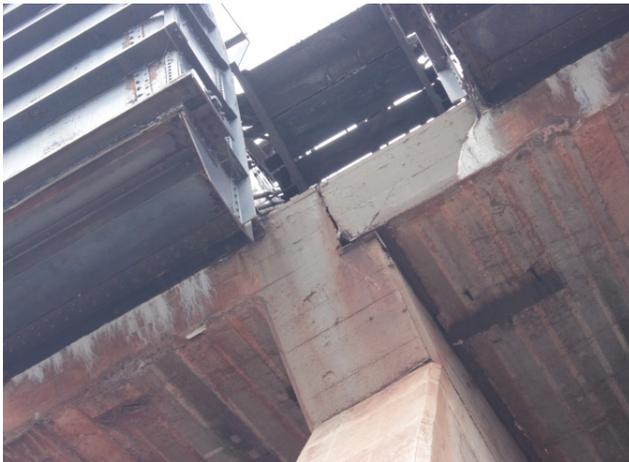
*Photo 9-3: View of expansion joint between Section 1 and 2 on south side at Bent 12.*

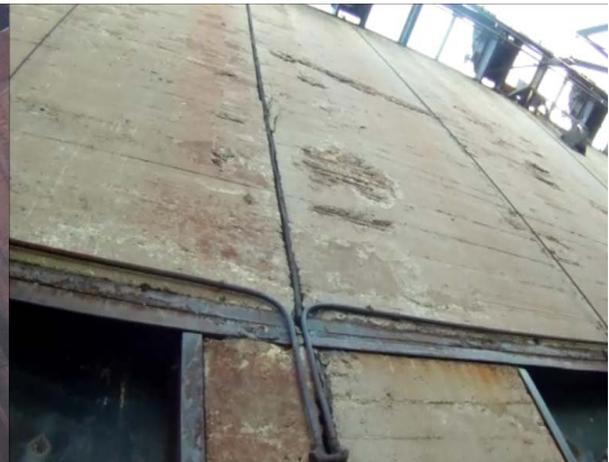
The expansion joint was observed at various locations. On the pile cap/floor, the joint was observed to be filled with debris, and was measured to be approximately 1.0 inch wide. The joint was observed at the overhangs between the chutes. The steel imbeds were observed to be in contact and in good condition. The joint was observed from the walkway on the north and south sides to contain expansion joint material. In each case, the joint width was observed to be consistent, with no measureable offset or differential movement. Photos 9-4 and 9-5 show the condition of the expansion joint.

*Photo 9-4: View of the expansion joint between Sections 2 and 3 from the walkway on the south side of the structure. Note good condition of expansion joint material.*

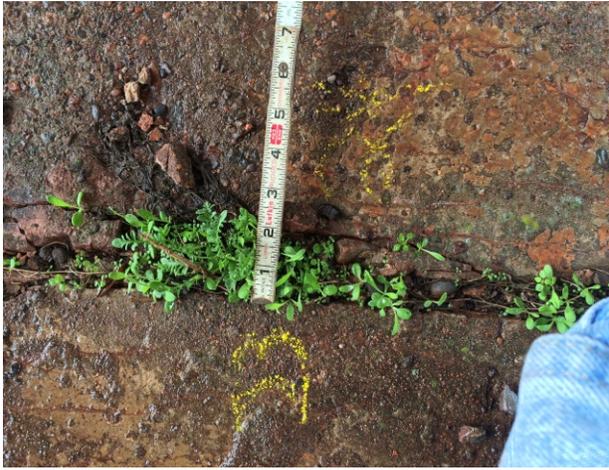
*Photo 9-5: Expansion joint on pile cap floor between Sections 2 and 3. Note debris and vegetal growth within joint.*

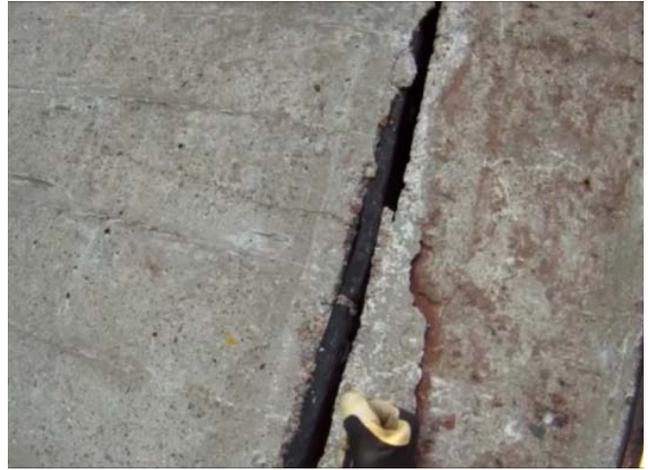
The expansion joint was observed at various locations. On the pile cap/floor, the joint was observed to be open with no expansion joint material, and was measured to be 1.25 inches wide. The joint was observed at the overhangs between the chutes. The steel imbeds were observed to be in contact and in good condition. The joint was observed from the walkway on the north and south sides to contain expansion joint material. However, the joint was wider than the width of the joint material. In each case, the joint width was observed to be consistent, with no measureable offset or differential movement. Photos 9-6 and 9-7 show the condition of the expansion joint.

*Photo 9-6: View of the expansion joint between Sections 3 and 4 from the walkway on the south side of the structure. Note the joint is open more than the width of the expansion joint material, and presence of delamination in adjacent concrete.*

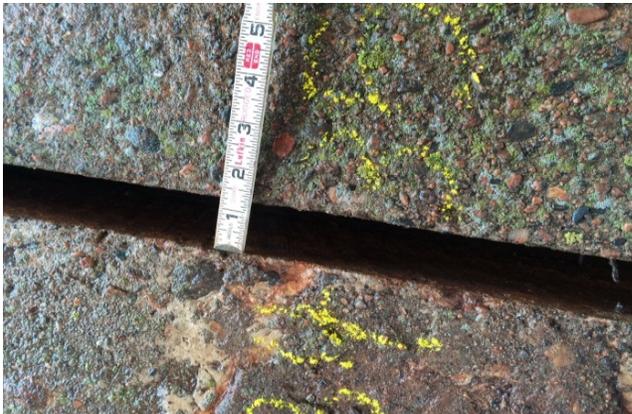
*Photo 9-7: Expansion joint on pile cap floor between Sections 3 and 4. Note no expansion joint material contained within joint.*

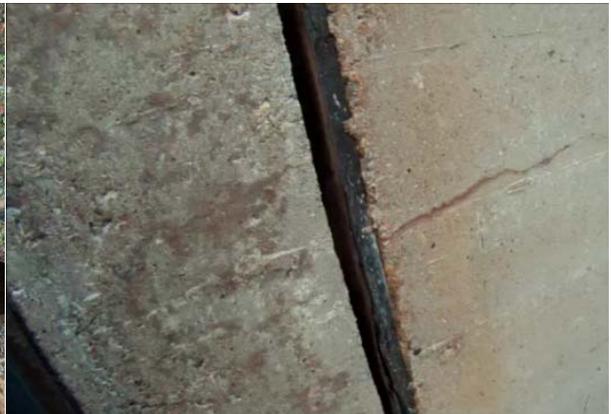
The expansion joint was observed at various locations. On the pile cap/floor, the joint was observed to be open with no expansion joint material, exhibit surface scaling, and was measured to be approximately 1.0 inch wide. The joint was observed at the overhangs between the chutes. The steel imbeds were observed to be in contact and in good condition. The joint was observed from the walkway on the north and south sides to contain expansion joint material. However, the joint was wider than the width of the joint material. In each case, the joint width was observed to be consistent, with no measureable offset or differential movement. Photos 9-8 and 9-9 show the condition of the expansion joint.

*Photo 9-8: View of the expansion joint between Sections 4 and 5 from the walkway on the south side of the structure. Note the joint is open more than the width of the expansion joint material.*

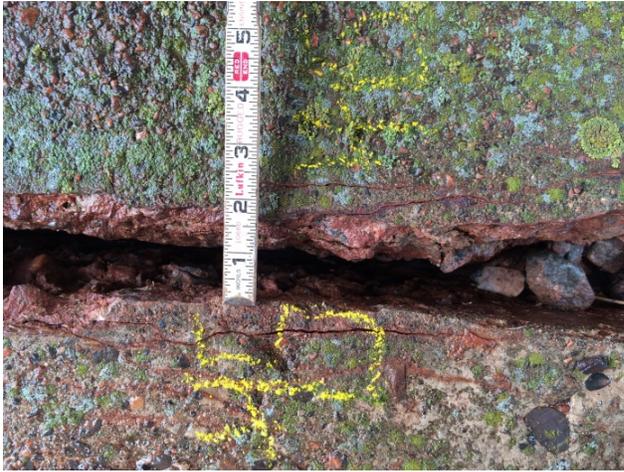
*Photo 9-9: Expansion joint on pile cap floor between Sections 4 and 5. Note no expansion joint material contained within joint, and concrete scaling and cracking.*

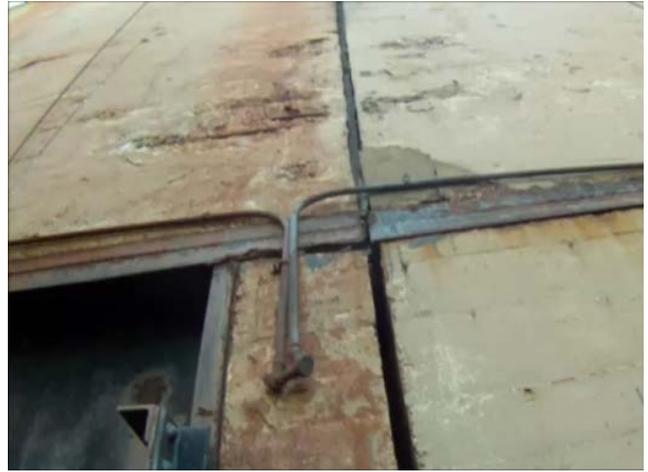
The expansion joint was observed at various locations. On the pile cap/floor, the joint was observed to be open with no expansion joint material, and was measured to be 1.25 inches wide. The joint was observed at the overhangs between the chutes. The steel imbeds were observed to be in contact and in good condition. The joint was observed from the walkway on the north and south sides. Some areas contained expansion joint material, while other areas the material had fallen out of the joint. In each case, the joint width was observed to be consistent, with no measureable offset or differential movement. Photos 9-10 through 9-12 show the condition of the expansion joint.

*Photo 9-10: View of the expansion joint between Sections 5 and 6 from the walkway on the south side of the structure. Note the joint is open slightly more than the width of the expansion joint material (top), and the joint material has fallen out (bottom).*

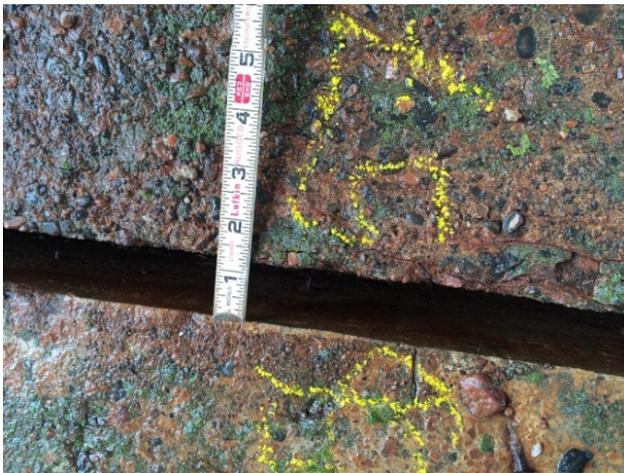
*Photo 9-11: Expansion joint on pile cap floor between sections 5 and 6. Note no expansion joint material contained within joint.*

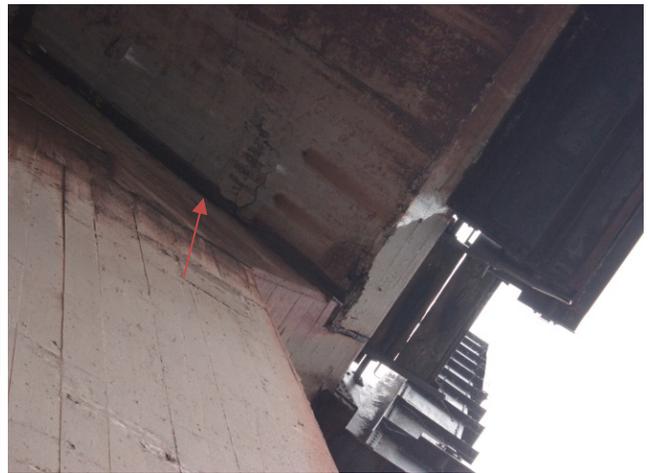
*Photo 9-12: View of expansion joint between section 5 and 6 on north side with delamination visible.*

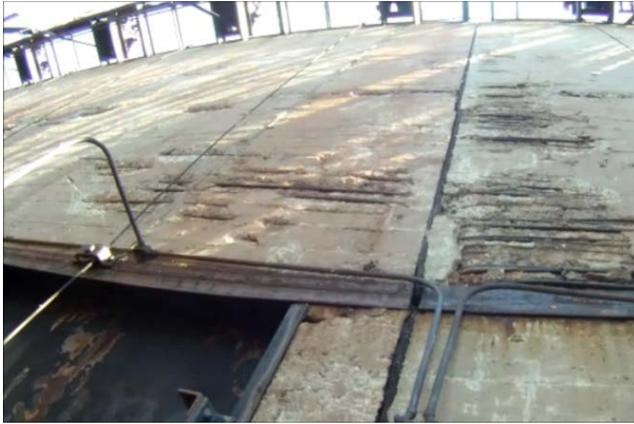
The expansion joint was observed at various locations. On the pile cap/floor, the joint was observed to be open with no expansion joint material, and was measured to be 1.0 inches wide. The joint was observed at the overhangs between the chutes and from the top of the dock. The steel imbeds were observed to be in contact and in good condition. The joint was observed from the walkway on the north and south sides to contain expansion joint material. In each case, the joint width was observed to be consistent, with no measureable offset or differential movement. Photos 9-13 and 9-14 show the condition of the expansion joint.

*Photo 9-13: Expansion joint on pile cap floor between Sections 6 and 7. Note expansion joint material contained within joint.*

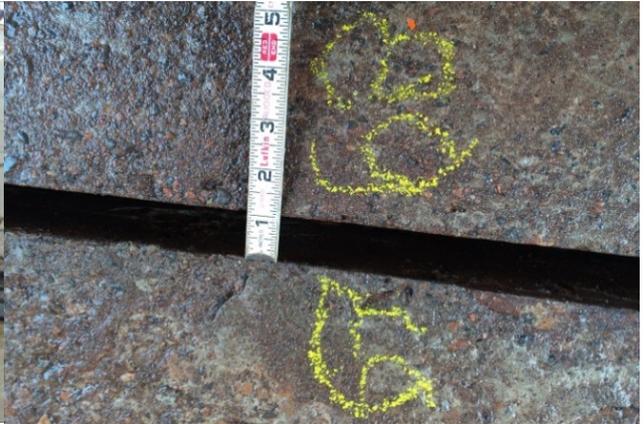
*Photo 9-14: Expansion joint on pile cap floor between Sections 6 and 7. Note no expansion joint material contained within joint.*

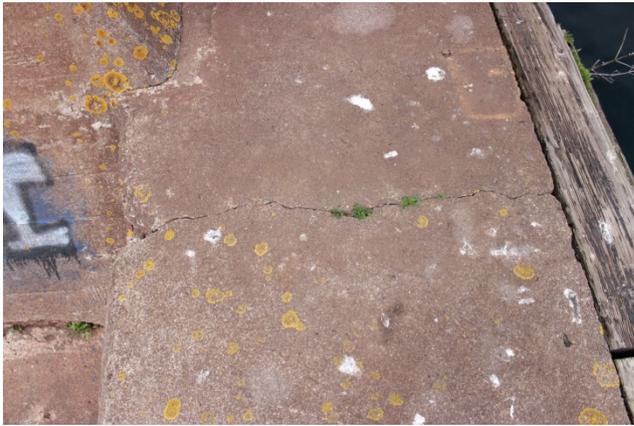
No formed expansion joint was constructed at the contact between these two sections. Although no formal expansion joint was constructed, differential movements between the sections have created a crack that acts as an expansion joint. As such, the joint does not contain joint filler material and is irregular with some concrete deterioration. Photos 9-15 and 9-16 show the condition of this joint on top of the north and south fenders.

*Photo 9-15: Crack in north fender that is serving as the expansion joint between Sections 7 and 8.*

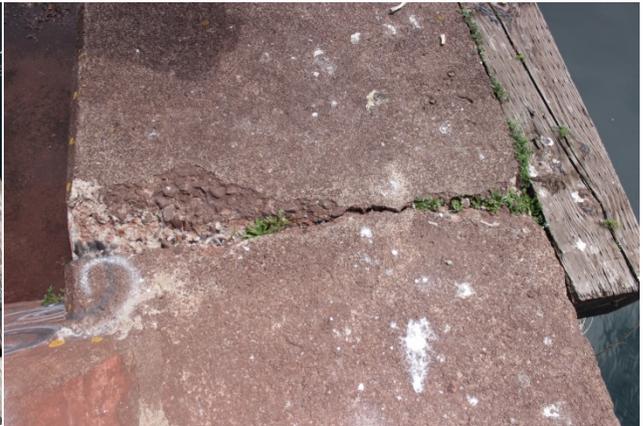
*Photo 9-16: Crack in south fender that is serving as the expansion joint between Sections 7 and 8.*

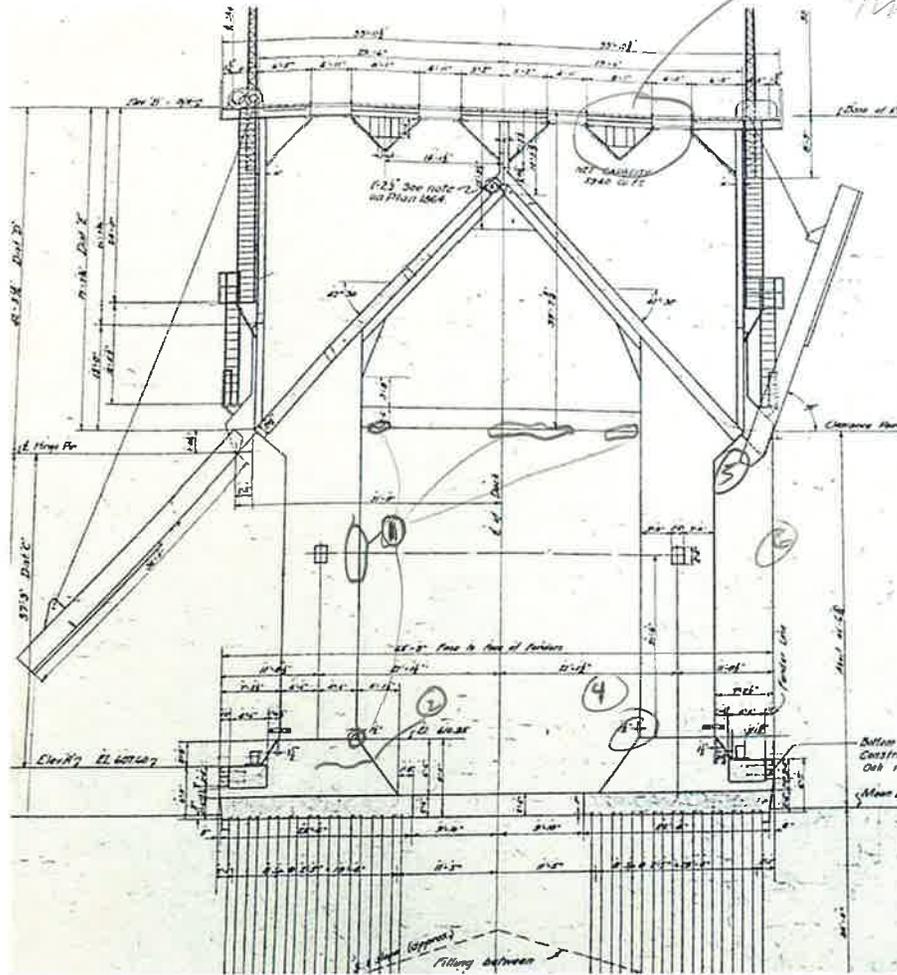
concrete extends to top everywhere  
 this detail incorrect

- ① Spalled core w/ exposed rebar - (4)  
 142, 143, 144
- ② crack along cold joint 145  
 Bu & up Railing on Northwest Side of  
 Vertical 1. 4282
- ③ South: Cracks on Footing
- ④ Spalling on corner north east corner  
 4283 4284  
 Between 1+2 vertical Cracking
- ⑤ Spalling has occurred. 4376
- ⑥ Spalling has also occurred with visible  
 Rebar on SW/SE & South Sides of  
 Vertical 4377  
 Cracking on South face between 1+2.

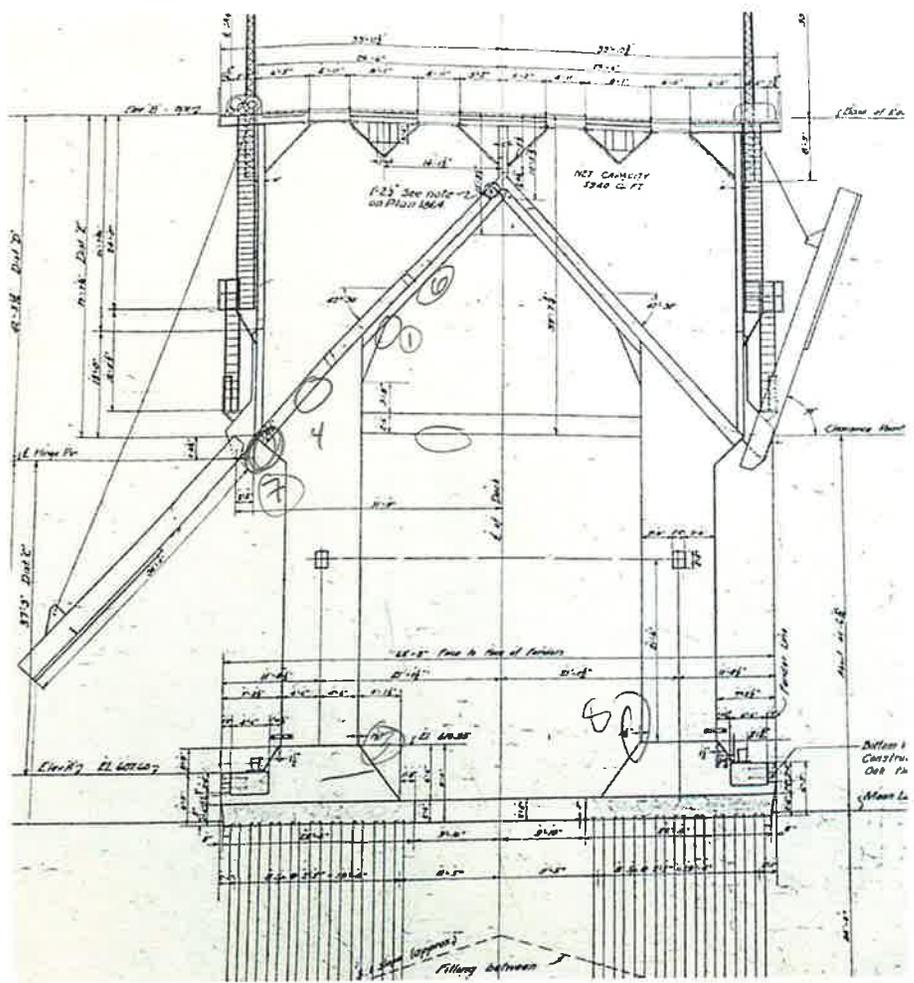
BENT #: 12

Expansion Joint 4316-4346

- ① Rebar Showing on face
- ② Aggregate showing on Cross beam same on Previous
- ③ Cracks in footing again  
Photo 4241
- ④ Deteriorated Horizontal, well spalled.
- ⑤ Expansion Joint 4243 / 4244  
4248
- ⑥ Between 12/13 Weathered Concrete  
Aggregate showing.
- ⑦ Spalled Concrete and Steel showing
- \* Lamp Above Possibly Hazardous.
- ⑧ Rebar visible and Spalling 4314

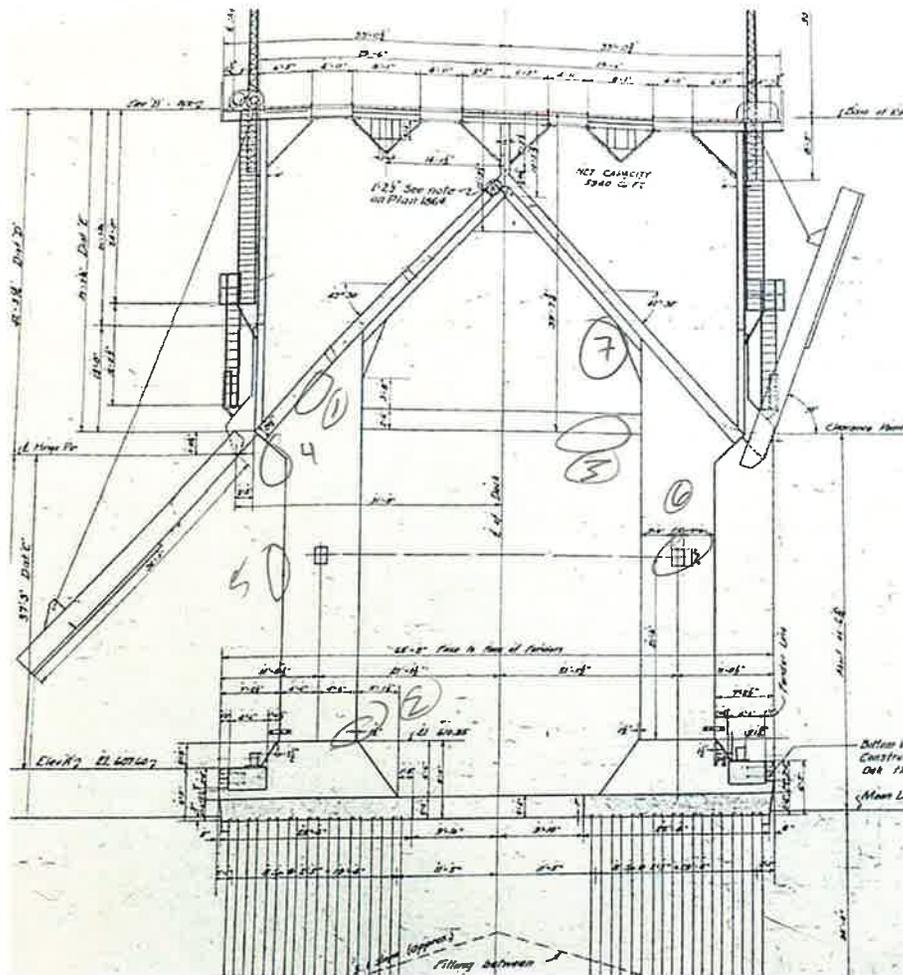
BENT #: 13

North ① 4380 Between 12-13 Aggregate showing

② Spalling on top of Fook 4381  
SW

④ Spalling Has occurred 4442 4444

⑤ Exposed Rebar and Visible Spalling  
Vertical Cracking on North Face  
Lighting Fixture

⑥ Spalling on member between 13+14 4447

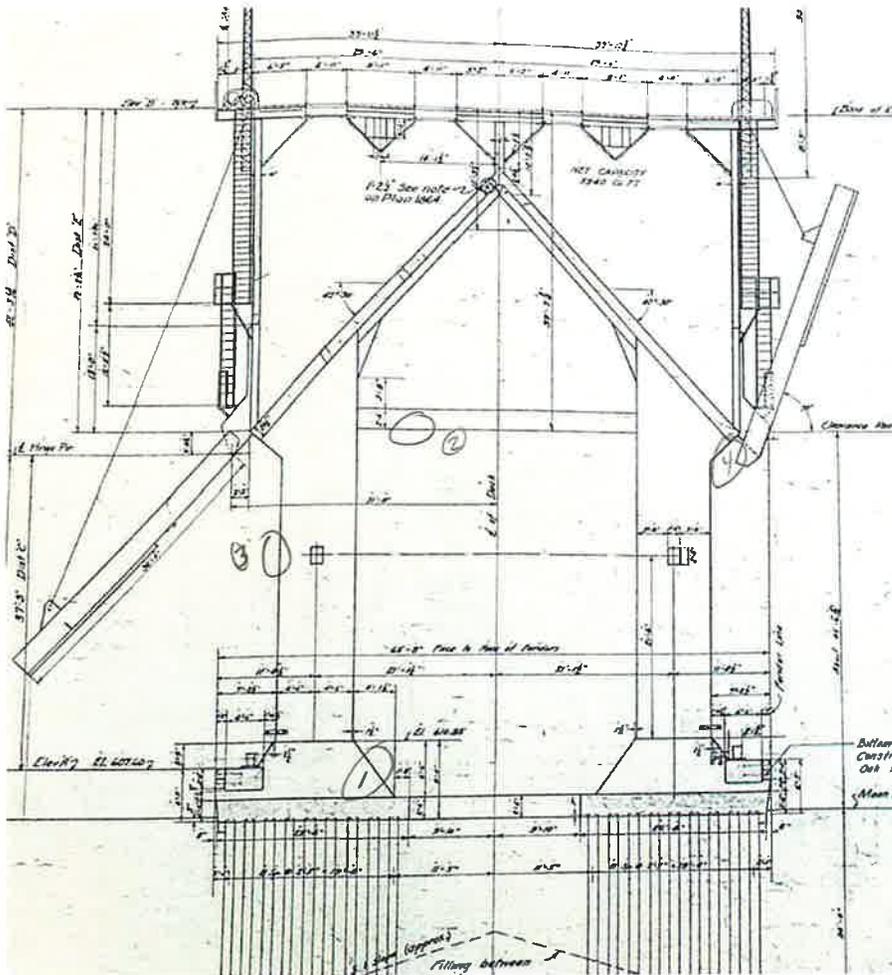
BENT #: 33

① Vertical Cracking on foot, Not uncommon.
③ Spalling Concrete w/rebar showing 4533
* North Over ③ Spalling is apparent on NW Edge Cracking on North Walkway of 32x33 33x34 Cracking on North Walkway South End NE Corner delamination 4565 South Over Exposed Rebar 4571 32x33 4572 Cracking
