## Lower Harbor Ore Dock Inspection Report

Marquette, Michigan

December 11, 2014

GEI Project No. 1330920

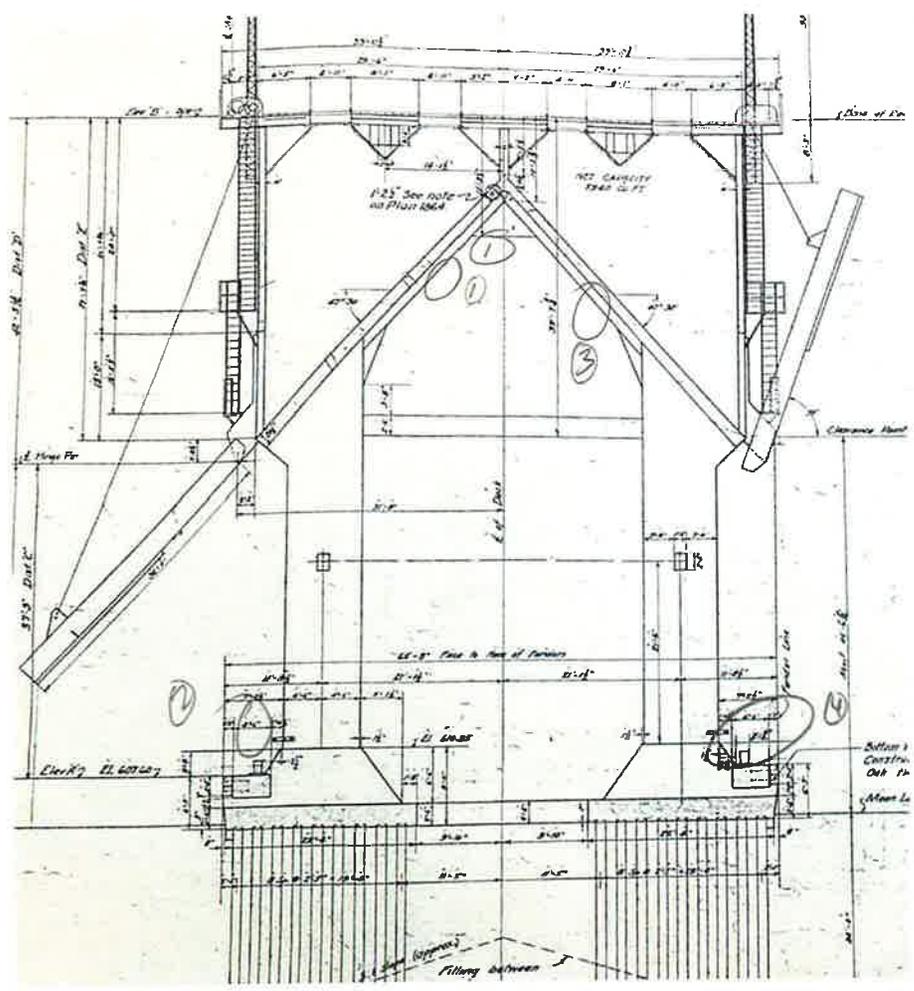
SECTION #: 4  
 BENT #: 36

North Inside: ① Rebar visible in Crest of Ceiling
4589 4590
Crack 4636 Crack in North Walkway
② Delamination on lower NE 4639
South Inside:
③ Delamination in between 36-37
Rebar apparent. 4701
South Outer:
Crack in South Walkway 36-37
Crack → Rebar in 36-37 Crossbeam.
④ Delamination on SE → SW Edges of Foot.
4735-39

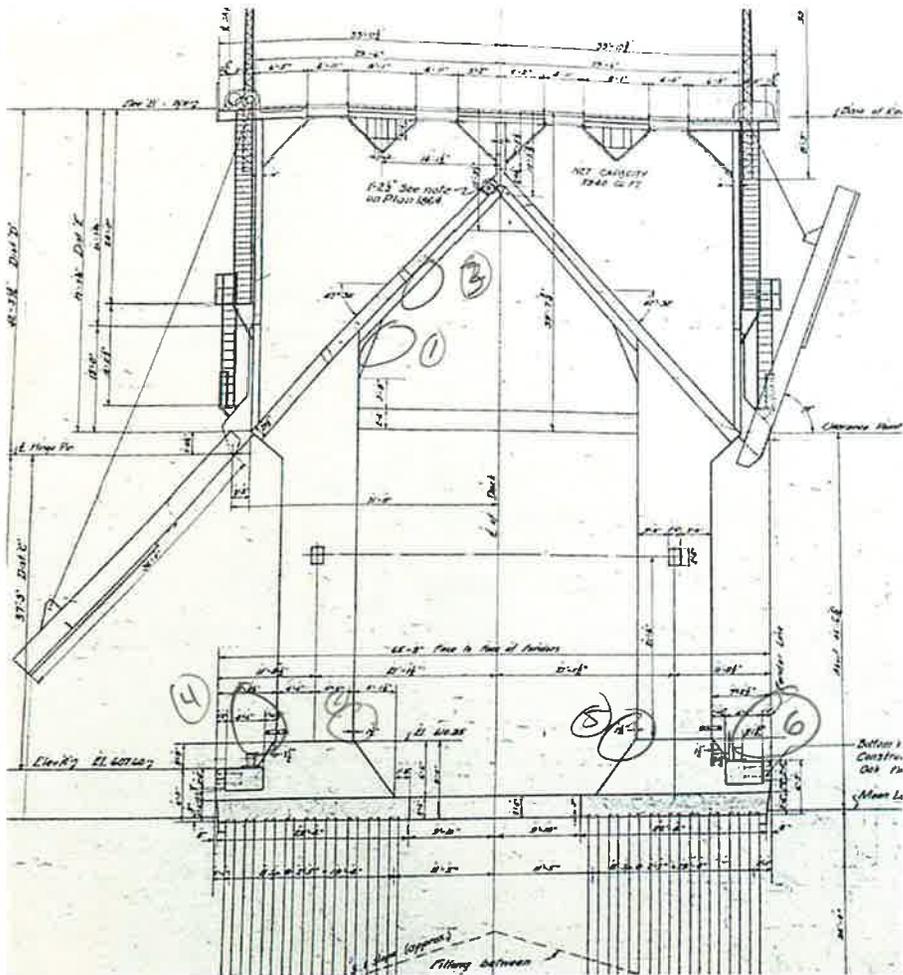
BENT #: 37

① Rebar visible w/ spalling 4591  
② Spalling/Delamination SE 4592  
Cross Member of 37-38 4593  
Rebar Visible.

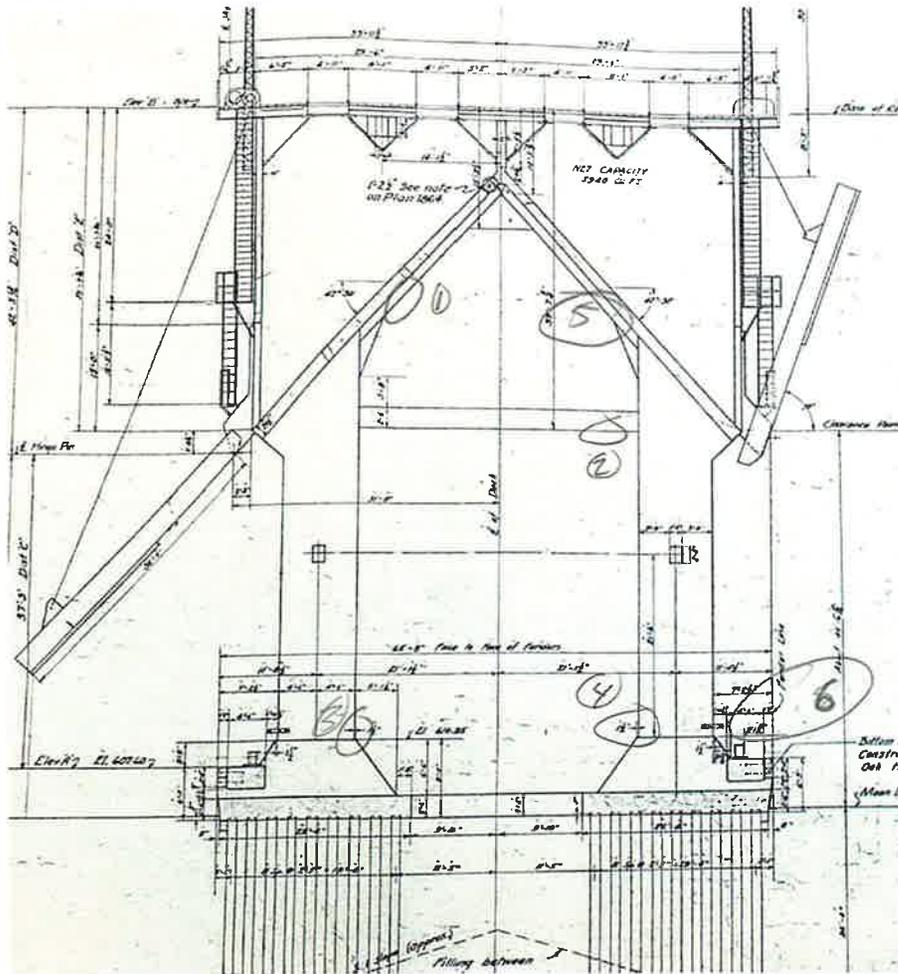
BENT #: 39

① 4595 Rebar Visible

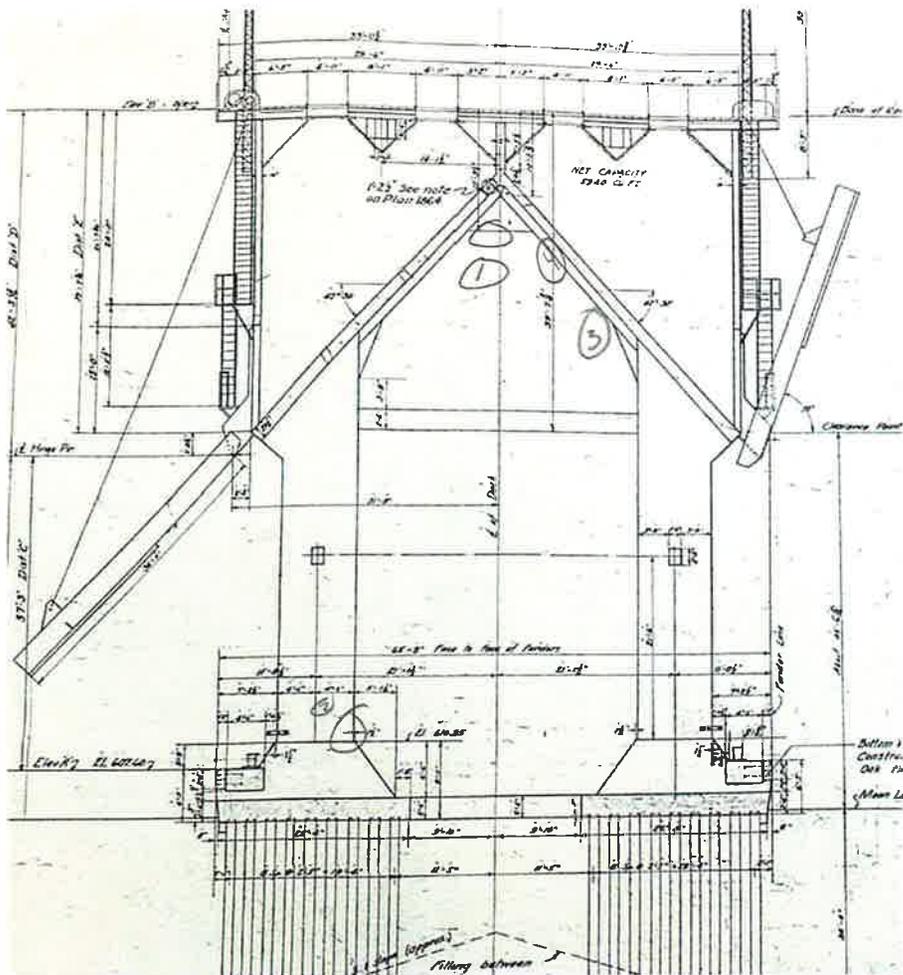
BENT #: 41

Rebar exposed on South face of 40-41  
4602

Rebar visible in Crotch of Ceiling.  
4603

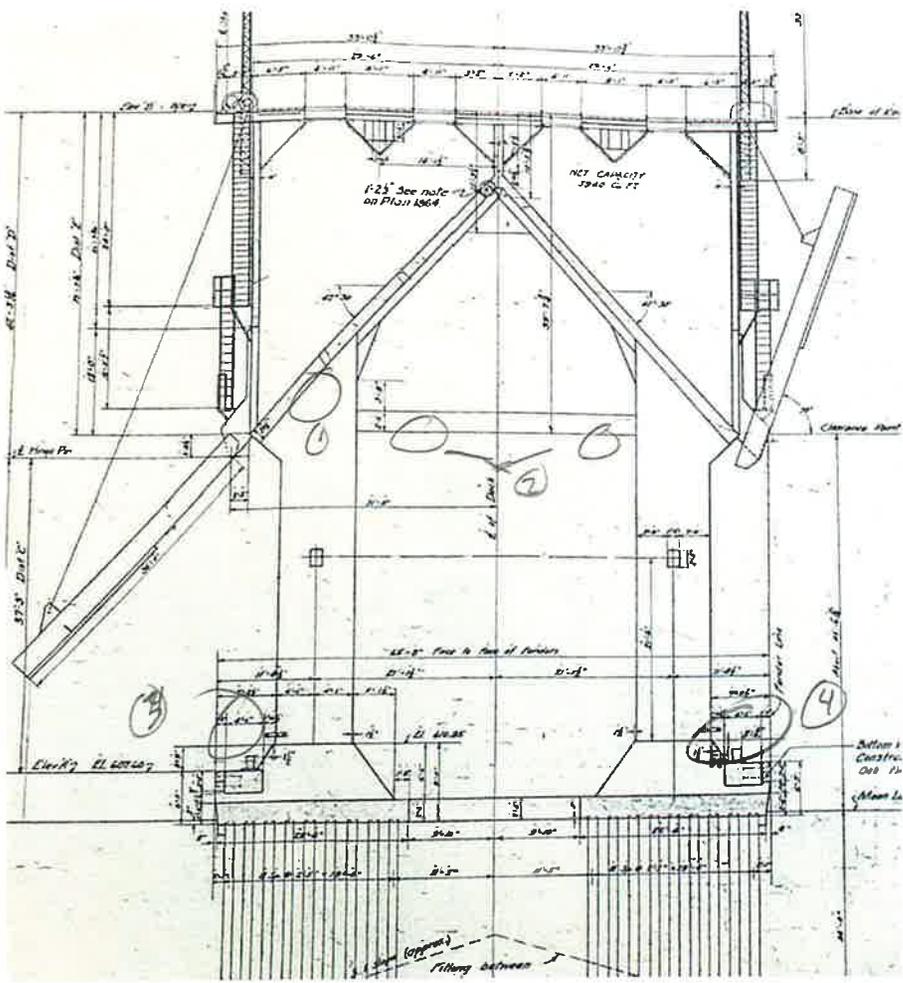
SECTION #: 4  
 BENT #: 42

①	41-42 Rebar Exposed 4605
②	Rebar exposed Cracking as well
North	Walkway
	42-43 Crack on North Walkway
③	NE Rebar Exposed 4628
	41-42 4629 Cracking on Corusbeam.
	41-42 4630 Crack on North Walkway.
	South Inside: 42-43 Crack on
	South walkway.
④	Deformation on SE+SW Edge of
	Top of Foot. 4704-25

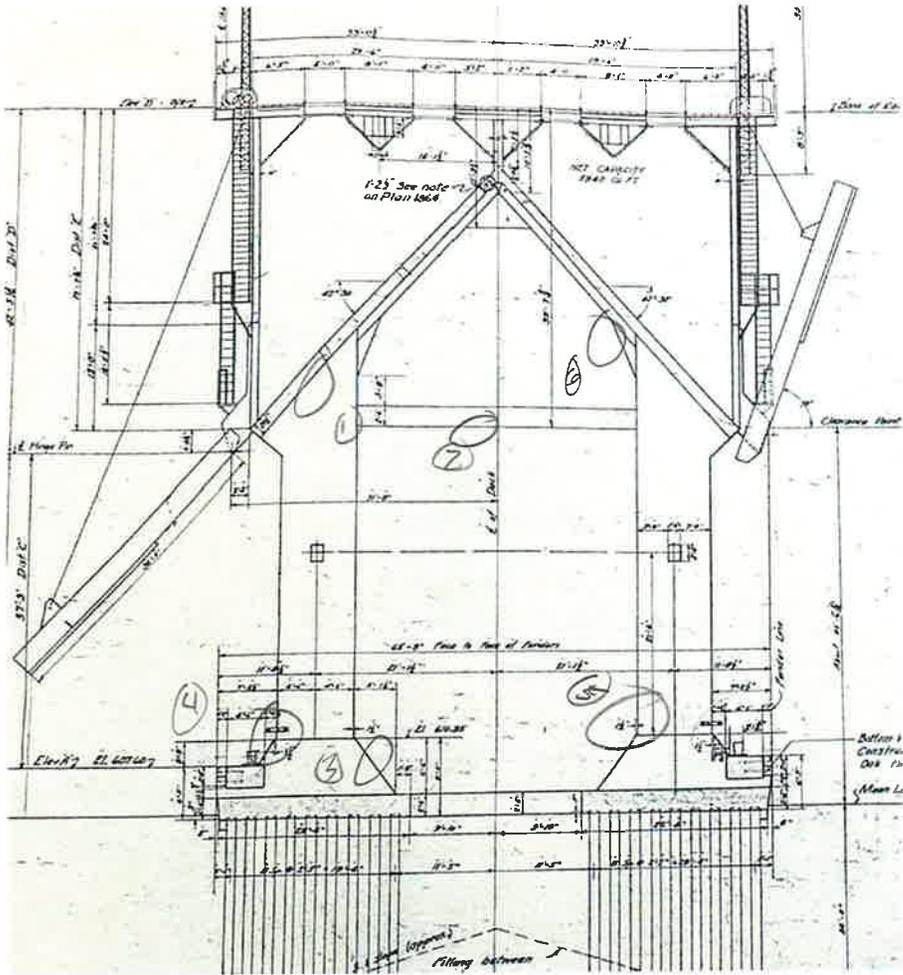
BENT #: 43

42-43	4608	(1) Rebar exposed
		(2) Potential Cracking. 4609
		(3) 4610 Vertical Cracking.
		North Outer
		Cracking on North Walkway 4624 43-44
(4)	4625 4626	Delamination on NE+NW Edges
		South Inside:
		(5) Top of Foot NE+NW Spalling w/ exposed rebar. 4710 4711
4712		(6) Exposed Rebar 43-44 on Face of Slab E. South Out. Crack on 43-44 South Walkway. 4723

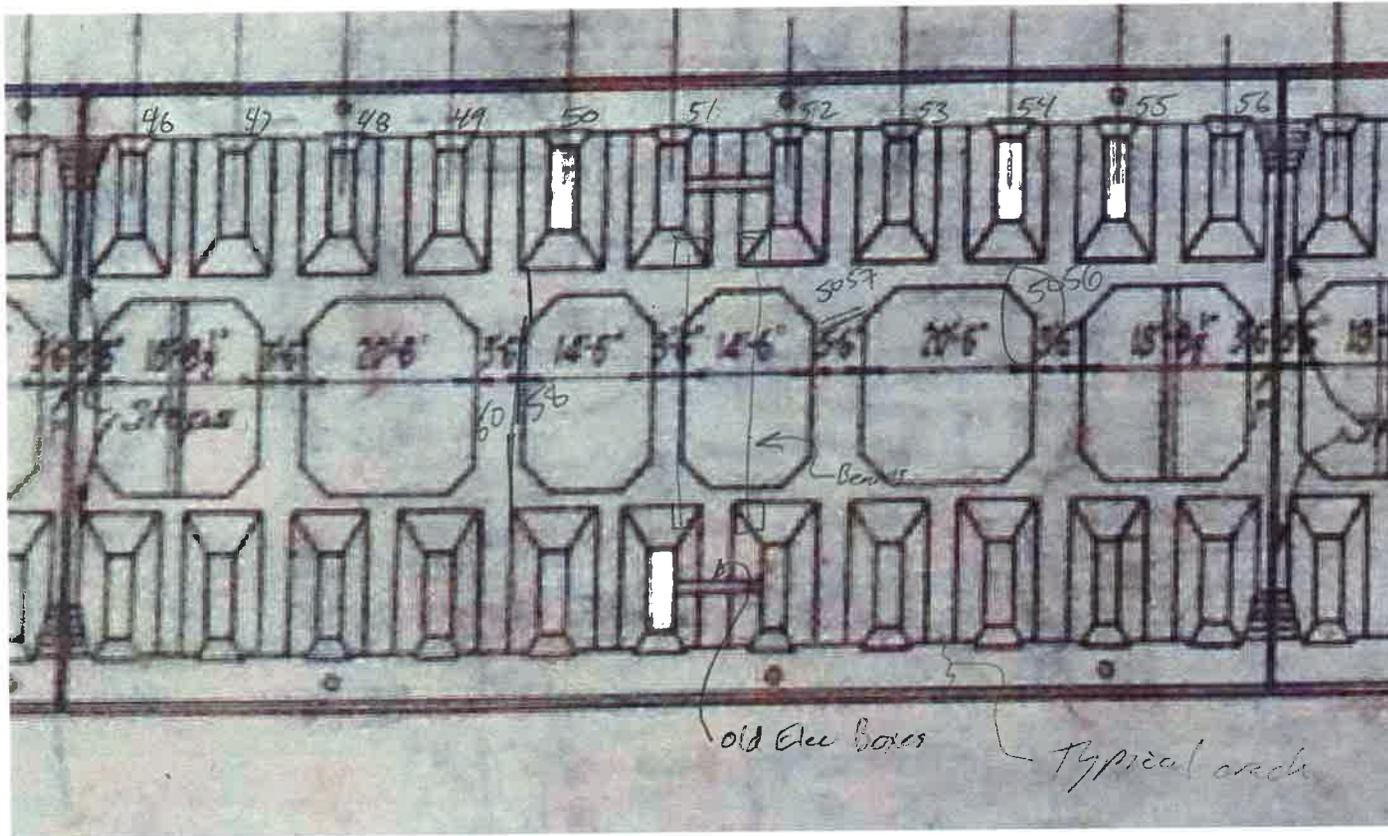
SECTION #: 5

Elec Deck between bents 40+41	5056- spalling along interior opening of pile cap
Dimensions match	pile cap
Minor conc. deterioration	
5057- Spalling/delamination of pile cap floor	
5058 - Construction joint w/ delamination

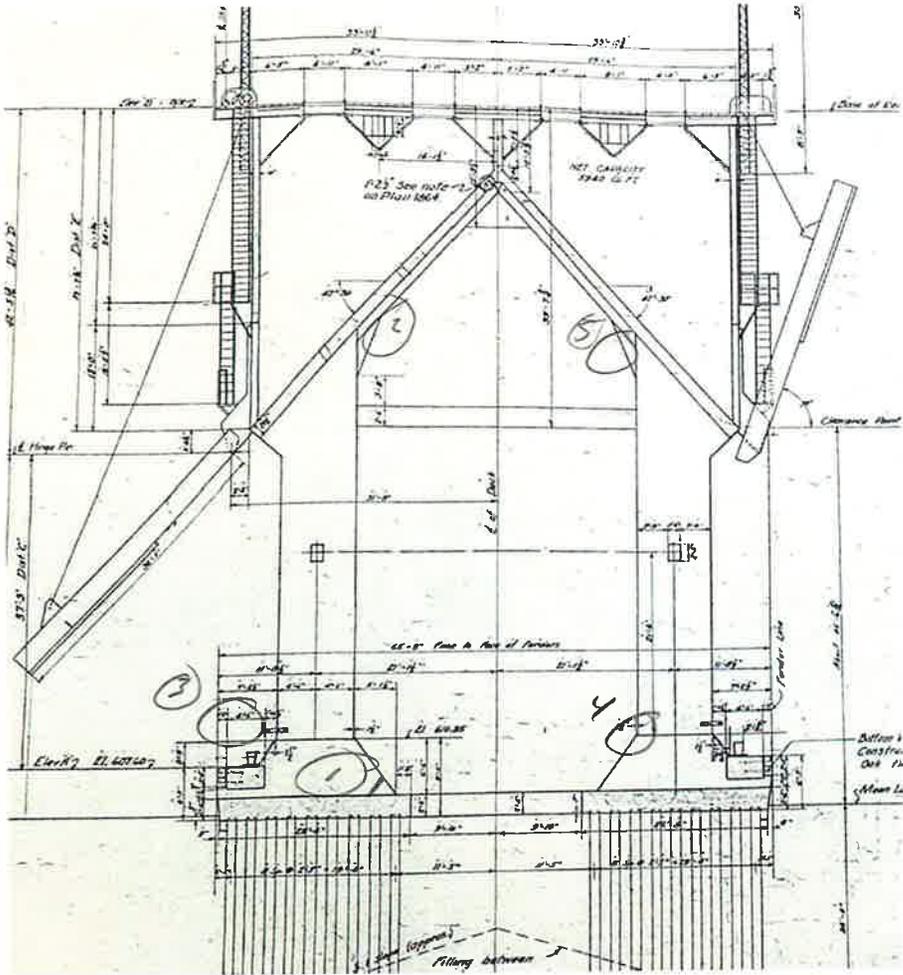
SECTION #: 5  
 BENT #: 47

North Inside
4746	① Spalling and delamination on base of foot as well as SE upper edge. w/rebar. Vertical cracking also apparent.
4747	② Visible Rebar in spots on 47 as well as slanted face of 47-48.
	North Outer
4752	③ Crack in 47-48 North Walkway. Rebar exposed on NE side of foot, as well as NW Edge.
4780 81	South Inner:
	④ Rebar visible on NW Edge. 4780
	⑤ Rebar on triangle. 4787
	47-48 some Rebar on Slanted Face.
4729	South Outer 47-48 Crack in South walkway
4730	Delamination 47-48 in Cross Beams.

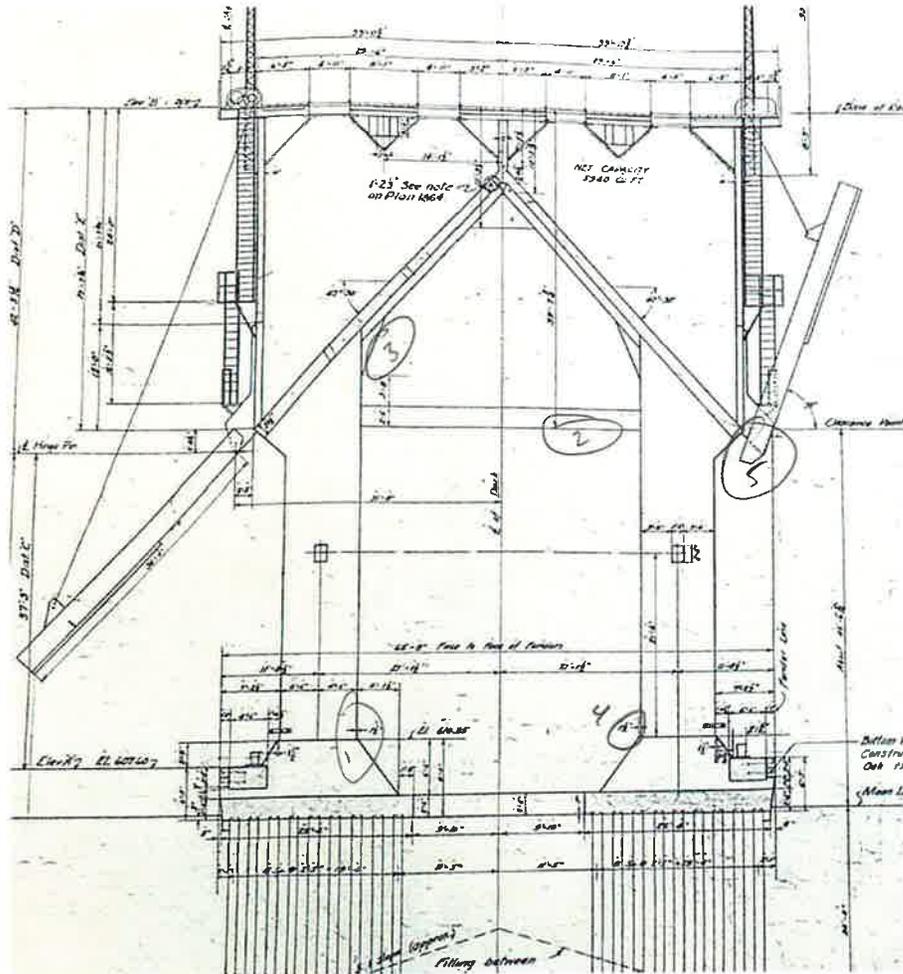
BENT #: 48

North Inside ① Spalling w/exposed Rebar on SW Edge.
4745	② Spalling
①	Deterioration of SE Edge
4749	③ Rebar visible,
4750	48-49 Cracking on Slanted Face,
	North Outer
	Crack in 48-49 North Walkway.
	South Inner
4758	④ Rebar visible on NE+NW Edges of Foot.
49	South Outer
4827	48-49 Crack in South Walkway.
⑤	48-49 cracking in Overhang

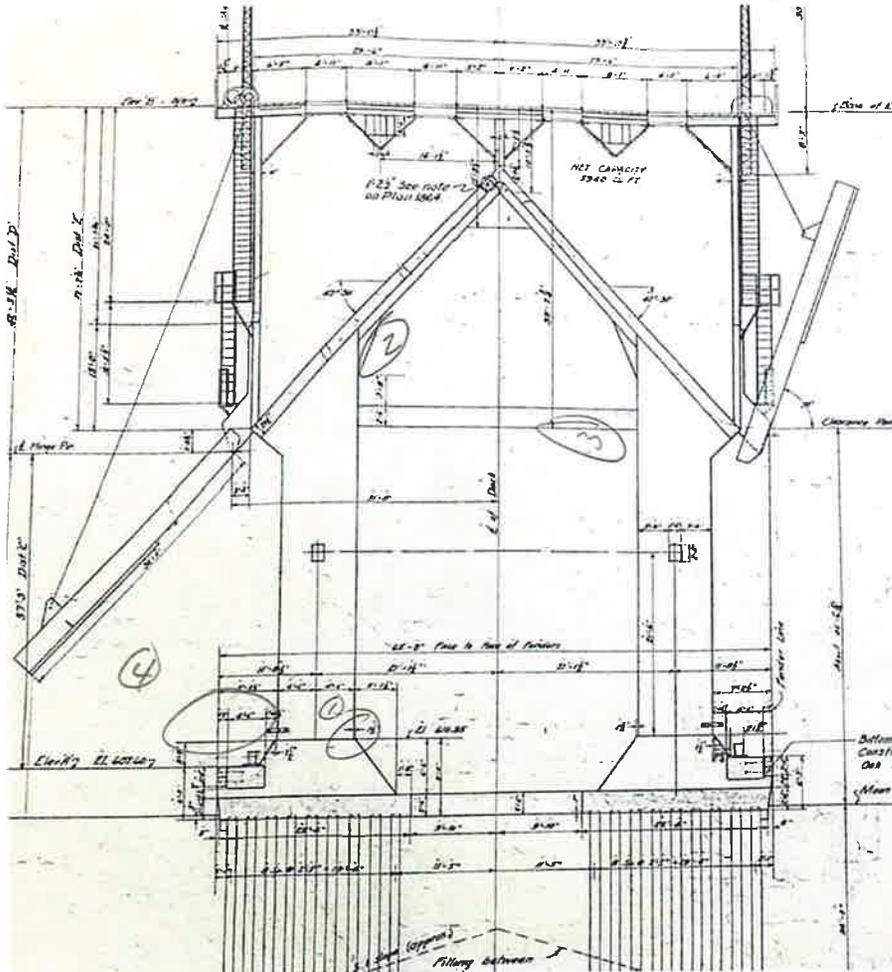
BENT #: 49

4751	North Inner (1) Delamination on SW Edge on top of foot & Spalling on SW Edge on
4752	Bottom.
(2)	49-50 Rebar visible on started face
(5)	Rebar visible 4753
	North outer 49-50 crack in North walkway. 4779
4778	49-50 Delamination on Cross Beam
(4)	Rebar exposed on NE Edge of foot South Outer
4524	49-50 Crack on South Walkway.
	49-50 Delamination in Overhang.
	Cross Beam 4525
	Crack in Walkway 4526

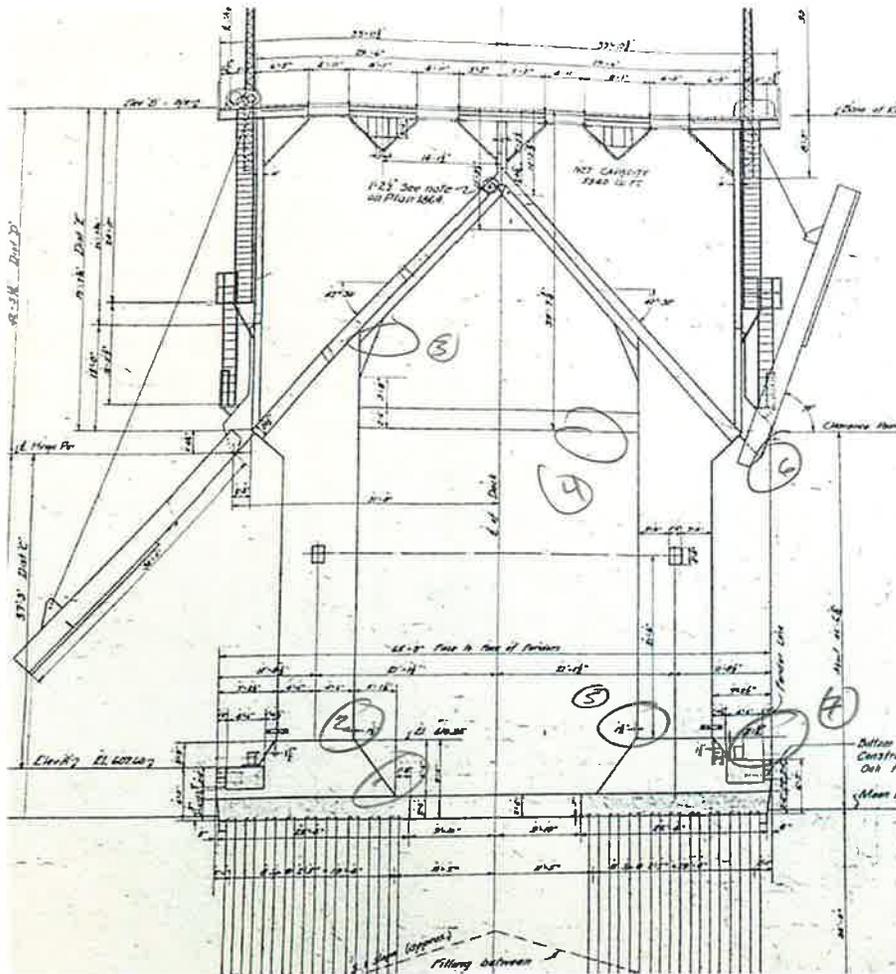
BENT #: 50

- ① North Inside, Spalling on SW Edge of bottom foot 4755
- ② Spalling w/ Rebar on South side of Vert. 49-50 cracking on Cross Beam. 4754
- ③ Rebar visible 49-50 Rebar visible on Spalled face.
- ④ Rebar on Ceiling Cross Member North Outer.
- 4777 Crack in North Walkway 50-51 South Inside
- 4781 ⑤ Spalling on NE Edge of Foot. South Outer
- ⑥ Vertical Cracks on Overhang 51-50
- ⑦ Delamination 4827 Cross Beam 4822

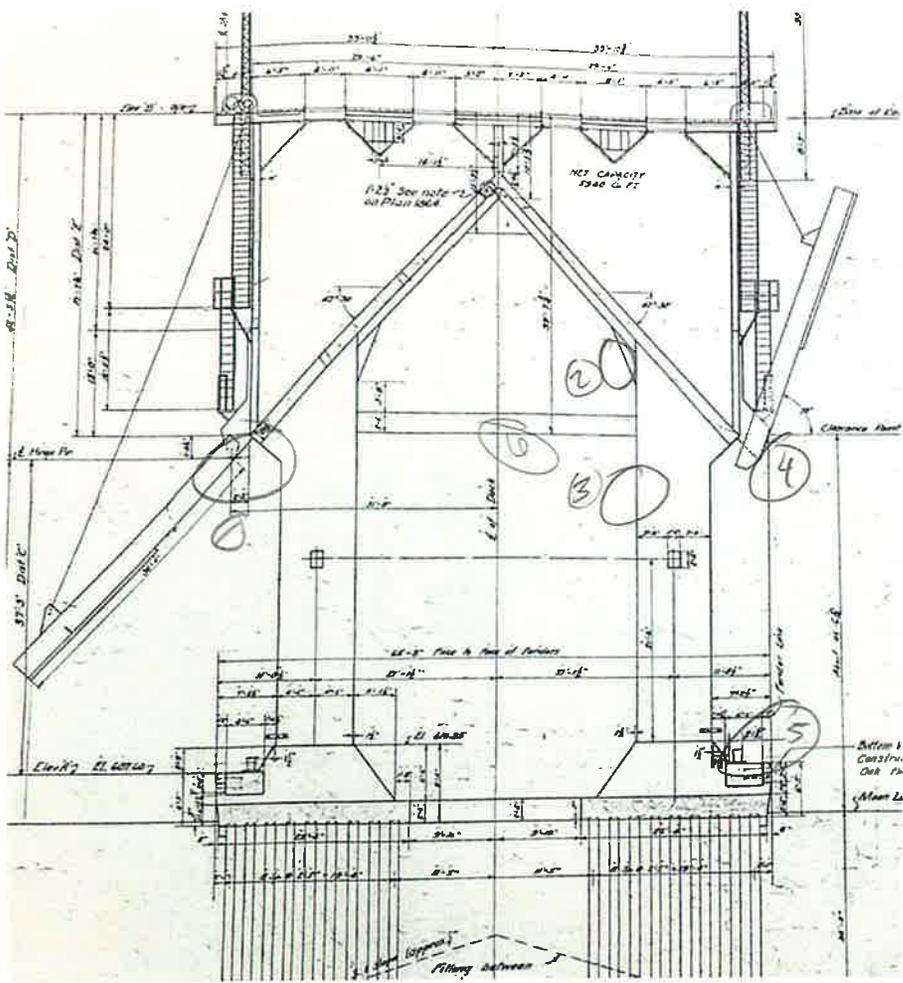
SECTION #: 5  
 BENT #: 51

North Inside.  
 50-51 Rebar Visible on Slanted Face. 4756

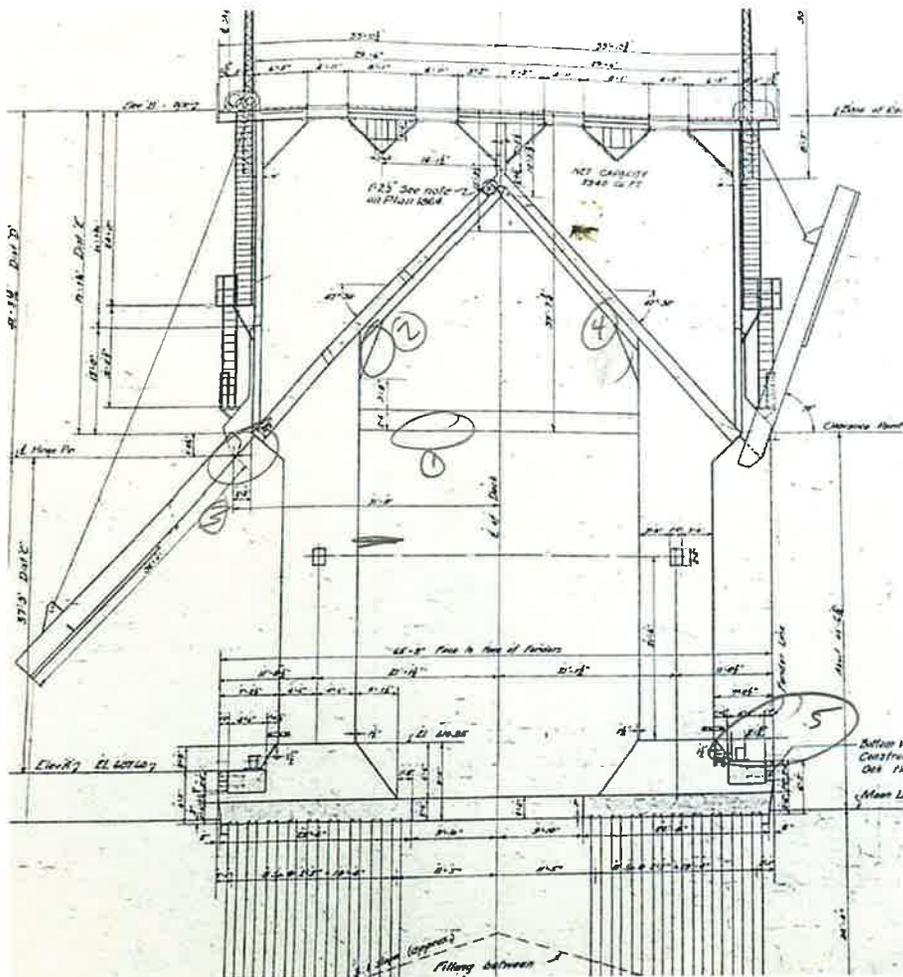
BENT #: 52

North Look.
4760 1/6 Horizontal Cracking 51-52 South Wall.
① Rebar > Cracking visible. 4761
Rebar Protruding From 51-52 Wall
② Rebar exposed. 4762
North outer:
③ Poorly consolidated concrete on edge.
52-53 4776
④ Rebar Exposed. 4794
South outer:
⑤ Spall > Rebar on SW Edge of foot.
<del>3</del>
Crack in Walkway 4816

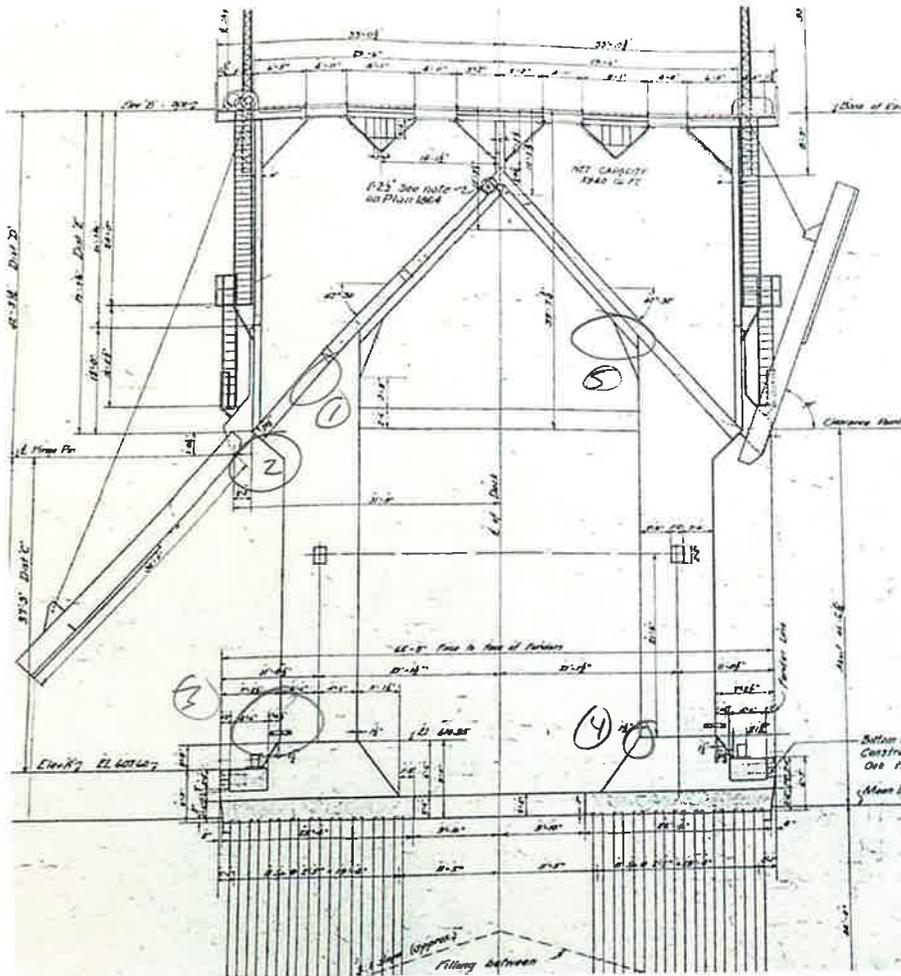
BENT #: 55

North Side (1) Rebar exposed  
on Slanted face of 55-56  
Multiple Places 4766  
Cracking in Cross Beam 55-56. 4767  
(2) Delamination. 55-56  
(3) Delamination on top of beam NE 4773  
South Inside.  
4802 (4) Spalling w/ rebar on NE edge of beam.  
4803 (5) Rebar exposed.  
South Outer.  
55-56 Crack in South Walkway 4809

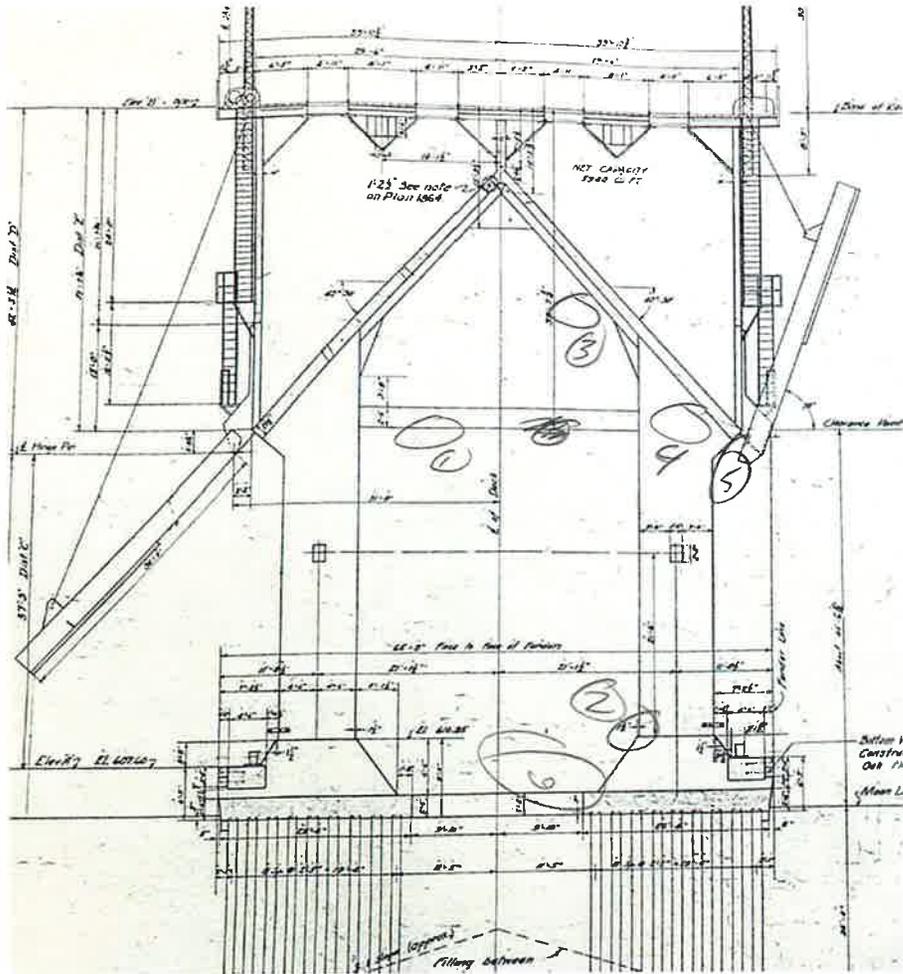
BENT #: 56

- North Side:
- (1) Rebar exposed on Beam. 4769
- Rebar exposed on Slanted Face 56-52
- Expansion Joint. 4770 4771
- Delamination on Expansion Joints
- Lighting Fixture 4772
- Loose Cable. 4765
- North End:
- South Lines
- 4805 (2) Delamination on NE edge of End
- (3) Spalling
- 4806 (4) Spalling on expansion Joint
- South Area
- (5) Cracking & Rebar visible
- 4807 (6) Rebar Ground
- 4805 Expansion Joint

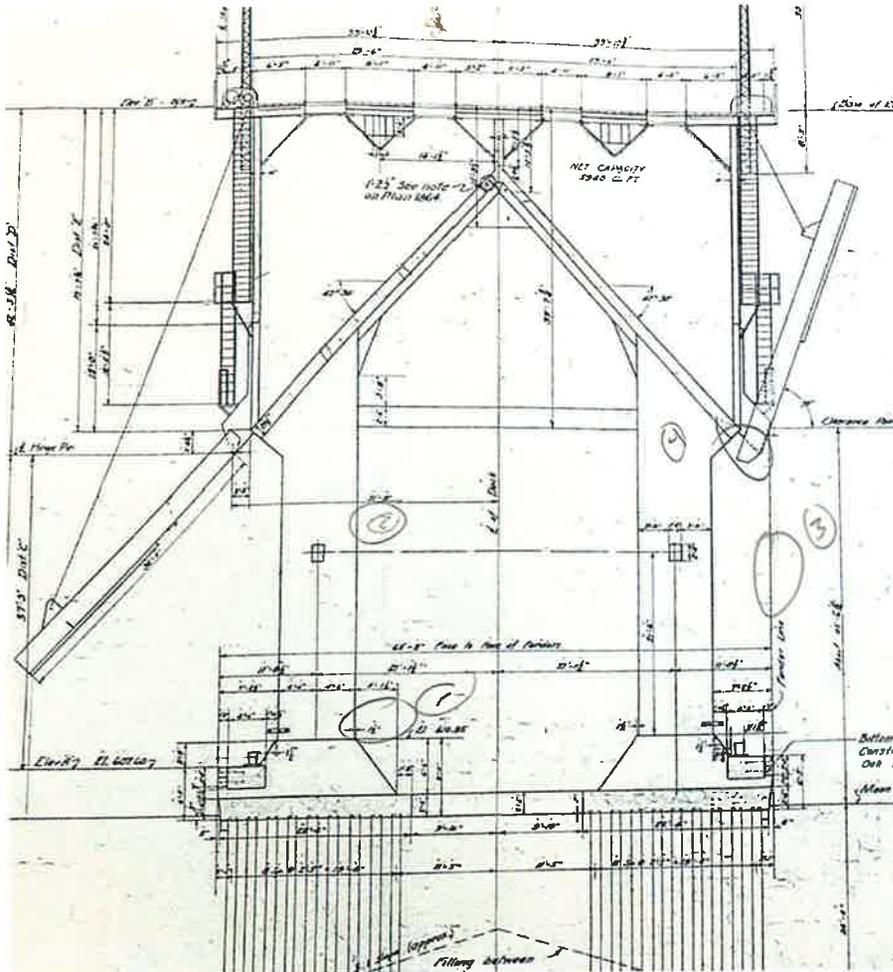
BENT #: 62

- ① North Inside 4919 on NW top of foot  
4920 Starting out Rebar 62-63  
Outer 4938 Rebar in 61-62 Cass  
6162 4939 Crack in North Walkway.  
South Inside  
Cracking on 62-63 wall 4957  
Piece of Rebar 4958
- ② Crk. 4977 Cracking 62-63  
4978 Rebar on Overhang.

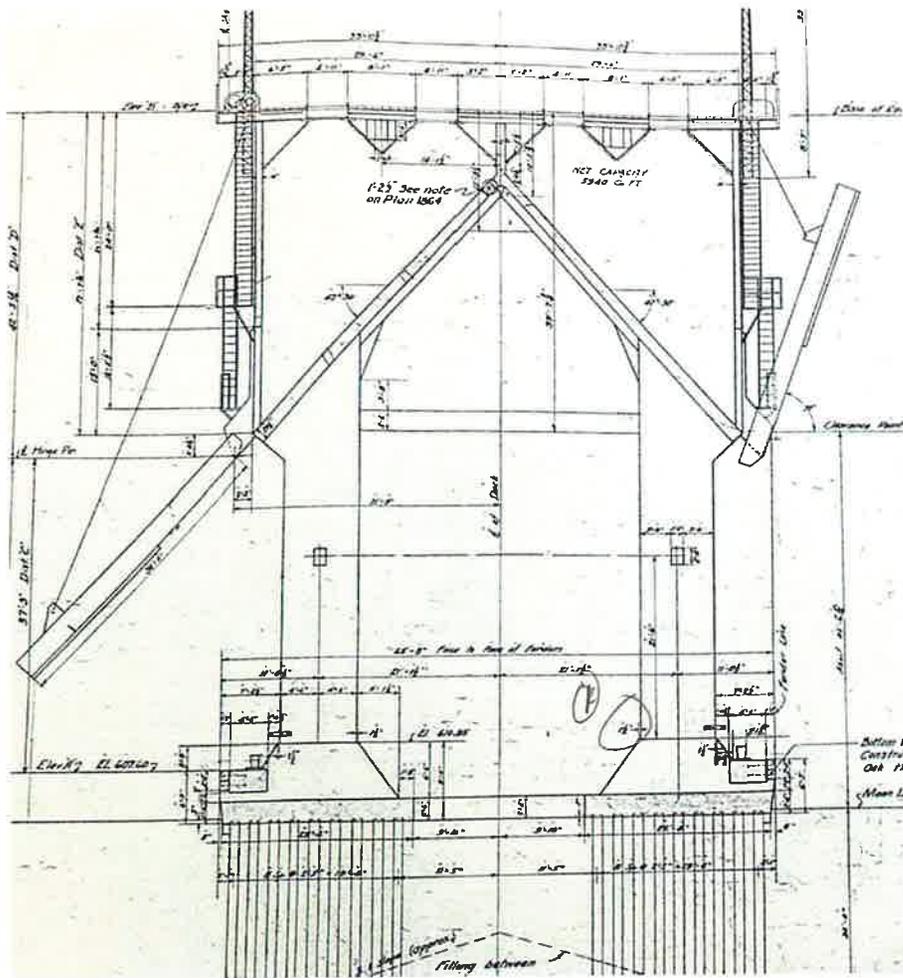
BENT #: 67

North Inside. Riber 4928 expansion joint 4929-31  
North Out- 4932 lighting Fixture  
South Inside- 04964 Riber NW Edge foot  
Displacement 4965 NE Edge foot  
Riber and Horizontal Crack 4966-69 ±70.  
Expansion joints

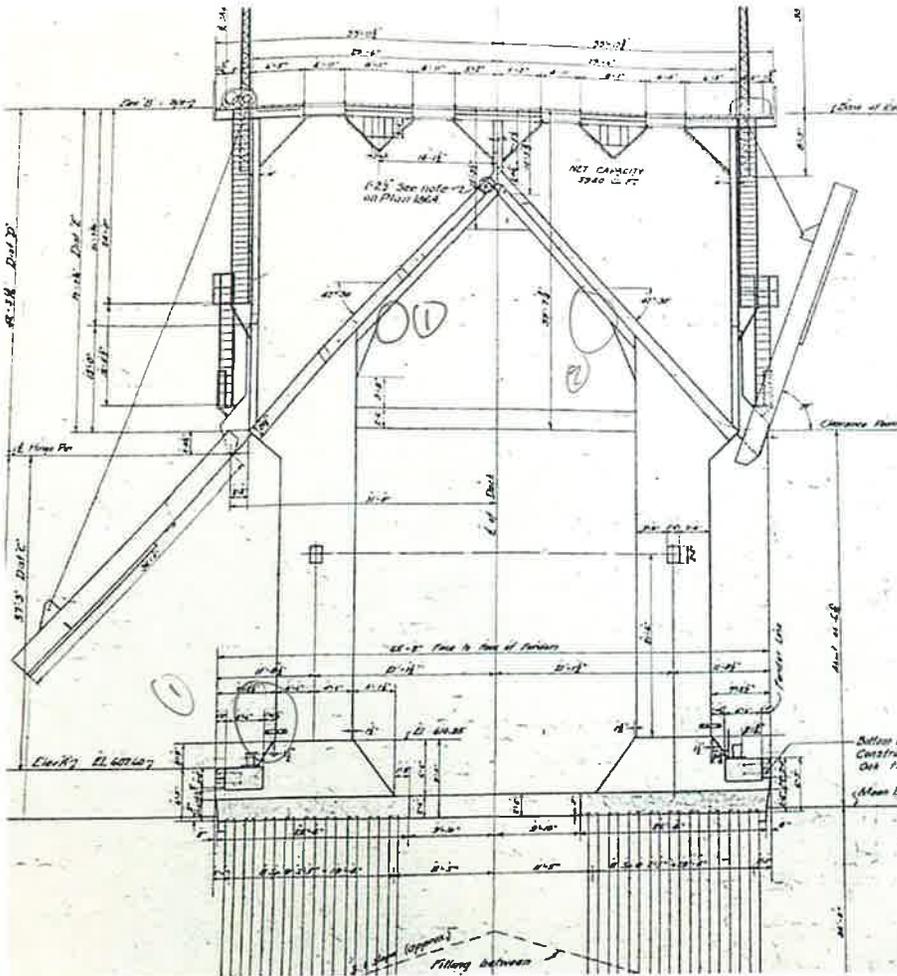
SECTION #: 7  
 BENT #: 69

North 22: 1988 Top of Trough Rivet.  
 Out 1 Crack in Bottom 5010  
 South 22: 2 Rivets in Ceiling 5014 69-70  
 out 5040 Crack in South Walkway.

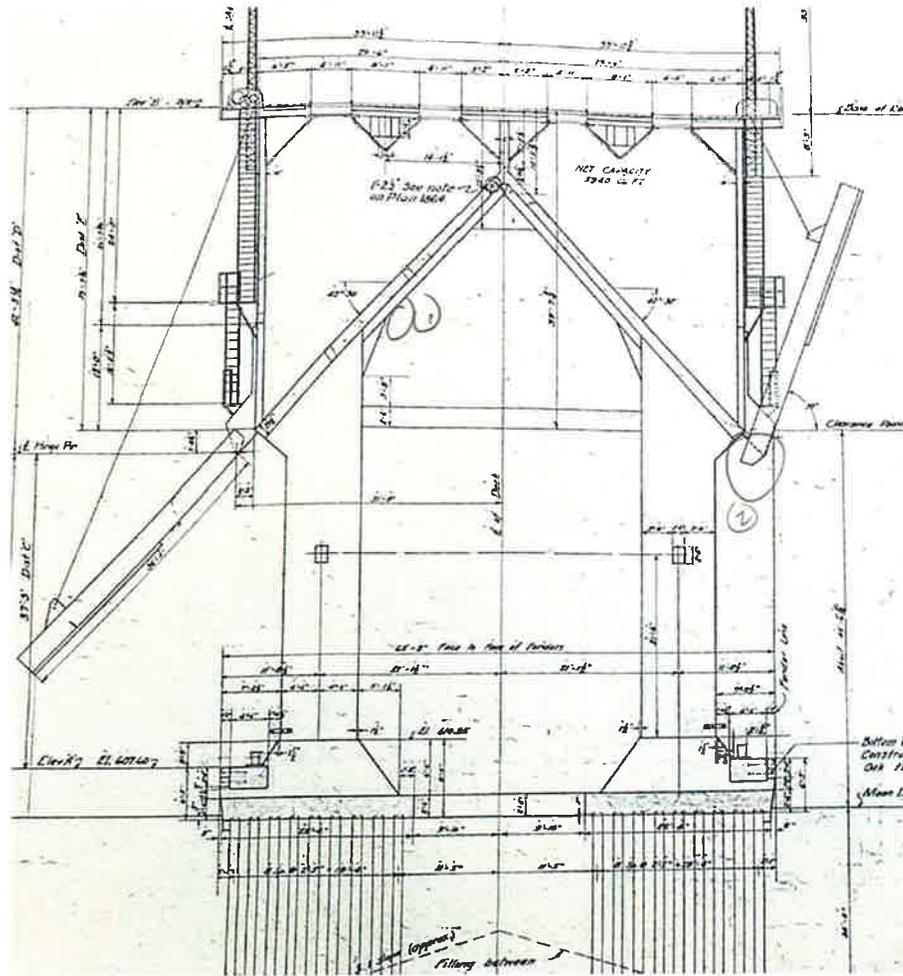
BENT #: 70

North in ① 4989 Top of Triangle Row

69-70 Crack in North Walkway 5009.

70-71 Walkway Crack. 5038

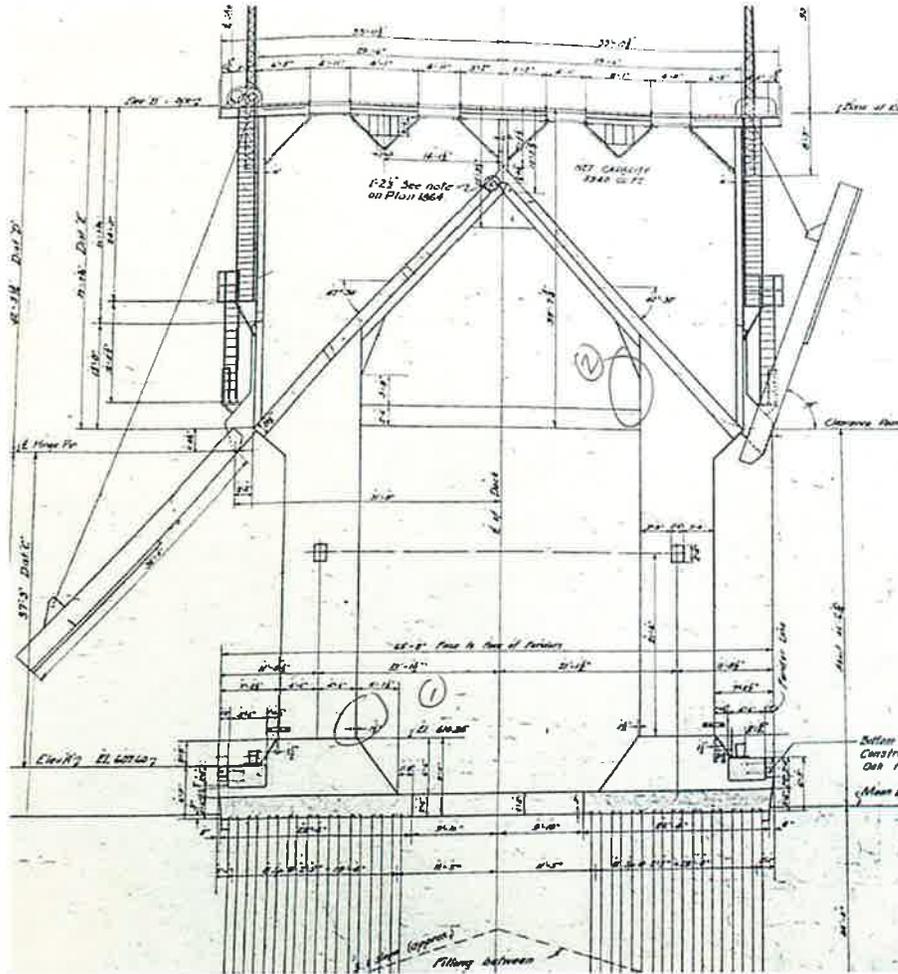
BENT #: 73

North In. ① SE Edge Relinced 4994

- Arc 72-73 Crack - weld 5005

- Arc 5032 72-73 Crack Walkway

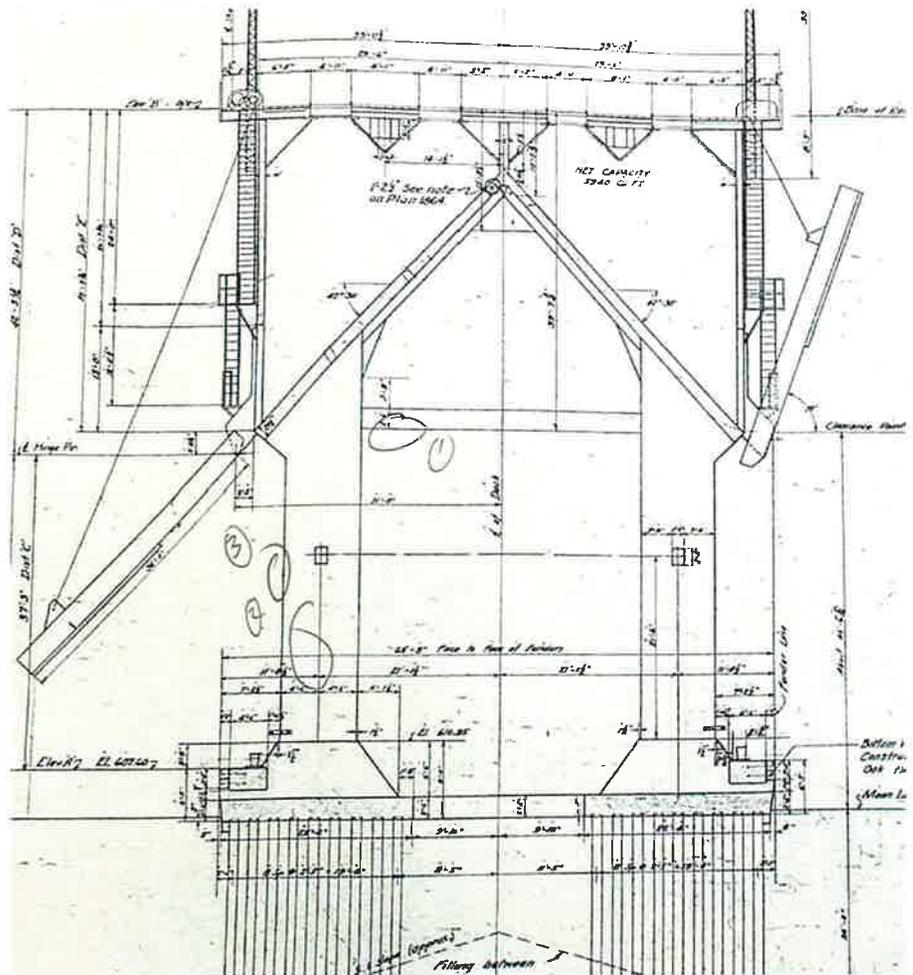
BENT #: 76

North In. 04999 5000 Rebar
② Rebar 5001
North Out. 5002 Crack in Walkway
③ Crack on North Wall w/Rebar. 5003
Soual
Crack 5025 Crack in Walkway
5026 Rebar in Wall
5027. George is attempting Photography
5028 Again.
